STANDARD FIELD SERVICE BULLETIN

FSB Number	CHRAEFSB2014-116
Author	Rajesh Verma
Date	11/24/2014
Subject	Moto X (2nd Generation) - Camera Cannot Focus/Blurry Image
Model Affected	XT1092, XT1093, XT1094, XT1095, XT1096, XT1097
Level Of Repairs	Level 2

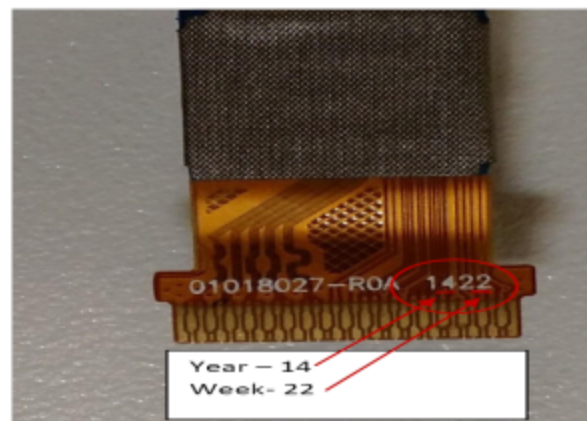
- Stock Rear Camera Module (Service P/N: 01018027001) Date Code 1435 and later. See below image example to decode date code.

- Cannot Focus
 - Blurry Image
 - Blurry Video
 - Picture Quality No Good
1. Following Service Manual, carefully disassemble the phone to gain access to the Rear Camera Module (Service P/N: 01018027001).
 2. Replace Rear Camera Module (Service P/N: 01018027001) with known good Date Code 1435 or later. See below image example to decode date code.
 3. Per Service Manual, reassemble the phone.
 4. Inspect Rear Camera operation for any focus, blurry images or picture quality issues.
 - a. If issue persist, then this bulletin does not apply. Follow normal troubleshooting to determine the problem.
 5. Following Service Manual, Completely reassemble and retest the device, per standard Service procedures, to ensure proper repair.
