STANDARD FIELD SERVICE BULLETIN

FSB Number	CHRAEFSB2014-98
Author	Rajesh Verma
Date	09/18/2014
Subject	Moto X (2nd Generation) - Skewed Medallion
Model Affected	XT1092, XT1093, XT1096, XT1097
Level Of Repairs	Level 2

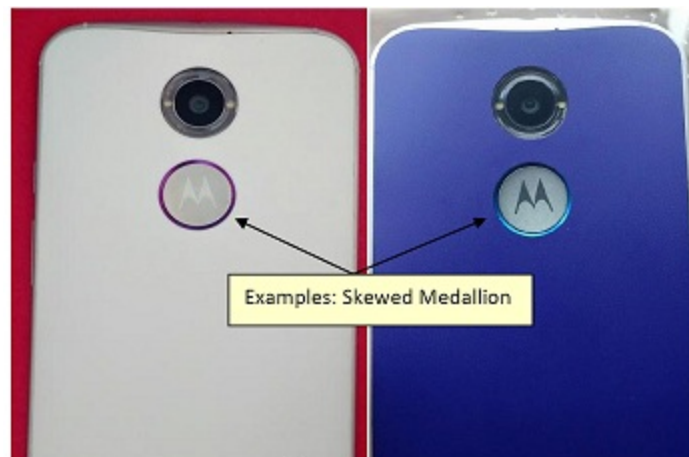
Figure: 1

Motorola is aware of a potential field return issue on the Moto X (2nd Generation) product related to Skewed Medallion. Engineering analysis identified that there was no adhesive on the back of the medallion to adhere to the housing or alignment fixture was used during assembly to make sure medallion was aligned correctly. New medallion part with adhesive on the back and alignment fixture has been designed to make sure part is aligned and placed correctly. See below example photos of skewed medallion.

Long Term Action: Since Sep 3, 2014, manufacturing start using new medallion parts with added adhesive on the back and alignment fixture.

1. Once replicated, Per Service Manual, carefully disassemble the rear cover from the device to gain access to the medallion as shown above in Figure 1.
2. Disassemble the medallion.
3. Replace new medallion part with adhesive on the back (Dark P/N: 01018061013 and Light P/N: 01018061014).
4. Use alignment fixture (P/N 4-00-U7-10000) to make sure medallion is aligned correctly.
5. Reassemble device Per Service Manual.
6. Inspect device for medallion alignment.
