STANDARD FIELD SERVICE BULLETIN

FSB Number	CHRAEFSB2014-108
Author	Anthony Bryan
Date	10/28/2014
Subject	XT1254 Droid Turbo - Rear Camera - Can't Launch
Model Affected	XT1254
Level Of Repairs	Level 2

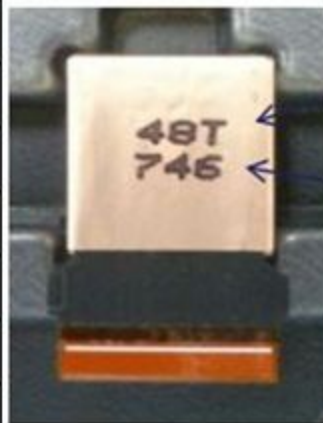
1. Following Service Manual, carefully disassemble device to gain access to 20MP Rear Camera Module (Service P/N: 01017884001).
2. Inspect the part markings to determine if it is affected by this symptom. See affected Date Code/Lot Code image below.
 - a. If affected, replace 20MP Rear Camera Module (Service P/N: 01017884001) and resume normal repair process.
 - b. If not affected, then this bulletin does not apply. Follow normal repair procedures.

Date	Lot
492	7EA
493	7EY
493	7EZ
493	7ET
493	7F3
49F	95Z
49F	955
49H	9A9
49G	970
49F	95Y

Date Code

Lot Code

Purge existing inventory of the 20MP Rear Camera Module (Service P/N: 01017884001) and scrap affected date codes. See affected Date Code/Lot Code image above.
