FSB Number	CHRAEFSB2015-26
Author	Tony Bryan
Date	06/01/2015
Subject	XT1225 Moto Maxx, XT1254 Droid Turbo - Power-Cycle / Slow Power-Up - Damaged Sensor (Drop)
Model Affected	XT1254 Droid Turbo, XT1225 Moto Maxx
Level Of Repairs	Level 4

STANDARD FIELD SERVICE BULLETIN

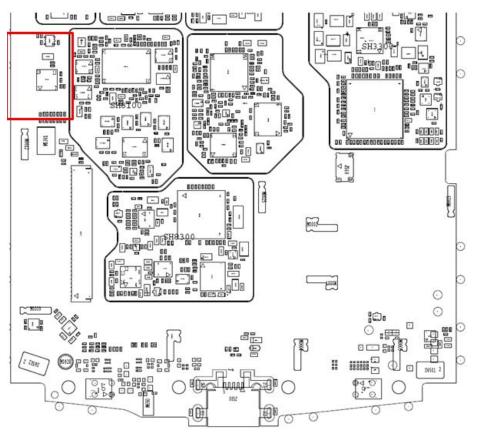
Engineering analysis of the returned devices found a damaged sensor component (U6150 - P/N: 51016138001). The sensor component was damaged by mechanical force likely resulting from a drop impact by the user. The observed symptoms can be intermittent or vary depending on the location and severity of the component damage. See Figure 1.0 below for details.

Figure 1.0 - Sensor Component - Board Location (U6150 - P/N: 51016138001)

- > Display Cannot Rotate
- > Device Randomly Reboots/Resets/Power-Cycles
- > Device Powers-Up Slowly (hangs for a long time during boot animation)
- 1. Validate the customer complaint thru testing. Please note that, in some cases, the symptom may be intermittent and require some extended testing to reproduce.
- 2. Re-Flash the device to the latest approved software to confirm issue is hardware related.
- 3. Disassemble and perform ABBA Swap technique to determine if the symptom tracks the PCBA.
- 4. Replace sensor component U6150 (P/N: 51016138001).
 - a. If issue is not resolved after re-flash and replacing sensor component U6150 (P/N: 51016138001), then the problem is likely related to a hardware memory issue and PCBA should be replaced/swapped.
- 5. Follow standard repair procedures to reassemble the device and complete re-testing to ensure proper repair.

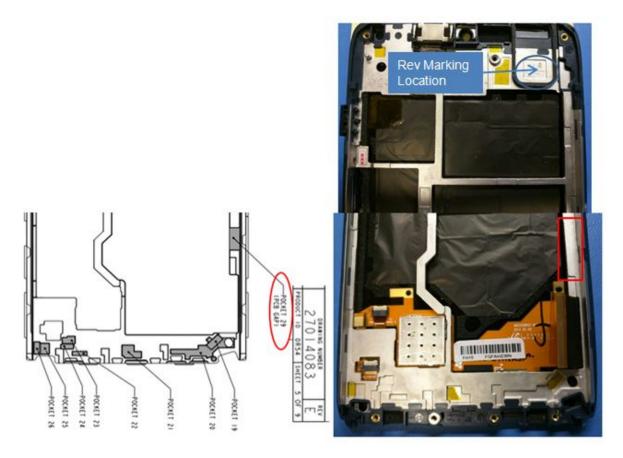
Figure 2.0 - F-Hsg Assembly (P/N: 0101785200x) - Rev E Changes

Motorola made a running change to the F-Hsg Assembly (P/N: 0101785200x) Rev. E and later to provide some additional air-space for U6150 in drop events. See Figure 2.0 below for details. Factory production cut-over to the Rev E F-Hsg Assembly starting in March 2015.
