## **STANDARD FIELD SERVICE BULLETIN**

FSB Number	CHRAEFSB2015-47
Author	Rajesh Verma
Date	07/20/2015
Subject	Moto G (3rd Generation) - Camera Picture Quality
Model Affected	XT1540/XT1541/XT1542/XT1543/XT1544/XT1548/XT1549/ XT1550/XT1551/XT1552
Level Of Repairs	Level 2

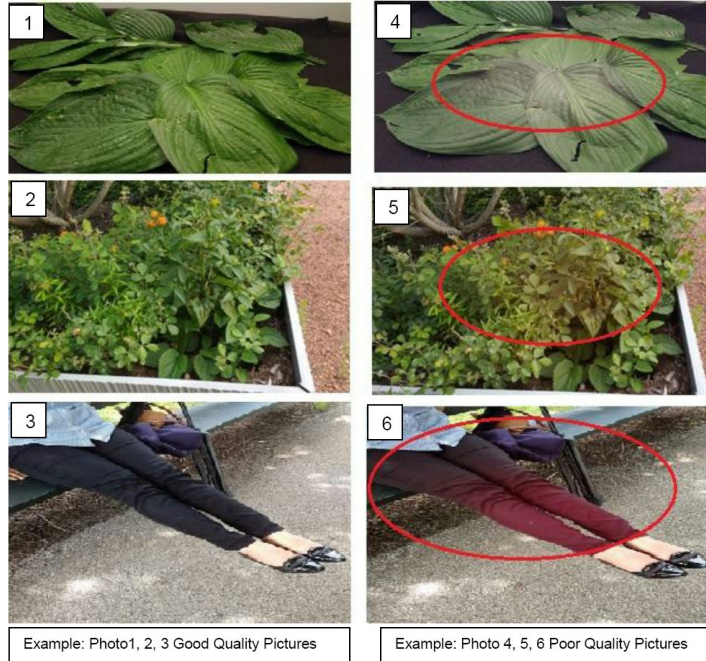
Motorola is aware of a potential field return issue on Moto G 3<sup>rd</sup> Gen product related to Camera picture quality. Photos taken with Moto G 3<sup>rd</sup> Gen under certain lighting conditions or at certain angles may show slight pink hue or in some cases increase red in center as shown below in example Photos.

Engineering analysis root caused this issue to a Camera module supplier manufacturing process issue where some out of specifications filters were used.

- c. If Fail then replace Rear camera Imager (P/N: 0101836700xW)
  - d. If pass then follow the normal troubleshooting process to repair the unit per customer complaint.

- b. Following Service Manual, carefully disassemble the phone to gain access to the Rear Camera module (P/N: 0101836700xW).
  - c. Replace Rear Camera Module (P/N: 0101836700xW) with a known good part date coded Z711xxD / Z711xxE and later. Refer to images provided above.

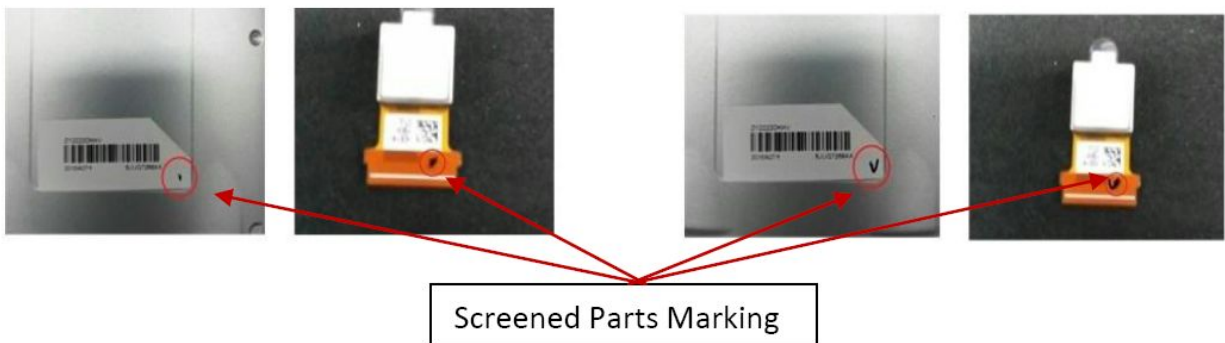
**Screened Part Markings:** Screened parts at manufacturing locations have been marked with “dot” or “V” marking on the Camera module as shown above.

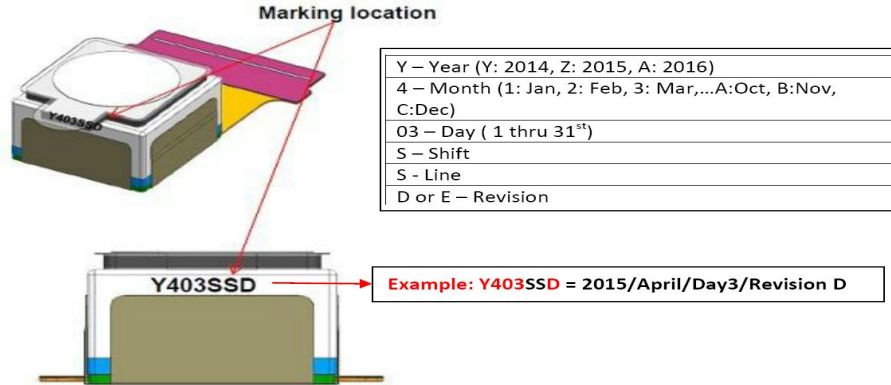
**New parts Good Date Code Markings: Z711xxD / Z711xxE and later (Date Codes after July 11, 2015 have been marked for screened parts)**

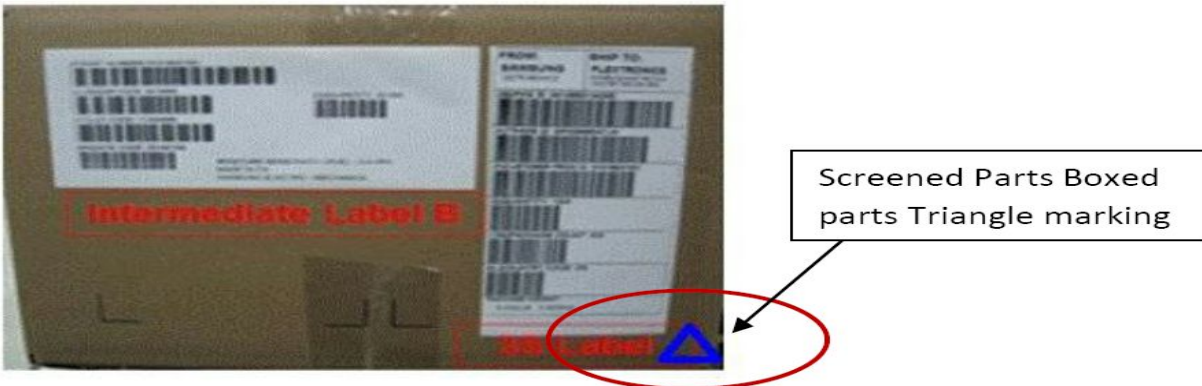
**Note:** Screened part boxes are marked with triangle as shown in photo above.

For Rear Camera Module (P/N: 0101836700xW), Use and Stock only parts that are either marked as screened (blue triangle on the box) or have a date code marking Z711xxD / Z711xxE and later.
