STANDARD FIELD SERVICE BULLETIN

FSB Number	CHRAEFSB2016-10
Author	Tony Bryan
Date	02/09/2016
Subject	Moto X Play, Droid Maxx 2 - Earpiece Speaker Audio (Pogo-Pins)
Model Affected	XT1562, XT1563, XT1564, XT1565
Level Of Repairs	Level 3

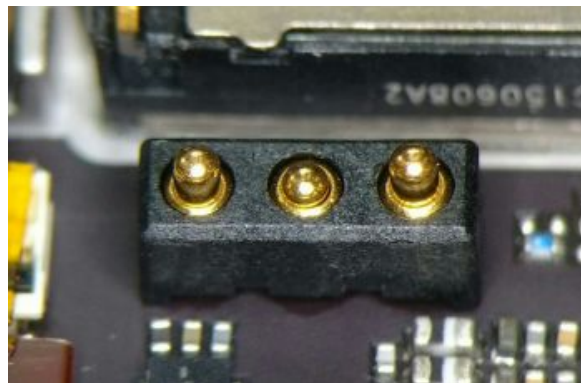
Motorola is aware of a potential field return issue on the Moto X Play (ROW) & Droid Maxx 2 (VZW) products related to "Earpiece Audio". Some users reported experiencing no in-call audio unless using speakerphone or accessory headset. In some cases the loss of in-call audio would be intermittent. Engineering analysis of these devices found that the Pogo-Pin Connector M5760 (p/n: 39014039007) had a pin that was stuck in a compressed state, preventing a proper connection with the earpiece speaker.

Cross-Section of the affected pin of the Pogo-Pin Connector M5760 (p/n: 39014039007) determined that the diameter of the barrel was slightly undersized, due to a supplier process issue.

The supplier has implemented process improvements to resolve this issue as of November, 2015.

1. Using standard testing procedures, confirm the device exhibits intermittent Earpiece Audio. **Note 1:** Some added light pressure to the rear housing, in the area of the earpiece speaker, may be required during standard testing to duplicate the issue. If confirmed:
2. Per Service Manual, carefully disassemble the device and replace Pogo-Pin Connector M5760 (p/n: 39014039007). **Note 2:** In the process of disassembly it is possible for the stuck pin to return to a normal position.
3. Per Service Manual, carefully reassemble the device and completely retest the device, per standard Service procedure, to ensure proper repair.
 - a. If issue persist, then this bulletin does not apply. Follow normal troubleshooting steps to determine the problem.
