## **STANDARD FIELD SERVICE BULLETIN**

FSB Number	CHRAEFSB2016-2 Rev. 1
Author	Tony Bryan
Date	03/21/2016
Subject	Moto X Play, Droid Maxx 2 - Device Not Charging
Model Affected	XT1562, XT1563, XT1564, XT1565
Level Of Repairs	Level 2

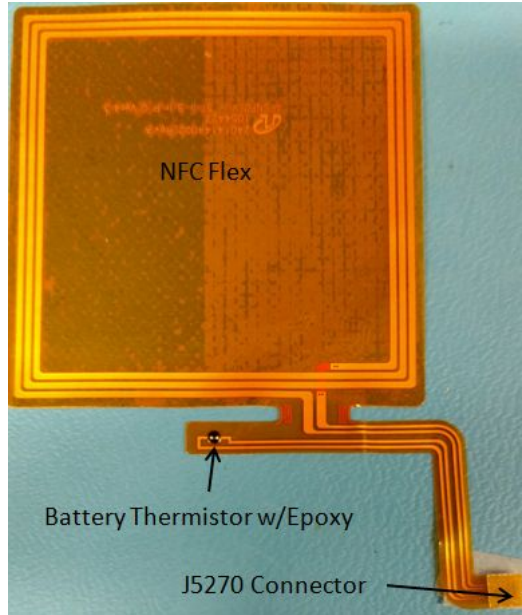
**Figure 1.0 - NFC Flex (Service P/N: 24014144002)**

Motorola is aware of a potential field return issue on the Moto X Play (ROW) / Droid Maxx 2 (VZW) product related to Battery Charging. Some users reported that although their device detects Charger is connected, the actual charge percentage in the Battery Meter never increases. Engineering analysis of these devices determined that the Battery Thermistor was damaged (cracked) from excessive mechanical stress (likely from drop impact in the field). The damaged Battery Thermistor results in erroneous battery temperature readings which disable charging.

Motorola added underfill epoxy over the Battery Thermistor component located on the NFC Flex (Service P/N: 24014144002) to protect the component from damage during drop impacts. See Figure 1.0 below.

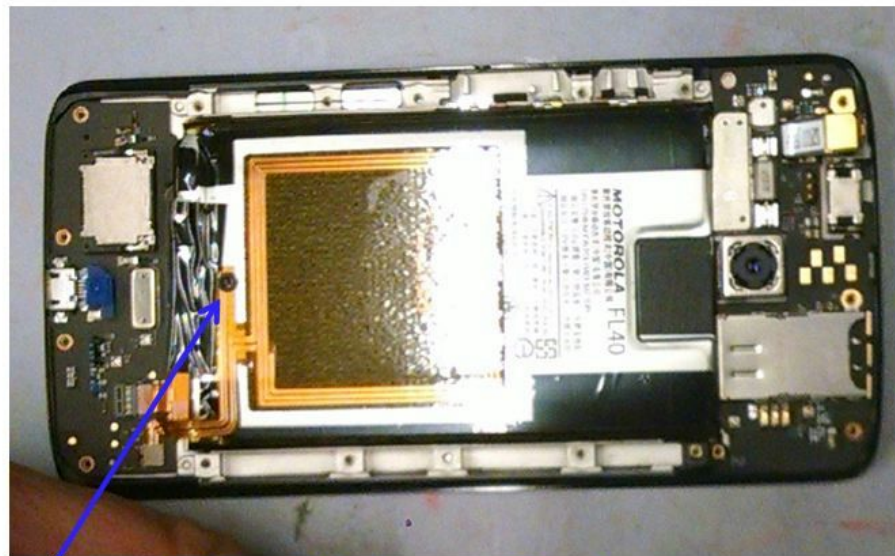
**Figure 2.0 - Thermistor Pad “Donut” (Service P/N: 75016246001)**

**Placed prior at final assembly prior to rear cover.**

Donut Poron Pad (P/N: 75016246001) Placed around Thermistor Component

**Update:** Motorola added a Thermistor Pad “Donut” (Service P/N: 75016246001) which is placed around the the Battery Thermistor component to further protect the component from damage during drop impacts. See Figure 2.0 below.

1. Verify if the Thermistor Pad “Donut” is placed around the Thermistor Component on the NFC Flex, and place if required. See Figure 2.0 above for placement location.

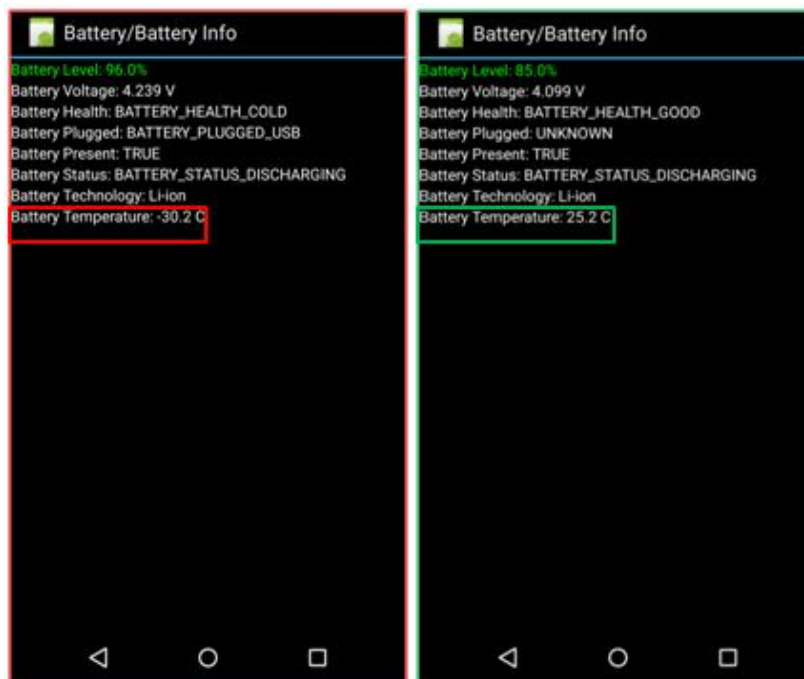
- a. If the Battery Temperature reading is normal (typically **positive** 25 to 30 degrees celsius) , then this bulletin does not apply. Follow normal repair process to determine the problem.

- b. If the Battery Temperature reading is abnormal (damaged component typical read **negative** 30 to 35 degrees celsius), then continue to Step 3.
3. Disconnect/Reconnect the NFC Connector (J5270) to ensure it is properly mated then repeat Step 2 above.

**Example: CQATest.Apk Battery Info Screen - Bad Reading (Left) vs. Good Reading (Right)**

- a. If the Battery Temperature reading is still abnormal, then replace NFC Flex (Service P/N: 24014144002).
4. Place Thermistor Pad “Donut” (Service P/N: 75016246001) around the the Battery Thermistor component on the new NFC Flex to further protect the component from damage during drop impacts.
