STANDARD FIELD SERVICE BULLETIN

FSB Number	CHRAEFSB2016-2
Author	Tony Bryan
Date	01/04/2016
Subject	Moto X Play, Droid Maxx 2 - Device Not Charging
Model Affected	XT1562, XT1563, XT1564, XT1565
Level Of Repairs	Level 2

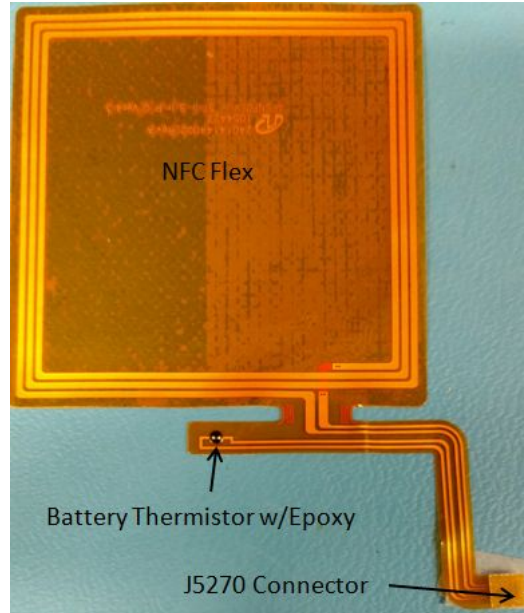
Motorola is aware of a potential field return issue on the Moto X Play (ROW) & Droid Maxx 2 (VZW) products related to Battery Charging. Some users reported that although their device detects Charger is connected, the actual charge percentage in the Battery Meter never increases. Engineering analysis of these devices determined that the Battery Thermistor was damaged (cracked) from excessive mechanical stress (likely from drop impact in the field). The damaged Battery Thermistor results in erroneous battery temperature readings which disable charging.

Motorola added underfill epoxy over the Battery Thermistor component located on the NFC Flex (Service P/N: 24014144002) to protect the component from damage during drop impacts. Motorola is currently working with supplier, and providing additional limit samples, to help better to control the epoxy application process. See image below.

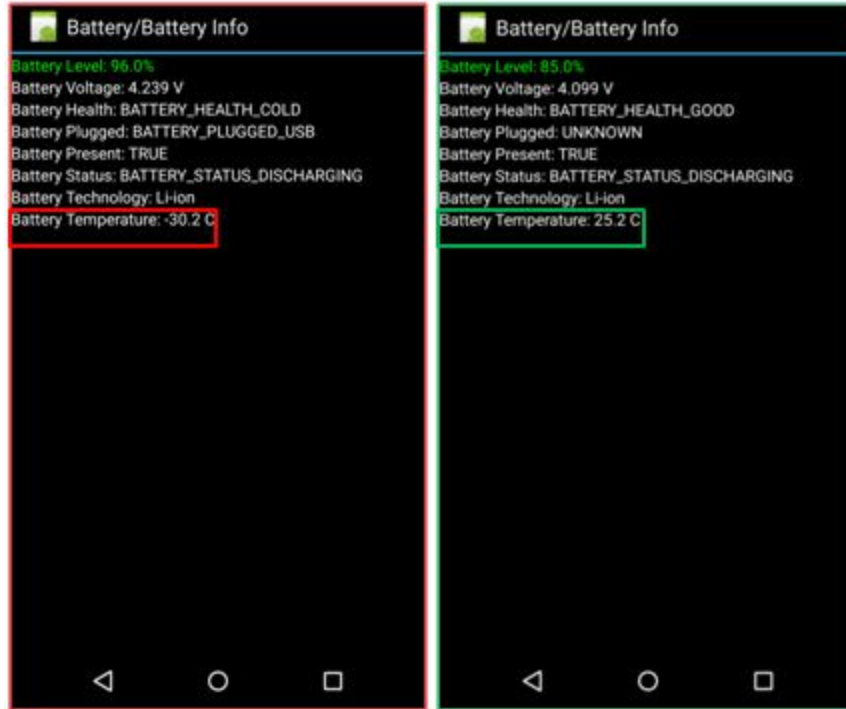
- b. If the Battery Temperature reading is abnormal (damaged component typical read **negative** 30 to 35 degrees celsius), then continue to Step 3.
3. Disconnect/Reconnect the NFC Connector (J5270) to ensure it is properly mated then repeat Step 2 above.

Example: CQATest.Apk Battery Info Screen - **Bad** Reading (Left) vs. **Good** Reading (Right)

- a. If the Battery Temperature reading is still abnormal, then replace NFC Flex (Service P/N: 24014144002).
4. Per Service Manual, carefully reassemble the device and completely retest the device, per standard Service procedure, to ensure proper repair.
