STANDARD FIELD SERVICE BULLETIN

FSB Number	CHRAEFSB2015-67
Author	Tony Bryan
Date	10/28/2015
Subject	XT1585 Droid Turbo 2, XT1580 Moto X Force - Display - Vertical Line
Model Affected	XT1585 Droid Turbo 2, XT1580 Moto X Force
Level Of Repairs	Level 2

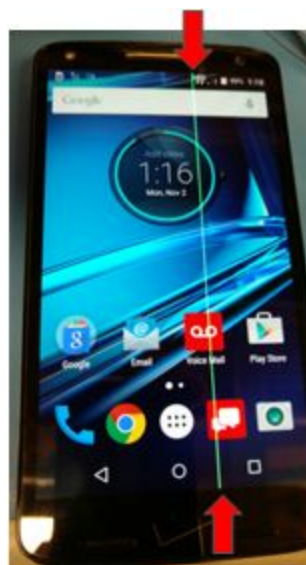
Motorola is aware of a potential field return issue on the Droid Turbo 2 / Moto X Force products related to Display. Design verification testing revealed that certain drop impacts can cause a thin colored (green/purple) vertical line to appear in the display image. See Figure 1 below.

Figure 1 - Display w/ vertical line

Motorola implemented design improvements to the Display/Lens Assembly (P/N: 01018108xxxW) to resolve this issue. Display/Lens Assembly (P/N: 01018108xxxW) Revision C reflects these changes. See Figure 2 below for location of Revision part markings.
