INFORMATIONAL FIELD SERVICE BULLETIN

FSB Number	CHRAEFSB2015-71
Author	Tony Bryan
Date	11/10/2015
Subject	XT1585 Droid Turbo 2 - SIM Tray - Detached End-Cap
Model Affected	XT1585 Droid Turbo 2
Level Of Repairs	Level 1

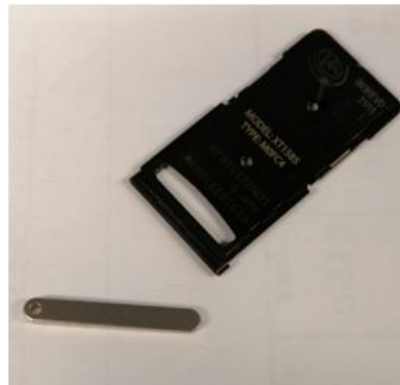
Motorola is aware of a potential field return issue on the Droid Turbo 2 product related to SIM Tray. Design verification testing identified an issue where excessive force from drop could cause the End-Cap to detach from the SIM Tray.
