STANDARD FIELD SERVICE BULLETIN

FSB Number	CHRAEFSB2016-12
Author	Tony Bryan
Date	02/25/2016
Subject	XT1585 Droid Turbo 2, XT1580 Moto X Force - Does Not Charge - USB Connection Issues
Model Affected	XT1585 Droid Turbo 2, XT1580 Moto X Force
Level Of Repairs	Level 3

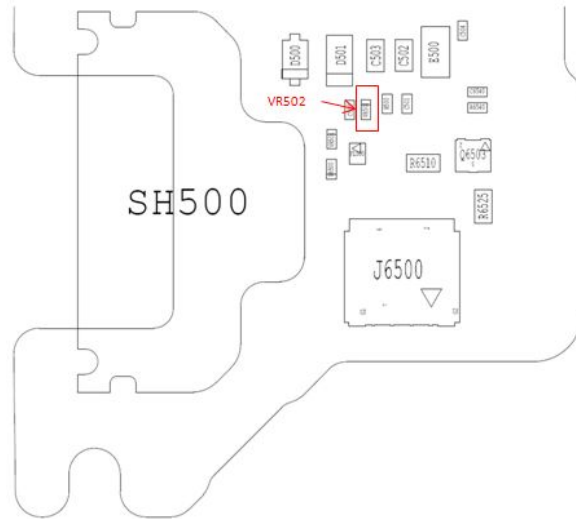
- Overvoltage Protection Diode VR502 (P/N: 48014187001) Damaged. Component is damaged from an undetermined over-voltage condition creating a low resistance on Pin #4 (EMU_ID) of the uUSB Connector. See Fig. 1 below.

Fig. 1 - VR502 Diode Location

- Overvoltage Protection Diode Damaged - Motorola added new factory test procedures to screen for this issue - Completed February 22, 2016.
- uUSB Connector Damaged - Motorola added epoxy (Loctite EO1072) over the internal pins of the uUSB Connector to help strengthen the mechanical connection to the PCBA - Completed April 25, 2016

- a. If one or more pins measure a higher than normal resistance, then the PCBA must be scrapped due to risk of solder pad delamination.
 - b. If Pin #4 (EMU_ID) of the uUSB Connector measures a lower than normal resistance, then replace Overvoltage Protection Diode VR502 (P/N: 48014187001).

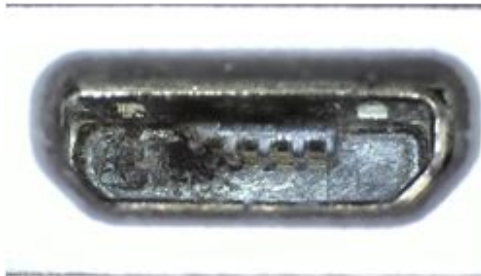
- uUSB Connector J500 (P/N: 09014162015W) Damaged. Connector has either damaged external contacts (Fig. 2a) or cracked solder joints on internal pins (Fig. 2b). The damage is due to excess mechanical force applied to connector from improper insertion/handling. See images below.

Fig. 2a - External Contact Damage

3. Apply the Epoxy (Loctite EO1072) to the uUSB Connector. Carefully follow the **L3_USB Epoxy Application Procedure** which is available to download from the [Global Service Site](#).

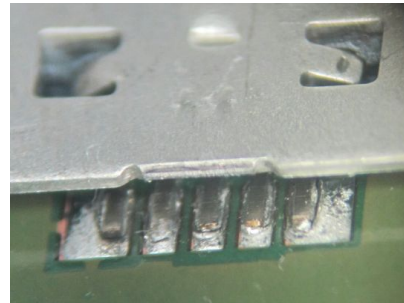
Fig. 2b - Internal Pin Damage

1. Carefully inspect the uUSB Connector J500, under 2x Magnification, for any signs broken/cracked solder joints.
 - a. If broken/cracked solder joints are observed, then the PCBA must be scrapped due to risk of solder pad delamination.
 - b. If no broken/cracked solder joints are observed, then continue to Step 2.
2. Apply the Epoxy (Loctite EO1072) , carefully follow the **L3_USB Epoxy Application Procedure** which is available to download from the [Global Service Site](#).
3. Continue with normal Repair Process.

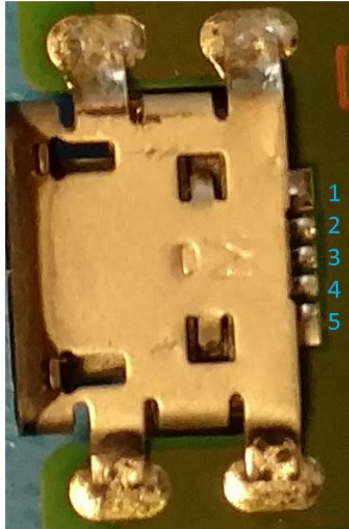
1. Confirm the customer complaint by testing “Charging” functionality using approved testing procedures.
2. Use a Digital Multimeter (DMM) to measure resistance from each of uUSB Connector pins to GND. See image below for details.

Pin	Line	Nominal Resistance	Symptom (If Bad)
1	USB_VBUS	30-35k Ohm	No Charge Indication / No SOL
2	USB_D-	725-755k Ohm	No Turbo Charge
3	USB_D+	725-755k Ohm	No Turbo Charge
4	EMU_ID	150-300k Ohm	Does Not Charge or Power-Cycles
5	GND	0 Ohm

- c. If Pins #2, #3 (USB D+/D-) of the uUSB connector measure a low resistance short to GND, then replace the U1000 MSM8994 IC (Service P/N: 51016314001).
