## **STANDARD FIELD SERVICE BULLETIN**

FSB Number	CHRAEFSB2016-12 Rev. 1
Author	Tony Bryan
Date	08/30/2016
Subject	XT1585 Droid Turbo 2, XT1580 Moto X Force - Does Not Charge - USB Connection Issues
Model Affected	XT1585 Droid Turbo 2, XT1580 Moto X Force
Level Of Repairs	Level 3

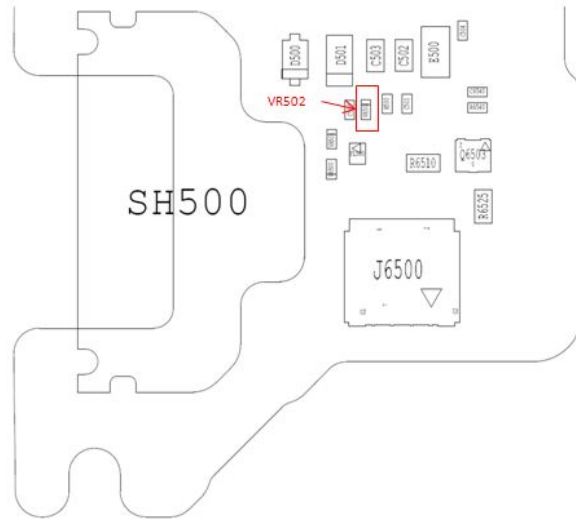
**Fig. 1 - VR502 Diode Location**

- Overvoltage Protection Diode VR502 (P/N: 48014187001) Damaged. Component is damaged from an undetermined over-voltage condition creating a low resistance on Pin #4 (EMU\_ID) of the uUSB Connector. See Fig. 1 below.

- Overvoltage Protection Diode Damaged - Motorola added new factory test procedures to screen for this issue - Completed February 22, 2016.
- uUSB Connector Damaged - Motorola added epoxy (Loctite EO1072) over the internal pins of the uUSB Connector to help strengthen the mechanical connection to the PCBA - Completed April 25, 2016

1. Confirm the customer complaint by testing “Charging” functionality using approved testing procedures.
2. Use a Digital Multimeter (DMM) to measure resistance from each of uUSB Connector pins to GND. See image below for details.
  - a. If one or more pins measure a higher than normal resistance, then uUSB Connector J500 needs replaced. Follow the Rework Procedure detailed in **Field Service Action - A** above.
  - b. If Pin #4 (EMU\_ID) of the uUSB Connector measures a lower than normal resistance, then replace Overvoltage Protection Diode VR502 (P/N: 48014187001).

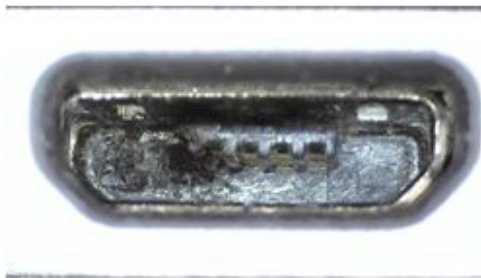
- uUSB Connector J500 (P/N: 09014162015W) Damaged. Connector has either damaged external contacts (Fig. 2a) or cracked solder joints on internal pins (Fig. 2b). The damage is due to excess mechanical force applied to connector from improper insertion/handling. See images below.

**Fig. 2a - External Contact Damage**

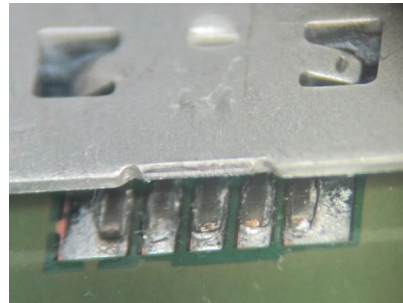
**Fig. 2b - Internal Pin Damage**

1. Carefully inspect the uUSB Connector J500, under 2x Magnification, for any signs broken/cracked solder joints.
  - a. If broken/cracked solder joints are observed, then continue to Step 2.
  - b. If no broken/cracked solder joints are observed, then skip to Step 4.
2. Remove uUSB Connector J500 from PCBA using approved procedure and then carefully inspect PCBA for any sign of pad delamination. See Fig. 3 below for examples of pad delamination.

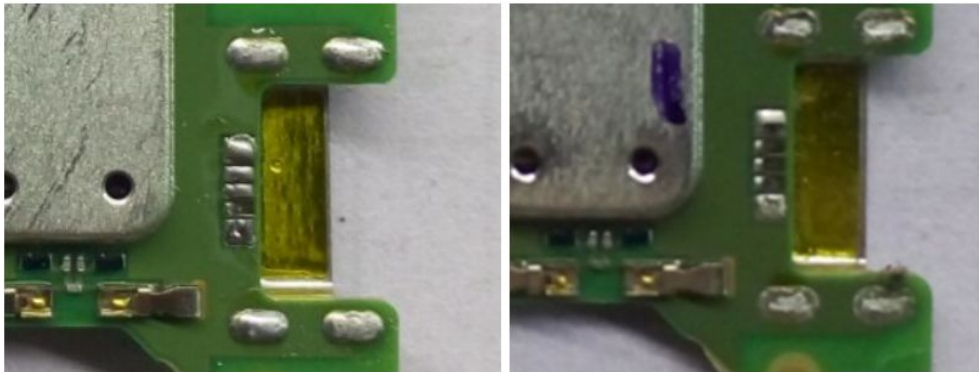
**Fig. 3 - PCBA w/Pad Delamination**

- a. If any sign of pad delamination is observed (like shown in Fig. 3 above), then the PCBA **must** be scrapped.
  - b. If no pad delamination is observed, then continue to Step 3.
3. Place new uUSB Connector J500 using approved procedure, clean area to remove any excess flux, and carefully inspect each pin under 2x Magnification for proper solder joint.
4. Apply the Epoxy (Loctite EO1072) , carefully follow the **L3\_USB Epoxy Application Procedure** which is available to download from the [Global Service Site](#).
5. Continue with normal Repair Process.

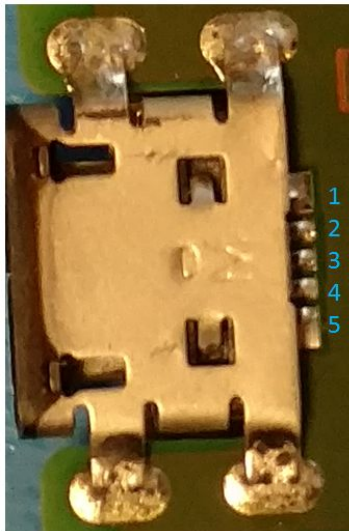
Pin	Line	Nominal Resistance	Symptom (If Bad)
1	USB_VBUS	30-35k Ohm	No Charge Indication / No SOL
2	USB_D-	725-755k Ohm	No Turbo Charge
3	USB_D+	725-755k Ohm	No Turbo Charge
4	EMU_ID	150-300k Ohm	Does Not Charge or Power-Cycles
5	GND	0 Ohm

- c. If Pins #2, #3 (USB D+/D-) of the uUSB connector measure a low resistance short to GND, then replace the U1000 MSM8994 IC (Service P/N: 51016314001).
3. Apply the Epoxy (Loctite EO1072) to the uUSB Connector. Carefully follow the **L3\_USB Epoxy Application Procedure** which is available to download from the [Global Service Site](#).
4. Per Service Manual, carefully reassemble the device and completely retest the device, per standard Service procedure, to ensure proper repair.
