STANDARD FIELD SERVICE BULLETIN

FSB Number	CHRAEFSB2016-14
Author	Tony Bryan
Date	03/04/2016
Subject	XT1585 Droid Turbo 2, XT1580 Moto X Force - Rear Camera - Can't Launch
Model Affected	XT1585 Droid Turbo 2, XT1580 Moto X Force
Level Of Repairs	Level 2

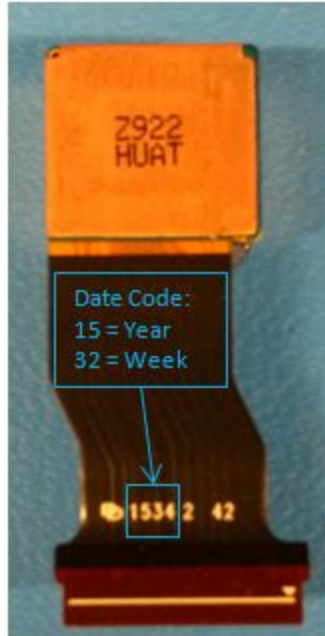
Figure 1 - Date Code Markings

Engineering analysis of the devices found that the 21MP Rear Camera Module (Service P/N: 01018287001W) was not functioning due to internal connection issues caused by poorly formed micro-via. This is a component fabrication issue at the camera supplier.

The camera supplier has implemented process improvements to resolve this issue as of November 15, 2015 (Date Codes: 1547 or later). For details on component date code markings, see Figure 1 below.

Purge existing inventory of the 21MP Rear Camera Module (Service P/N: 01018287001W) and scrap affected date codes. Refer to Figure 1 above.
