STANDARD FIELD SERVICE BULLETIN

FSB Number	CHRAEFSB2016-22
Author	Tony Bryan
Date	06/28/2016
Subject	Moto G4, Moto G4 Plus - Side-Key Tactile (Stuck Keys)
Model Affected	XT162x, XT164x
Level Of Repairs	Level 2

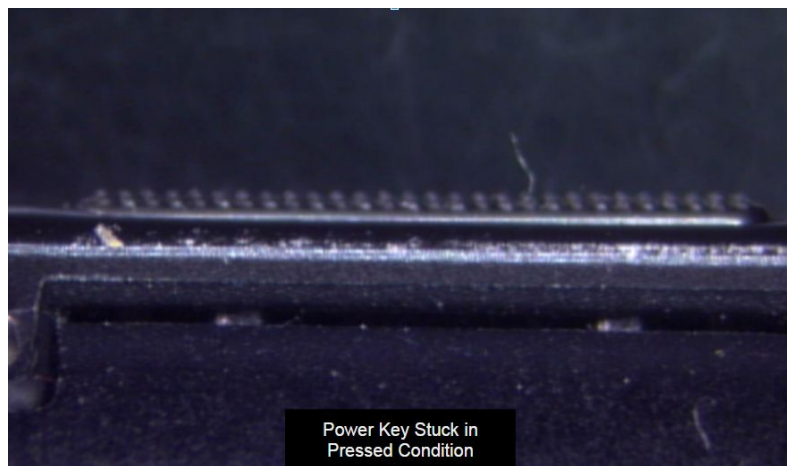
Figure 1.0 - Example Stuck Side-Key

Motorola is aware of a potential customer experience issue on the Moto G4 and Moto G4 Plus products related to Side-Keys. Some users reported experiencing poor tactile feel and/or stuck side-keys on their Moto G4 device. See Figure 1.0 below.

Engineering analysis determined the issue was caused by improper alignment between the side-key buttons and the SMT switches on the PCBA.
