STANDARD FIELD SERVICE BULLETIN

FSB Number	CHRAEFSB2016-22 Rev. 1
Author	Tony Bryan
Date	08/30/2016
Subject	Moto G4, Moto G4 Plus - Side-Keys (Stuck / Loose Keys)
Model Affected	XT164x, XT162x
Level Of Repairs	Level 2

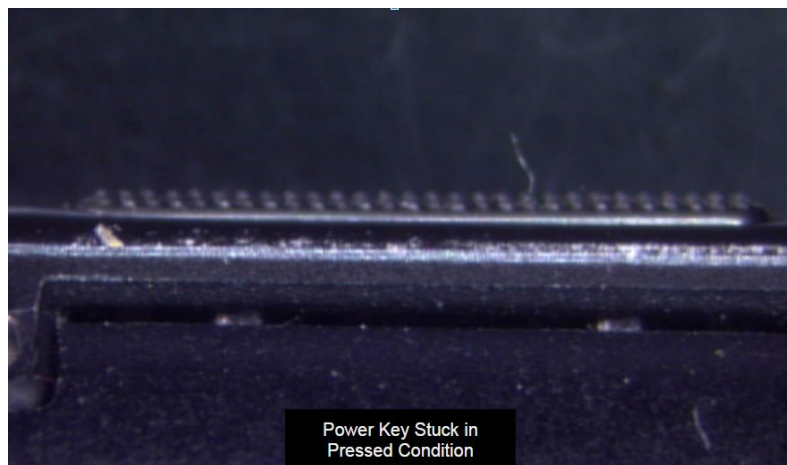
Motorola is aware of a potential customer experience issue on the Moto G4 / Moto G4 Plus products related to Side-Keys. Some users reported experiencing either poor tactile feel (stuck side-keys) or Loose Keys on their Moto G4 / Moto G4 Plus device. See Figure 1.0 below.

Figure 1.0 - Example Stuck Side-Key

1. Stuck Keys: Engineering analysis determined the issue was caused by improper alignment between the side-key buttons and the SMT switches on the PCBA.
2. Loose Keys: Engineering analysis determined this issue was a side-effect of the Stuck

Keys issue above. Key Buttons showed damage indicating user likely picked the key out after it got stuck initially.

As of 5/31/16, the factory added a Side-Key Kapton Shim (p/n: 11018240001) to the Assembly Process to help better align the side-key button plungers to the SMT switches on the PCBA. See Figure 2.0 below.

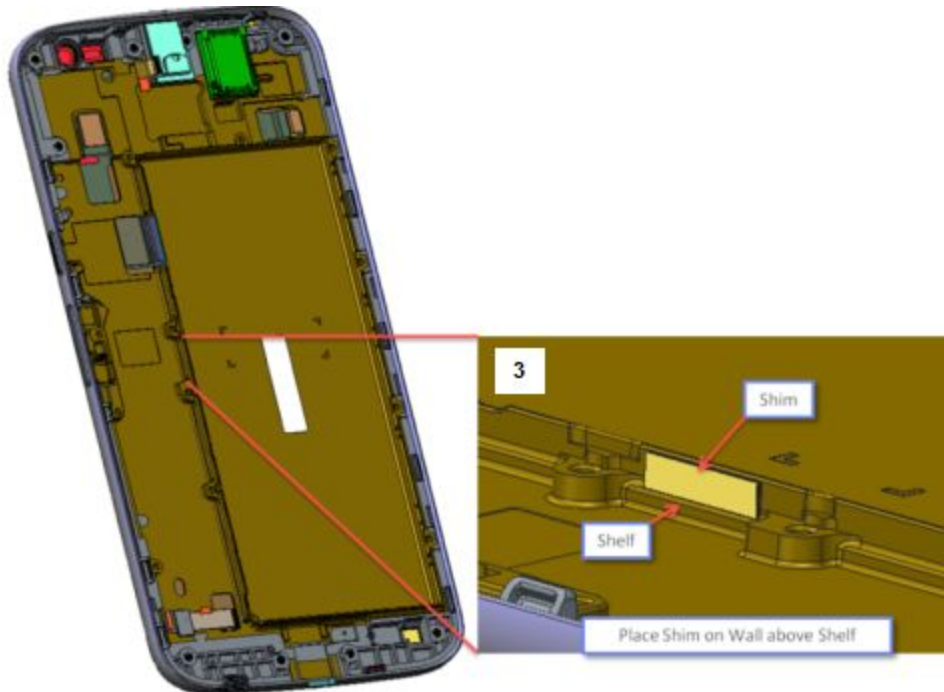
Figure 2.0 - Side-Key Kapton Shim Placement

Note: Shim must sit above shelf of housing wall and must be hand pressed to achieve good wetting on housing surface.

1. Inspect for and place if necessary the Side-Key Kapton Shim (p/n: 11018240001) prior to reassembly. See Figure 2.0 above.
