STANDARD FIELD SERVICE BULLETIN

FSB Number	CHRAEFSB2016-26
Author	Tony Bryan
Date	08/29/2016
Subject	Moto G4 Plus - Fingerprint Reader
Model Affected	XT164x
Level Of Repairs	Level 1

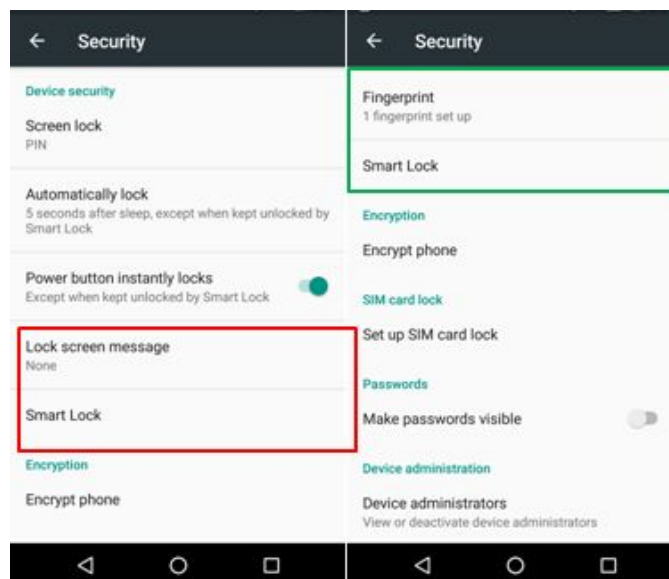
Figure 1.0 - Security Settings (Fingerprint)

1. No option for "Fingerprint" in menu under Settings/Security. See Figure 1.0 below.
2. Fingerprint Reader stops responding and/or not able to read properly

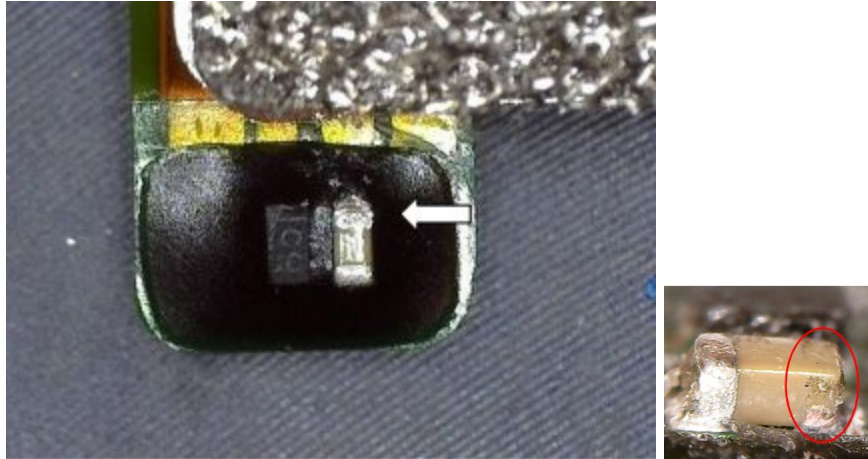
Figure 2.0 - Fingerprint Sensor, Discrete Component Dmg

1. No option for "Fingerprint" in menu under Settings/Security - Fingerprint Sensor has mechanical damage to discrete components on flex due to assembly rework. See Figure 2.0 below.

1. Damaged Components on Flex: Factory Assembly Process Improvements - Completed 7/1/2016
2. ACF Bond Separation: Supplier optimized ACF Bonding Process - Completed 8/25/2016

1. Confirm issue by testing Fingerprint Sensor functionality, using approved test procedures, if confirmed:
2. Replace the Fingerprint Sensor (p/n: 0101885600xW or 0101871500xW)
3. Reassemble and complete full functional testing to ensure proper repair.

Important Note: If reworking the Fingerprint Sensor, then complete 100% inspection of discrete components on flex under magnification and add a 100% functional re-test prior to reassembly into F-Hsg.
