STANDARD FIELD SERVICE BULLETIN

FSB Number	CHRAEFSB2017-39
Author	Tony Bryan
Date	09/26/2017
Subject	Moto G4, Moto G4 Plus - No Speaker Audio (PCBA Open Trace)
Model Affected	XT164x, XT162x
Level Of Repairs	Level 3

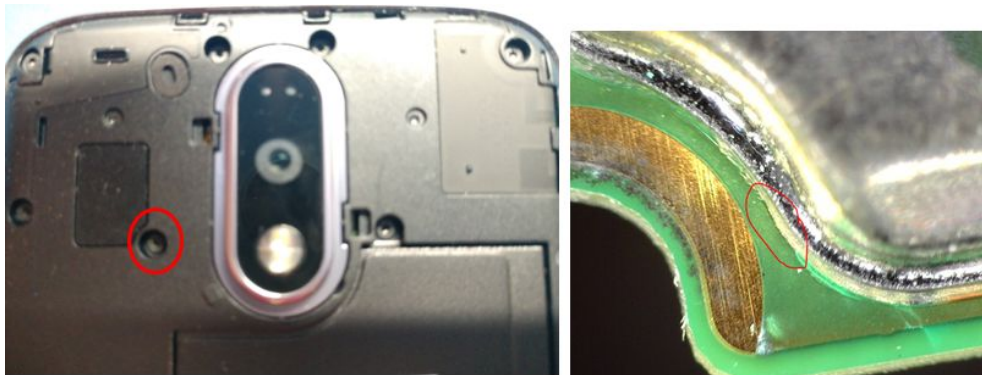
Figure 1.0 - Screw Boss & PCBA Stress Location

Motorola is aware of a potential field return issue on the Moto G4 / Moto G4 Plus product related to Speaker Audio. Service Centers reported receiving returns for “No Speaker Audio” and “No Headset Audio” where the symptom follows the Main PCBA. Analysis of the Main PCBA found trace damage located at screw boss location on the PCB. See Figure 1.0 below. The root cause is mechanical overstress to PCBA at screw boss as board flexes after multiple drop impacts by users in the field.

Global Repair Teams should use the information in this bulletin to help confirm customer returns with damaged PCB's.

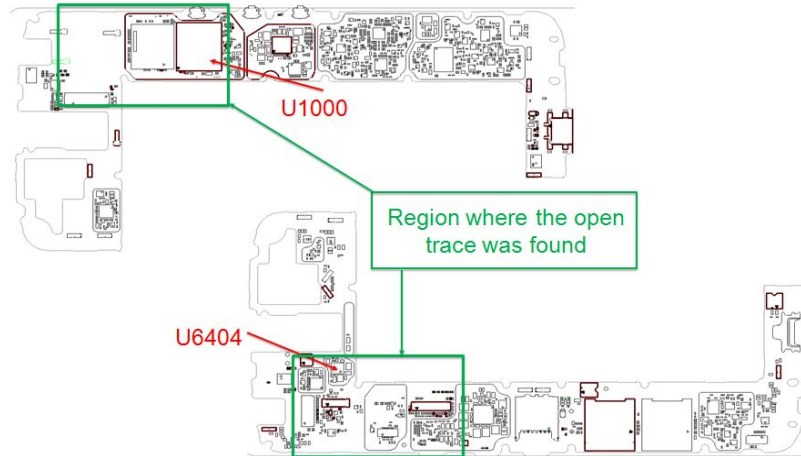
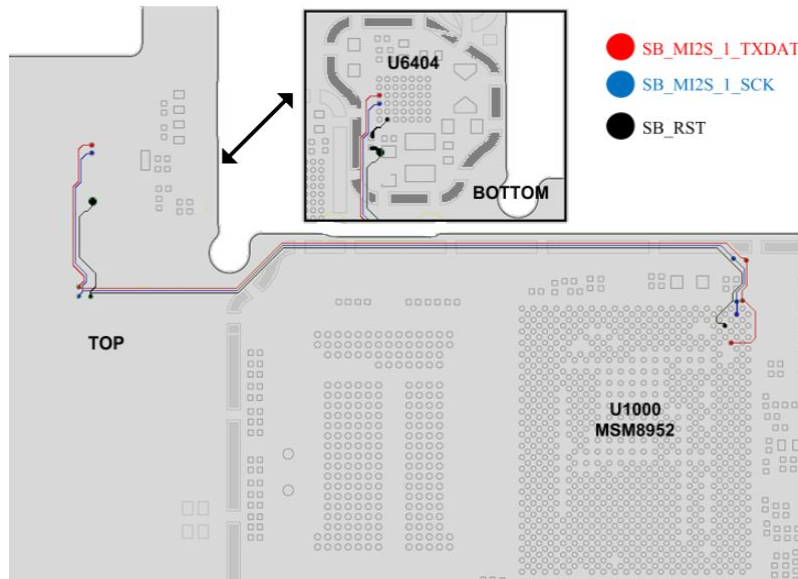
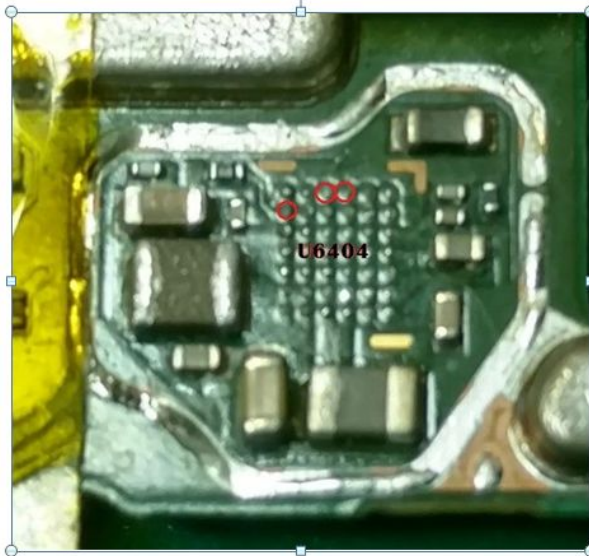
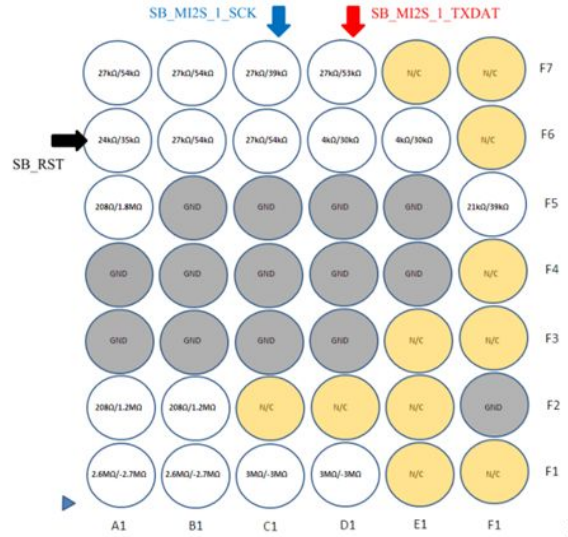
Figure 2.0 - Board Layout Views

The PCBA trace damage in this location breaks the SB_MI2S (Clk/Data/Reset) communication lines between U1000 MSM IC and U6404 Audio Smart Boost IC, resulting in no audio output symptom observed. See detailed views in Figure 2.0 and Figure 3.0 below.

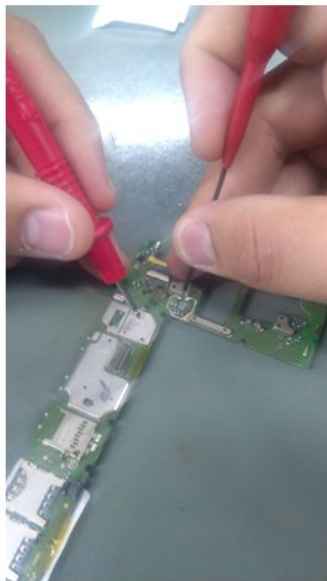
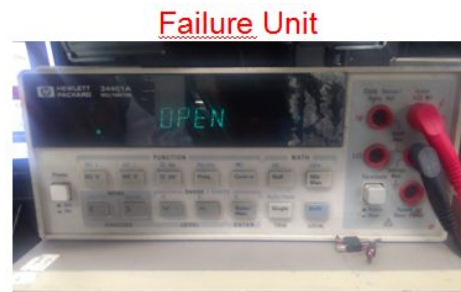
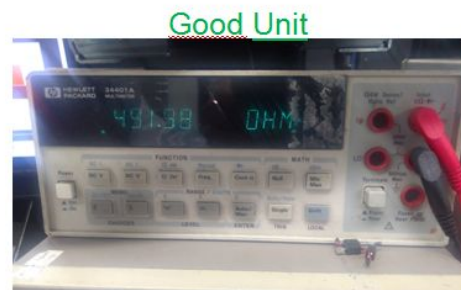
Figure 4.0 - DC Impedance Measurement

Verify open trace by measuring impedance between pin and ground.

5. Remove U6404 Smart Boost IC from the PCBA
6. Finally, use DMM in to measure DC Impedance on SB_MI2S (Clk/Data/Reset) pins to ground. Damaged PCBA will measure as OPEN. Reference Figure 4.0 below.
Important Note: Apply some slight twisting pressure to the board during this step to help reproduce open trace condition.
