## **REWORK FIELD SERVICE BULLETIN**

FSB Number	CHRAEFSB2016-34
Author	Tony Bryan
Date	12/05/2016
Subject	Moto Z, Moto Z Droid - Battery Swell
Model Affected	XT1650-01, XT1650-03, XT1650-05
Level Of Repairs	Level 2

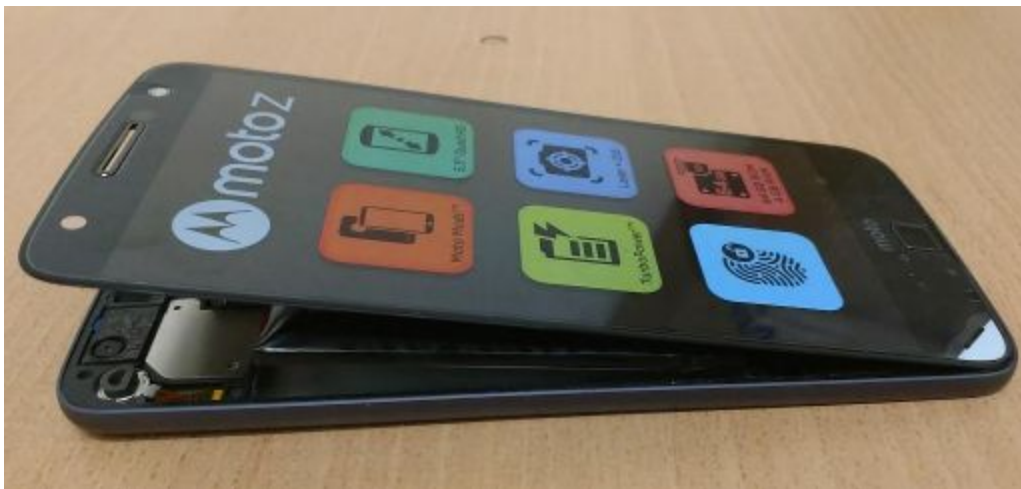
Motorola is aware of a potential customer experience issue on the Moto Z product. A small number of Moto Z users have reported an issue in which the housing has separated due to an expansion of the battery. See Figure 1.0 below. Motorola has confirmed that this issue is manufacturing related and not due to how people use their phones, and does not pose a safety concern.

**Figure 1.0 - Swollen Battery Condition**

Engineering analysis determined that the Battery Pack insulator was peeled away from one corner leaving that corner of the battery pack exposed to possible damage during phone level assembly. Once the outer layer of the battery pack is damaged during initial assembly, interaction with exposed metal housing can cause chemical reaction within the pack, resulting in the swelling observed.

**A.** When servicing any Moto Z customer returns which are confirmed to show the “Swollen Battery” condition (Reference Figure 1.0 above), then:

1. Process an exchange to swap out the customer’s device as engineering has determined devices exhibiting this condition should not be repaired by global service teams.

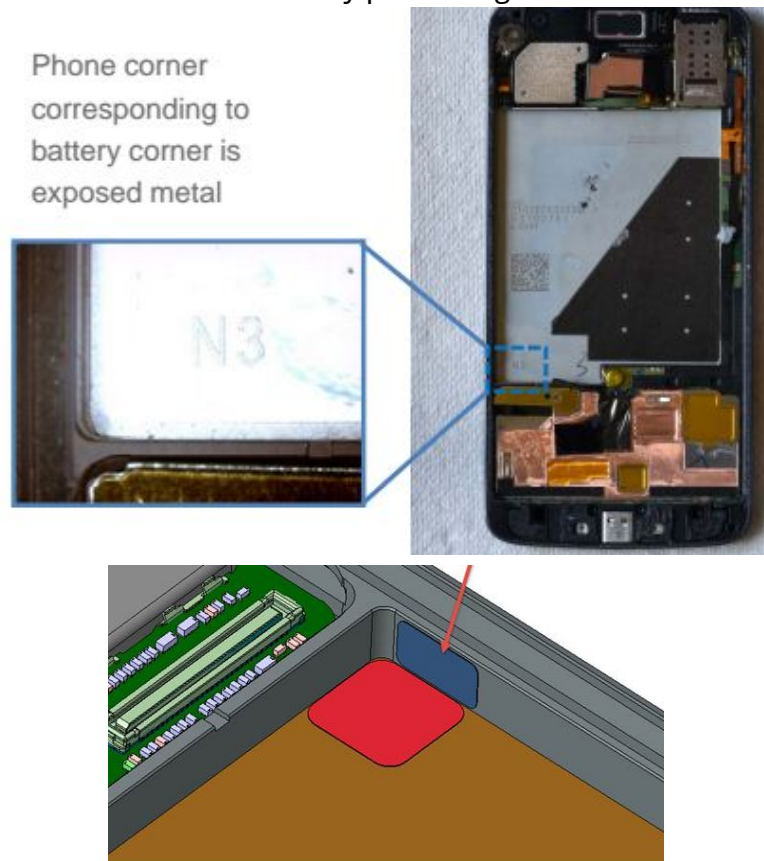
**Figure 2.0 - Kapton Tape Placement**

1. Motorola optimized the battery assembly method to align the battery pack along the right side of the pocket to avoid contact with housing along left side.
2. Motorola has implemented the placement of two pieces of kapton tape in the affected bottom left corner of the housing battery pocket to isolate the battery pack from the metal housing. See Figure 2.0 below for placement.
  - a. Tape #1 - 5.75mm x 5.75mm Kapton Tape (p/n: 11018063002) placed flat in bottom left corner of battery pocket aligned with corner edges.
  - b. Tape #2 = 5.0mm x 2.75mm Kapton Tape (p/n: 1105063003) placed along bottom left side of the battery pocket aligned with corner edge

1. If not already placed, place the two pieces of Kapton Tape in bottom left corner of housing battery pocket to isolate the battery pack from the metal housing. Reference Figure 2.0 above for details on placement.
  - a. Tape #1 - 5.75mm x 5.75mm Kapton Tape (p/n: 11018063002) placed flat in bottom left corner of battery pocket aligned with corner edges.
  - b. Tape #2 = 5.0mm x 2.75mm Kapton Tape (p/n: 1105063003) placed along bottom left side of the battery pocket aligned with corner edge
2. Place GV30 Battery Pack (p/n: SNN5972A) making sure to align the battery pack along the right side of the pocket and avoid contact with housing along left side.
3. Following the Service Manual document, complete reassembly.
4. Per normal service procedures, completely retest to ensure proper repair.

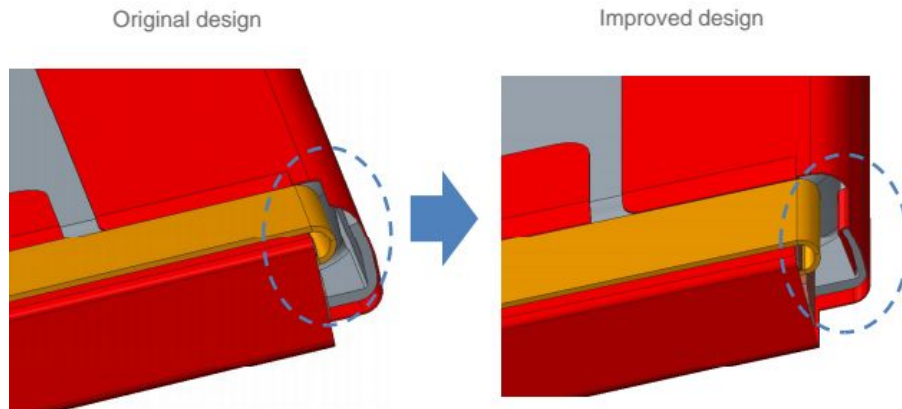
**Figure 3.0 - Battery Insulator Change**

The battery supplier will increase the size of the battery insulator to better protect the corner of the pack. See Figure 3.0 below for details. This will be a running change to the existing GV30 Battery Pack (p/n: SNN5972A).
