STANDARD FIELD SERVICE BULLETIN

FSB Number	CHRAEFSB2017-17
Author	Tony Bryan
Date	05/25/2017
Subject	Moto G5 - Thermal Performance Improvements
Model Affected	XT1677 (India Only)
Level Of Repairs	Level 2

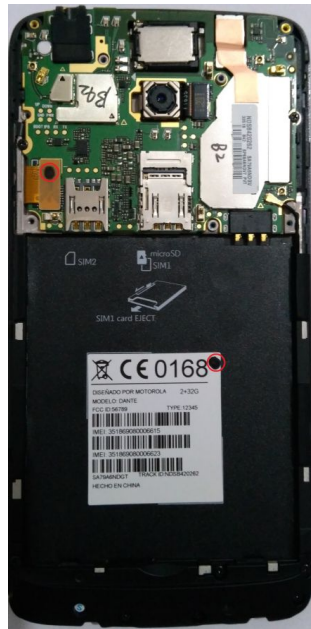
Figure 1.0 - Black-Dot Markings to indicate service rework completed

1. Per normal Repair SOP, update the device to latest approved software release for India region (NPP25.137-73 or later) to pick-up of the software change.
2. Scrap existing Battery Cover and replace using only the new part numbers S948C19327[gold] & S948C19328[gray].
3. Following Service Manual, carefully disassemble the device and replace existing Display/Touch Panel Assembly using only the new part numbers 5D68C08848[gray] & 5D68C08849[gold].
4. Place black-dot markings on both the Display Flex Tail and IMEI Label, like shown in Figure 1.0 below, to indicate device has completed this service rework procedure.
5. Following Service Manual, carefully reassemble the device.
6. Per normal Repair SOP, complete full functional retest to ensure proper repair.
