## **STANDARD FIELD SERVICE BULLETIN**

FSB Number	CHRAEFSB2018-8
Author	Tony Bryan
Date	02/23/2018
Subject	Moto G5 - No Speaker Audio
Model Affected	XT1670/71/72/75/76/77
Level Of Repairs	Level 2

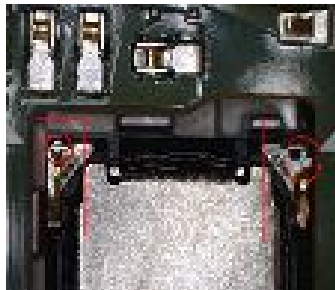
1. Speaker (p/n: 5SB8C07378): Speaker contacts may get deformed during Factory Assembly process as Rear Housing Assy is attached, resulting in intermittent connection. See Figure 1.0 below.

**Figure 1.0 - Speaker Contacts Deformed**

1. Speaker (p/n: 5SB8C07378): Contacts Deformed - Factory implemented a fixture to aid in Rear Housing Assembly and avoid deforming speaker contacts - Completed WK15 (April 15th) of 2017.
2. Rear Housing Assy (p/n: 5S58C0742x): Audio Flex Supplier improved their etching process to avoid trace damage - Completed WK26 (July 1st) 2017. See image below for Audio Flex date code markings.

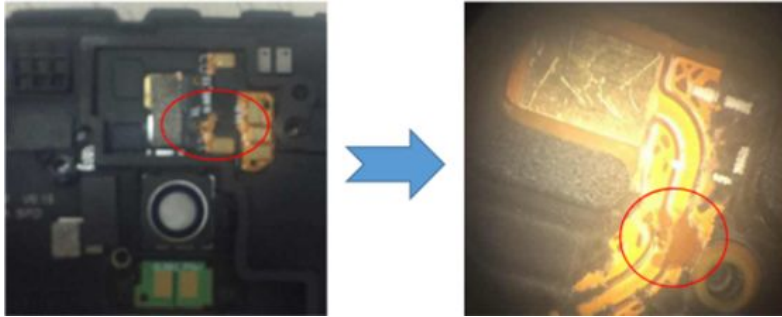
2. Rear Housing Assy (p/n: 5S58C0742x): The Audio Flex has an improperly formed trace from supplier's etching process, resulting in an open circuit condition. See Figure 2.0 below.

**Figure 2.0 - Audio Flex - Open Trace**

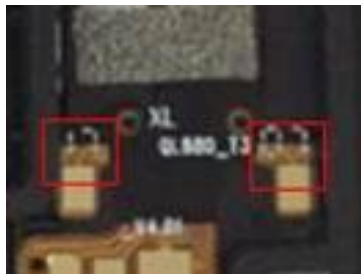
**Date Code as shown = 17(YR) 07(WK)**
