STANDARD FIELD SERVICE BULLETIN

FSB Number	CHRAEFSB2017-8
Author	Tony Bryan
Date	04/05/2017
Subject	Moto G5 Plus - SIM Card / SD Card Insertion
Model Affected	XT1680/81/83/84/85/86/87
Level Of Repairs	Level 2

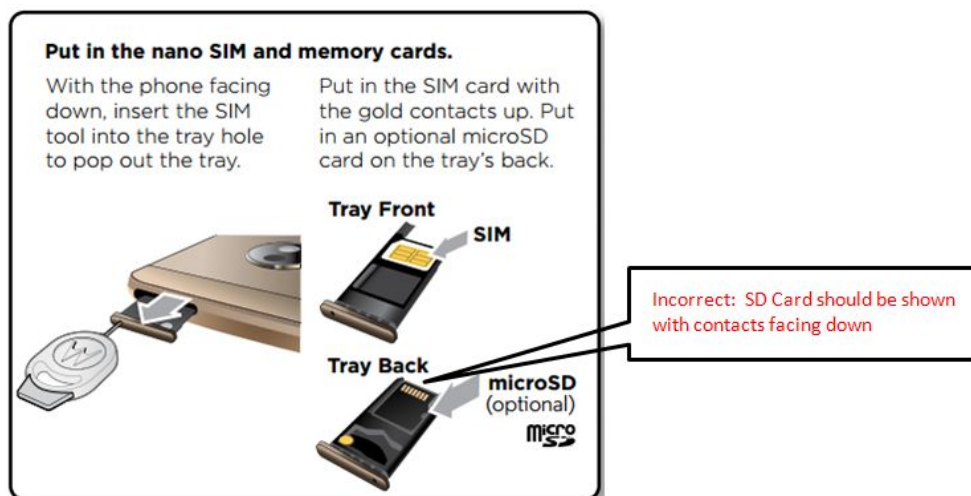
Figure 1.0 - Diagram showing improper orientation of the SD Card

Motorola is aware of a potential customer experience issue on the Moto G5 Plus product related to the proper insertion of SIM Card(s) and/or SD Card. It was identified that the instructional diagram shown in both the Getting Started Guide and User Guide improperly showed the SD Card with the contact facing up. See Figure 1.0 below.

The correct insertion is with the contacts facing down.

Motorola has corrected the online versions of both the Getting Started Guide and User Guide as of April 11, 2017. Same corrections will be rolled into printed version of the guides as a running change.

Motorola has published a consumer viewable FAQ with correct instructions at the [Motorola.Com/Support site \(https://motorola-global-portal.custhelp.com/app/home/\)](https://motorola-global-portal.custhelp.com/app/home/).
Note: There are two different versions available to accommodate both Single SIM and Dual SIM models. See details below.

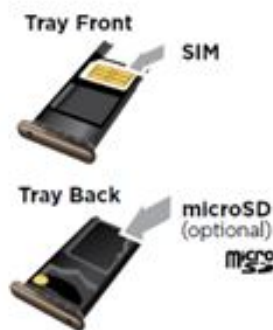
2. Put in the SIM card with the gold contacts facing up. Put in an optional microSD card on the tray's back with the gold contacts facing down.
