## **REWORK FIELD SERVICE BULLETIN**

FSB Number	CHRAEFSB2017-33
Author	Tony Bryan
Date	09/07/2017
Subject	Moto Z2 Play - Turn On/Off - Battery Wire Routing/Damage
Model Affected	XT1710 (All)
Level Of Repairs	Level 1

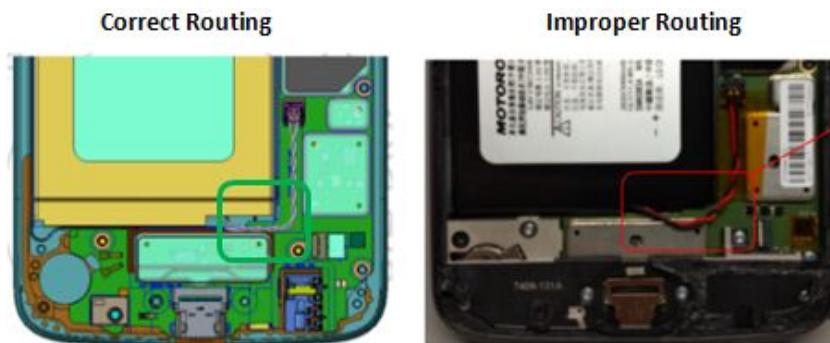
**Figure 1.0 - Battery Wire Routing**

Motorola is aware of a potential customer experience issue on the Moto Z2 Play product related to Turn On/Off issues. Some users reported that their Moto Z2 Play device would randomly power itself off and/or not power on. Engineering analysis of the returned devices found that the Battery Wires were not properly routed during initial assembly. See Figure 1.0 below.

1. Carefully inspect the Battery Wires for proper routing, reference Figure 1.0 above.
  - a. If Battery Wires are routed properly, then:

- Highlighted issue to both Factory and Service Teams and added a 2nd 100% inspection point to verify wire-routing before moving to the next assembly process.

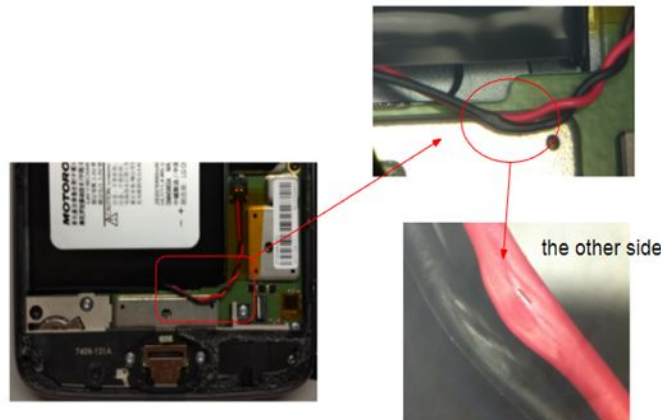
**Figure 2.0 - Battery Wire Damage**

In this case, the improperly routed Battery Wires rest on top of PCBA Shield (SH500) and will be further pressed against the shield once device is fully assembled causing damage to the rubber insulation, and resulting in a potential short circuit. See figure 2.0 below.

- A soft short will affect battery impedance and result in erratic battery metering and/or

- random power downs if Battery Safety Circuit is tripped.
- A hard short will result in device no longer powering up.

Global Service Team may choose to implement an offline Microscope Inspection Process to carefully inspect all replaced HZ40 Battery Packs [P/N: SNN5983A] for any sign of wire damage, reference Figure 2.0 above.

- If any sign of Battery Wire damage is found under microscope inspection, then HZ40 Battery Pack [P/N: SNN5983A] must be scrapped.
- If Battery Wire damage is not found under microscope inspection, then HZ40 Battery Pack [P/N: SNN5983A] may be reused.

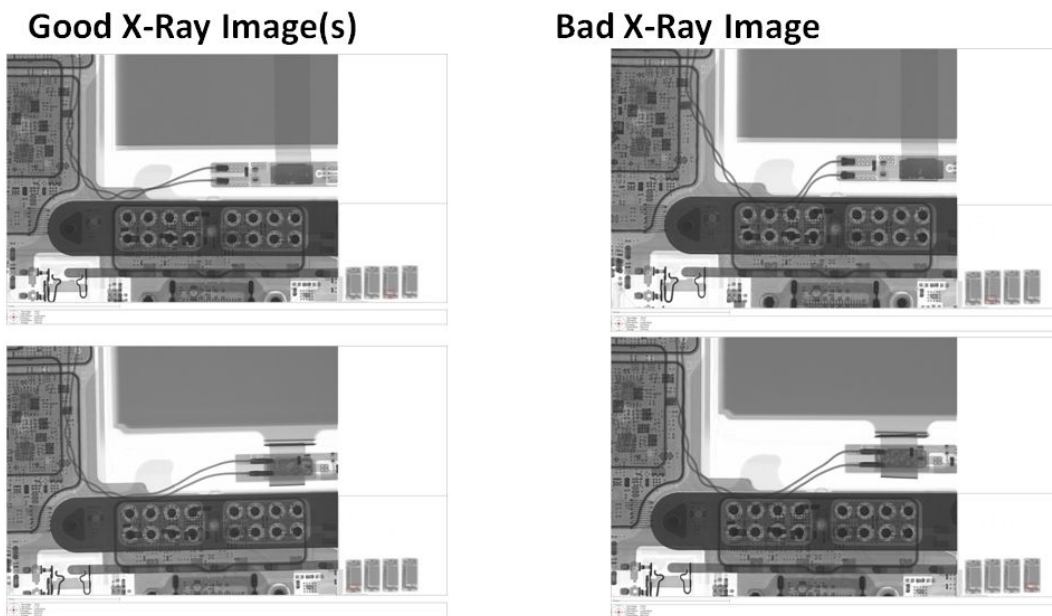
**Figure 4.0 - X-Ray Limit Examples**

If access to X-Ray Machine is available, then this can be used to 100% screen devices for this issue at incoming prior to disassembly. See Figure 4.0 below for limit examples.
