STANDARD FIELD SERVICE BULLETIN

FSB Number	CHRAEFSB2018-3
Author	Tony Bryan
Date	01/12/2018
Subject	Moto X4 - Front Camera Focus Performance
Model Affected	XT1900-1-7 (All Models)
Level Of Repairs	Level 2

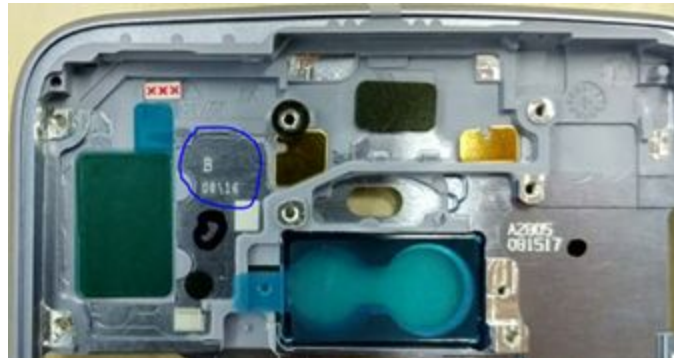
Figure 1.0 – Rear Housing Assembly Rev Marking

Any device confirmed to exhibit one of these two issues, using the provided Focus Test Procedure below, can be considered as problematic. Evaluation of problematic devices determined that although all individual components in the system were with-in specifications, the z-axis stack-up of the system as a whole may position the camera too close to the lens, resulting in a shift in focus range.

- A revision was made to the Rear Housing Assembly (P/N: 5S58C09xxx & SS58C19xxx) to add additional space for the Front Camera. Rear Housings Assemblies with this change can be identified with markings Rev B and later. See image below.

- i. Following Service Manual, carefully disassemble the device and remove PCBA from Rear Housing Assembly (P/N: 5S58C09xxx & SS58C19xxx).
 - ii. Inspect the Rev Marking on the Rear Housing Assembly (P/N: 5S58C09xxx & SS58C19xxx). If marking is Rev A, then replace Rear Housing Assembly (P/N: 5S58C09xxx & SS58C19xxx) with Rev B or later. Reference **Figure 1.0** above.

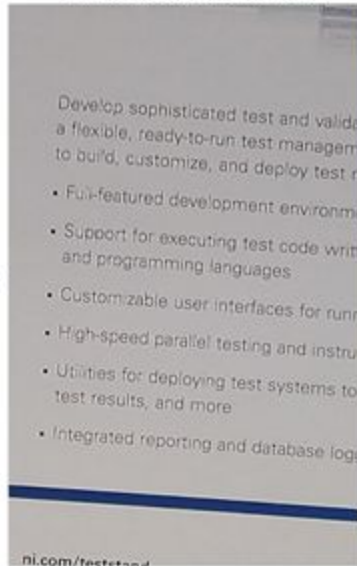
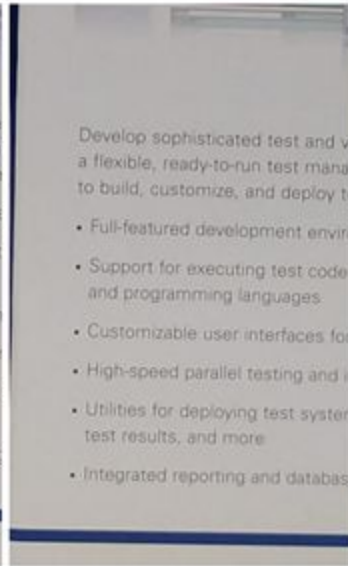
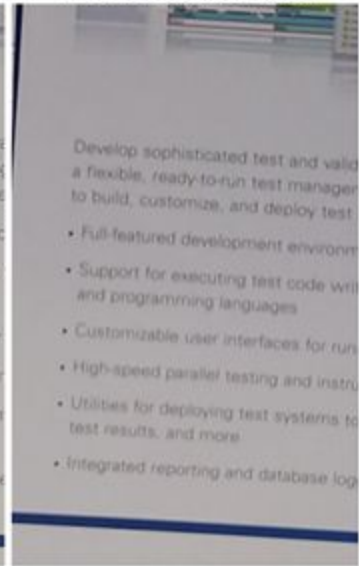
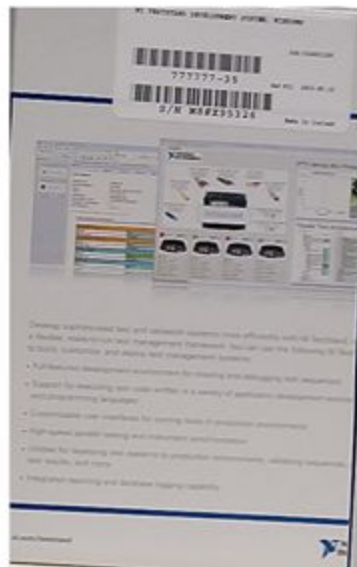
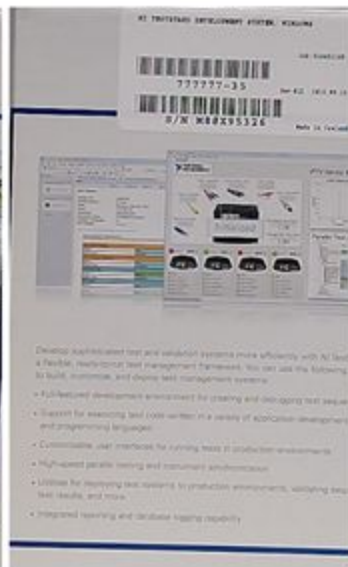
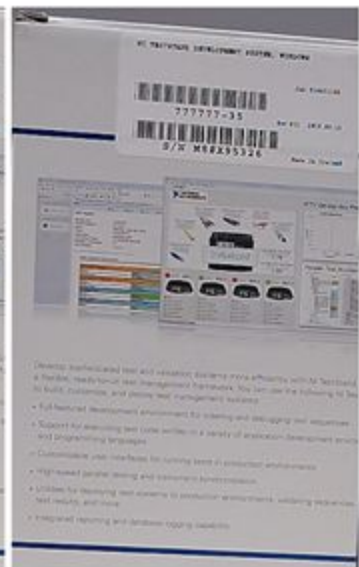
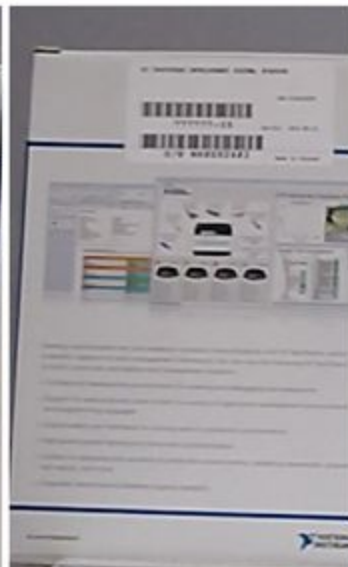
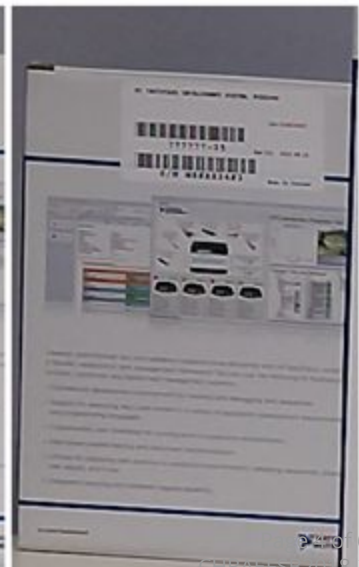
**Undesired Behavior
(Decreasing Sharpness Perception)**

Expected Behavior

**Undesired Behavior
(Increasing Sharpness Perception)**

3. If the resulting photos show a behavior similar to example images labeled as **UNDESIRE** above, consider this device to be problematic and should be repaired.

1. Execute the **Focus Test Procedure** specified in the **Short Term** solution section above to confirm if the device has a functional issue or not.
 - a. If the captured photos show a behavior similar to example images labeled as **UNDESIRE** above, then consider this device to be problematic and should be repaired as directed below.
