STANDARD FIELD SERVICE BULLETIN

FSB Number	CHRAEFSB2018-12
Author	Tony Bryan
Date	04/02/2018
Subject	Moto G6 Play - Intermittent Mic Audio (mic diaphragm stuck)
Model Affected	XT1922-1/2/3/4/5/10 (ROW Models Only)
Level Of Repairs	Level 3

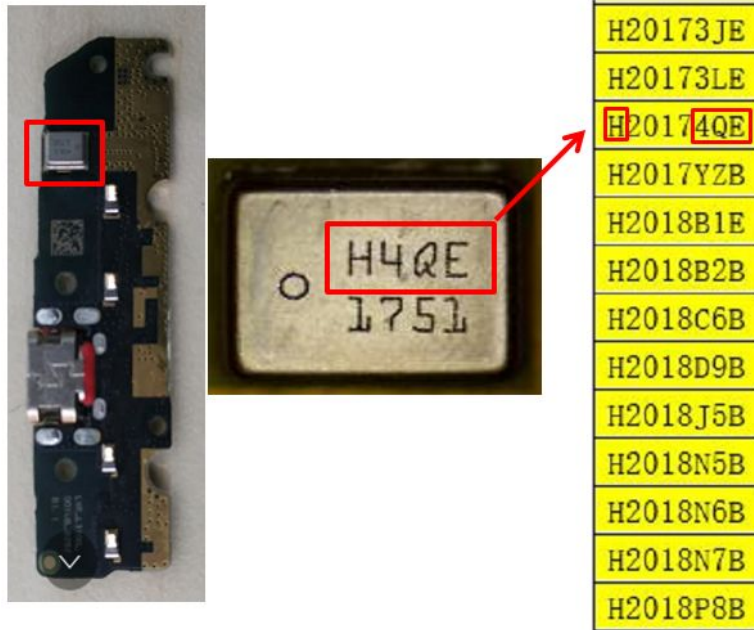
Figure 1.0 -MEMS Supplier - "High Risk" Material Identification

Engineering Analysis of affected devices determined that the diaphragm, internal to the microphone, was getting stuck in one position as a result of the external pressure. This issue was traced to a process control issue at microphone supplier (MEMS) for particular lot codes of material.

Short-Term: The affected microphone supplier (MEMS) has implemented process improvements to help prevent this issue lot codes. See Figure 1.0 below to identify “High-Risk” material fabricated prior to supplier process improvements.

1. Following the Service Manual, carefully disassemble the device to gain access to the Sub-PCBA where the Primary Microphone (p/n: S938C29034) component is placed.
2. Inspect the part markings on the Primary Microphone (p/n: S938C29034) component to determine if it listed as ‘High Risk’ in Figure 1.0 above.
3. If the lot code shown is listed as “High-Risk”, then either replace the Primary Microphone (p/n: S938C29034) component or swap the Sub-PCBA (p/n: SP68Cxxxxx).
4. Perform standard functional testing on device to confirm customer’s original “Mic Audio” related complaint.
 - a. If an audio issue is confirmed, then follow normal troubleshooting steps to determine the problem and repair the device.

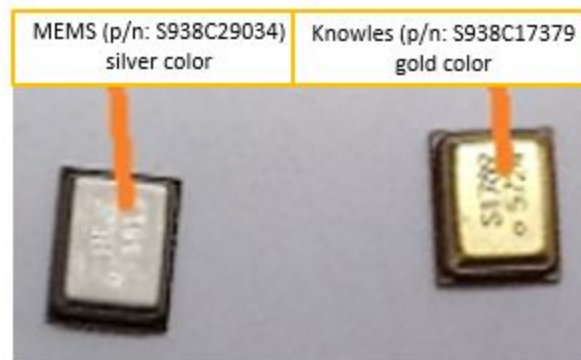
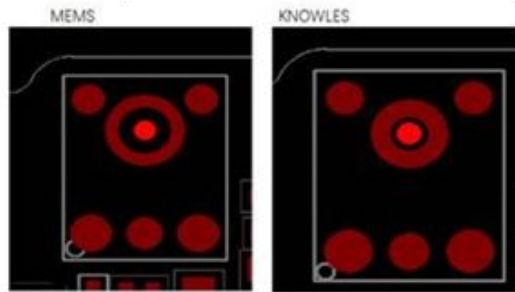
There is a difference in the solder mask between the two microphone suppliers, as shown in image above.

Long-Term: Motorola is currently qualifying a 2nd supplier (KNOWLES) for the Microphone component. Due to a solder mask difference between the two suppliers, this will require a layout change to both the Main-PCB and Sub-PCB. The part numbers printed on the Main-PCB and Sub-PCB will also be updated to reflect this change. Please see details below in Figure 2.0. This will be completed as a running change with a estimated implementation date of June 2018.

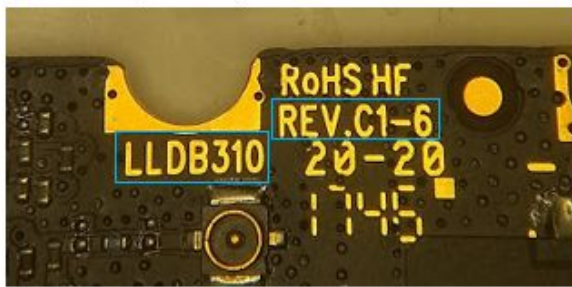
Sub PCB: LLDB310 REV. C1-6 (shown)
 Mic Supplier 1 (MEMS) = LLDB310 REV. C5-6
 Mic Supplier 2 (KNOWLES) = LLDB310 REV. C6-6

Main PCB and Sub PCB part numbers will change to support Mic Supplier 2 (KNOWLES) as shown below.

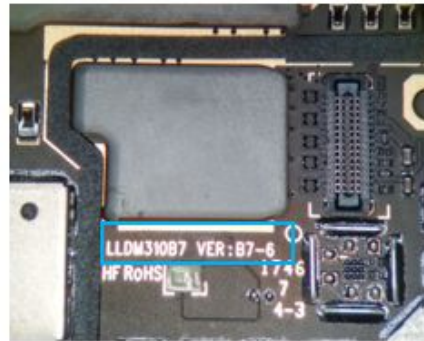
Figure 2.0 - 2nd Microphone Supplier (KNOWLES) - Change Details

Main PCB: LLDM310 REV. B7-6 (shown)
 Mic Supplier 1 (MEMS) = LLDM310 REV. B8-6
 Mic Supplier 2 (KNOWLES) = LLDM310 REV. B9-7

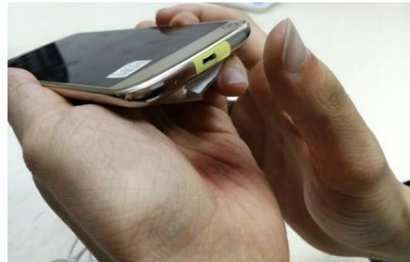
- a) Insert the headphone into the device and have the operator to wear the headphone.
- b) Dial: ***##*#2486#*##***
- c) Enter Audio Loopback mode: CQA menu→Audio→MIC Loopback→Primary MIC
- d) Carry the phone as picture below and press with thumb to cover the MIC hole. The frequency is once per second.
- e) Judge the function by if the tester can hear the sound. If it's function then keep pressing action till 100 times. And sort out if once no sound during 100 times.

B. Service should implement the Phone-Level Test Screen method shown below, on Moto G6 Play (ROW) devices regardless of complaint, as an outgoing quality measure to catch intermittent primary microphone audio issues.
