STANDARD FIELD SERVICE BULLETIN

FSB Number	CHRAEFSB2018-20
Author	Tony Bryan
Date	04/12/2018
Subject	Moto G6 Play - Intermittent Headset Audio (Connector Detect Pin)
Model Affected	XT1922-1/2/3/4/5/10 (ROW Models Only)
Level Of Repairs	Level 3

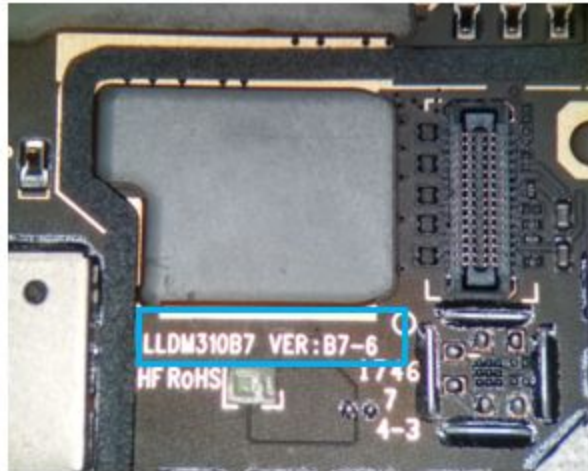
Figure 1.0 - Main-PCBA Part Numbers for Headset Jack Layout Change

Main PCB: LLDM310 REV. B7-6 (shown)
Current Headset Jack Layout = LLDM310 REV. B8-6
Updated Headset Jack Layout= LLDM310 REV. B9-7

Long-Term: Motorola is implementing a further change to the Main-PCBA Layout to move the location of the detect line from the bottom pin to a side pin location. The Main-PCB part number will be updated to reflect this board layout change. Please see details below in Figure 1.0. This will be completed as a running change with a estimated implementation date of June 2018.

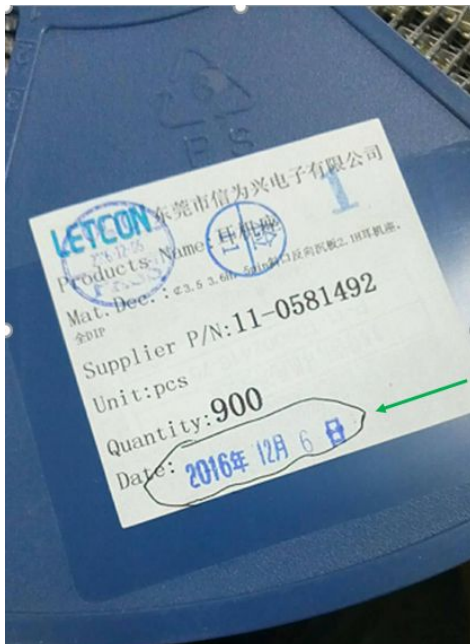
- Quarantine any existing inventory of Headset Connector (p/n: S938C25814), received prior to 4/10/2018.
 - This material cannot be used with current Main PCB: LLDM310 REV. B8-6. However, this material can be held and used later with new Main PCB w/Updated Headset Jack Layout: LLDM310 REV. B9-7
- Place new orders for Headset Connector (p/n: S938C25814) which will be filled by supplier with newer revision parts. See image below for Reel Data Code location, date codes after 4/10/2018 are new revision part.
