# Level 2.5 Repair Documentation for XELIBRI

## X2 & X4

V 1.0	Page 1 of 14	ICM MP CCQ GRM
X2 / X4	Company Confidential Copyright 2003© Siemens AG	04/03

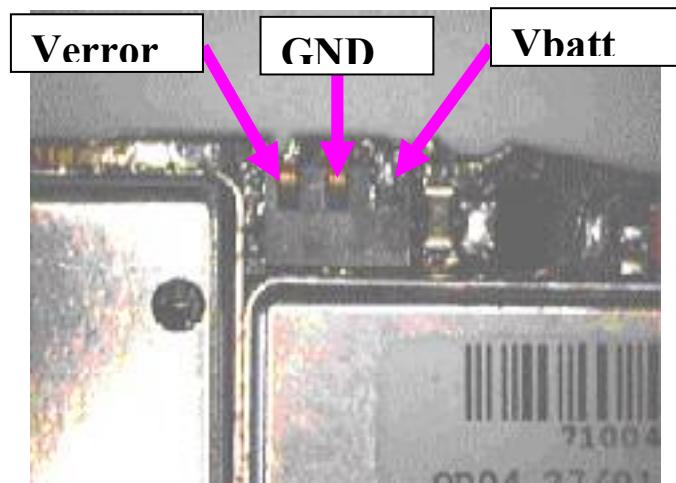
**Figure 1: XELIBRI Board Battery Connector Placement**

Can't power on under normal operation  
Can't charge this handset when power off

The connector (1610) is the battery connector with 3 contacts.  
During power on, 3.5V to 4.2V is supplied to the handset via VBat.  
VERROR is provided to the Battery, goes into the Power Management Unit control charge.

Visually check pins for oxidation or deformity.

Measure pins to test points (Vbat, GND, Verror) with a multimeter to check for continuity.

1. Use a hot air nozzle to remove the defective connector.

***Do not apply excessive heat and flow to avoid to destroy the adjoining solder joints.***

2. Level the solder joint on the pads (eventually add solder).
3. Secure new connector on the PCBA.
4. Reheat the solder on the pads with a fine-tipped soldering iron to allow the solder to flow on the connector's pins.

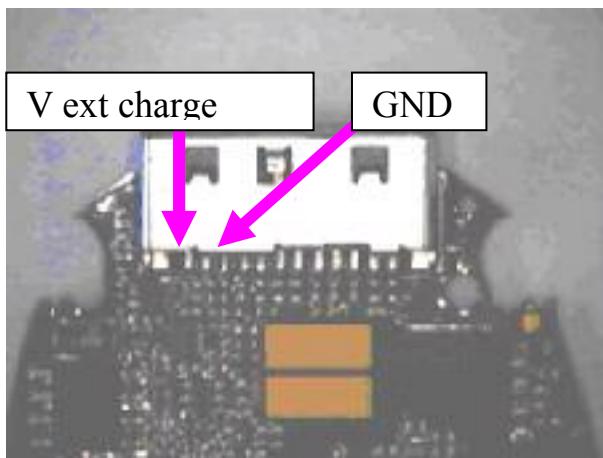
**Figure 2: XELIBRI Board Battery Connector Placement**

Can not charge the handset

The connector (1660) is I/O connector (12 contacts) used the adapter charger.  
The adapter charger uses the PIN1 for V\_EXTERNAL\_Charge and PIN2 GND BOTTOM

Visually check pins for oxidation or deformity.

Visual inspection of the fittings and I/O pads solder joints (short circuit, leak, poor brightness).

Measure pins to test points (Vexternal charge, GND) with a multimeter to check for continuity

1. Use a hot air nozzle to remove the defective connector.

*Do not apply excessive heat and flow to avoid to destroy the adjoining solder joints.*

2. Level the solder joint on the pads (eventually add solder).
3. Secure new connector on the PCBA.
4. Reheat the solder on the pads with a fine-tipped soldering iron to allow the solder to flow on th the connector's pins.

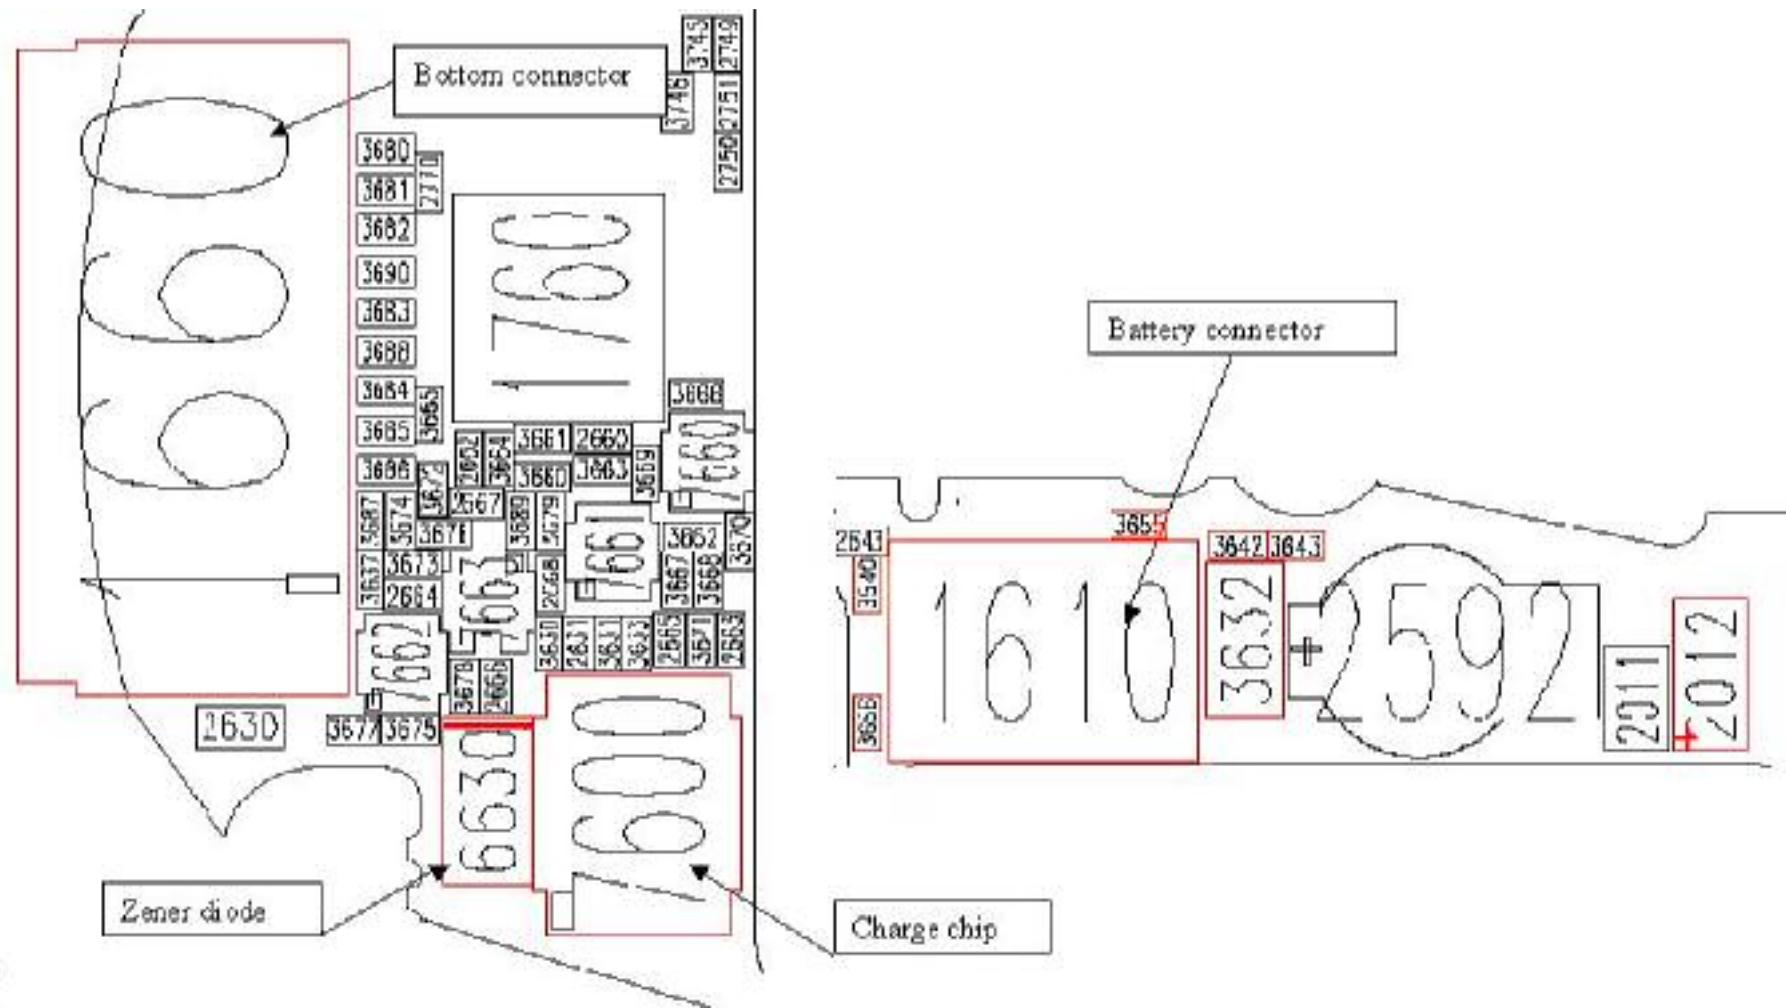
6 PCB OVERVIEW

Normaly no special complain from customer. Desoldered or damaged components during a connector rework.

Visual inspection of the solder joints (bad soldering, poor brightness, no joint, bad placement, no component).

1. Use a hot air nozzle to remove the charge chip (pos. 7600) and the zener diode (pos. 6630) and a fine-tipped soldering iron for the other components.
2. Level the solder joint on the pads (eventually add solder).
3. Replace a new component on the pads.
4. Reheat the solder on the pads with a fine-tipped soldering iron to allow the solder to flow on the contacts (eventually add solder with a solder wire).
