Title: Troubleshooting-Guide **V3i / V3_05**

Doc. No: TSG_V3i/V3_05

Date: 04.09.2006

Troubleshooting Guide V3i and V3_05 – Level 3/4

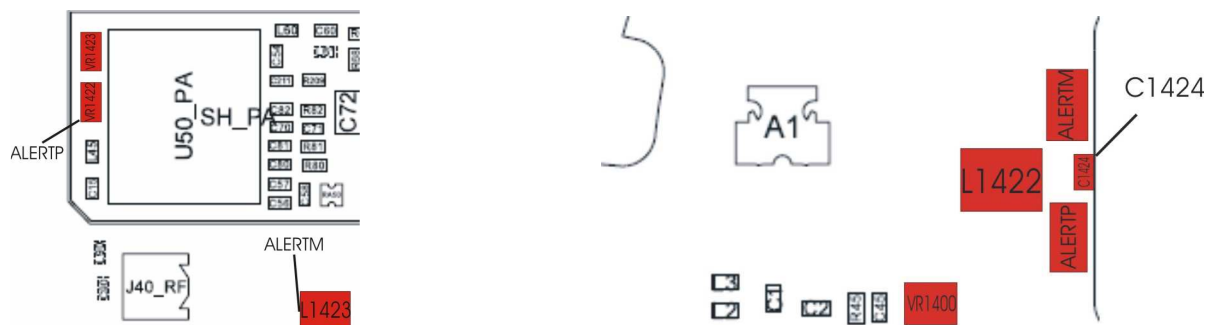
Check ALERTP and ALERTM -- both should have around 2.1Vdc

- **If not** check L1422/L1423/ for broken connection, C1424 for low resistance
VR1400/VR1422/VR1423 for shortcut to ground
- check PCB for open tracks from ALERTM to U900-V10 /ALERTP to U900-U8
- you can either use“Repair-Studio” to switch on 1 kHz tone to the alert to check for open tracks, but be careful: **You can have 1 kHz and audio in call at ALERTM/ALERTP, but no alert-tone, because the ATLAS is defect!**
if 1kHz is ok, replace Atlas (U900). **Please use underfilm for U900.**

The alert signal is converted to analog and amplified by the ATLAS, but generated by the Neptune, so if the ATLAS alert audio path is ok there could be a problem with the Neptune not generating the alert signal.

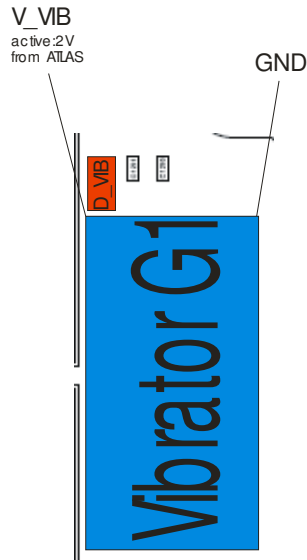
Turn on vibrator using Repair Studio/ Radiocomm. Measure V_VIB – should be about 2Vdc. V_VIB is provided directly by the ATLAS (U900). To verify if the vibrator is defective a simple method is to provide a supply voltage (1Vdc should be enough) via test probes directly on the vibrator G1 (radio in off state!). It should be rotating, if not replace the vibrator G1. Check the diode D_VIB . Otherwise replace ATLAS (U900). **Please use underfilm for U900.**

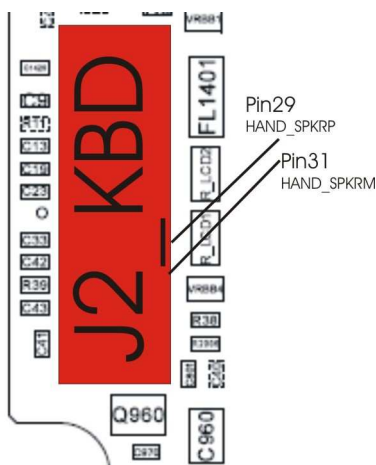
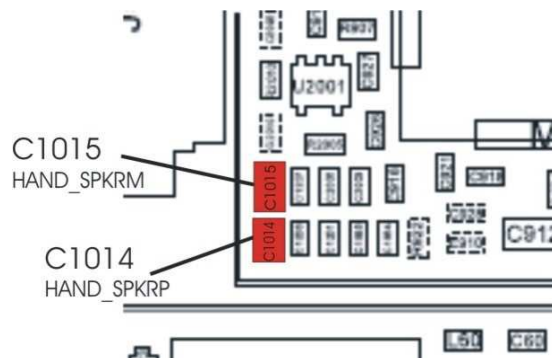
Check HAND_SPKRM at C1014 and HAND_SPKRP at C1015. Both should have around 1.4Vdc offset voltage, if audio-loop is switched on and additional up to 2,7Vpp at 1 kHz, if test-tone is switched on.

- **If not** check J2 for solder shorts, C1014/1015 for low resistance
- (eventually) check PCB on open tracks from J2 to C1014/U900-T6 and J2 to C1015/U900-R7
- **If ok,** replace Atlas (U900). **Please use underfilm for U900.**

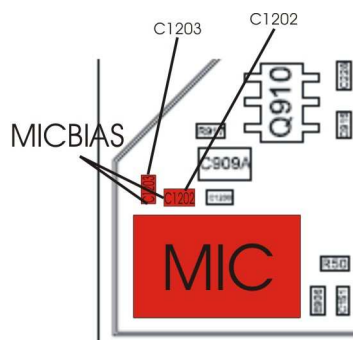
- check MIC BIAS1 at C1207 – should be around 1,75Vdc
- **if not** check C1207/1206/1201/1202/1200/1203 for low resistance
- **if ok** check MIC_IN_M at C1206 while blowing into the microphone to see the audio signal caused by the blowing
- **if not** replace microphone
- **if ok** replace ATLAS (U900) **Please use underfilm for U900.**

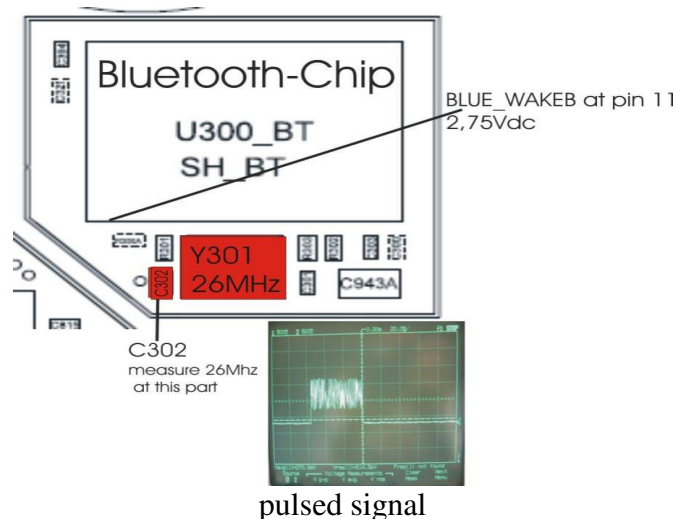
Verify if Bluetooth can be activated and is able to find other Bluetooth devices.

- **If not**, check oscillator Y301 (26MHz).
- check the BLUE_WAKEB
- replace U300
- **If not**, replace Neptune (U800)

Note: You can only measure the signals, when Bluetooth is activated.

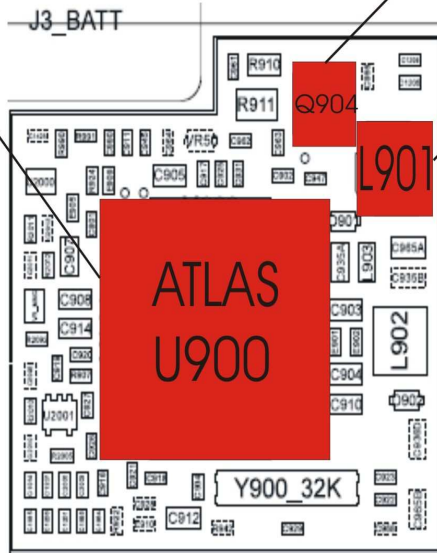
The voltages V_SIM 3V, RF_REG 2,775V,
 BTRF_REG 1,875V, REG_3V 3,1V,
 REF_REG 1,575V, IO_REG 2,775V,
 GRAPH_REG_AUL 1,275V,
 AUD_REG 2,775V, PERIPH_IO_REG 2,775V,
 VBUCK 1,875V, VBOOST 5,5V was generated
 by ATLAS, so check all the lines for parts to get warm

Q904 provides BP_3,7V which is used for
 the ATLAS(U900) and the PA(U50), part is getting
 warm, check the ATLAS and the PA for
 internal short.

L901 is a load-coil for the V_BUCK_1,875V.
 If it is getting hot, there may be a short on the
 voltage line or L901 is defective (low inductance)

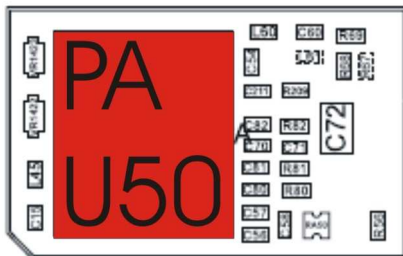
-- Defective U50

- BAT00 -- radio draws about 250mA in standby, no off current
- U900 are getting warm
- U900 provides BR 3,85V for PA (using Flensburg Layout Viewer)
- GSM-PA is also getting warm (see below)
- U50 itself has an internal short

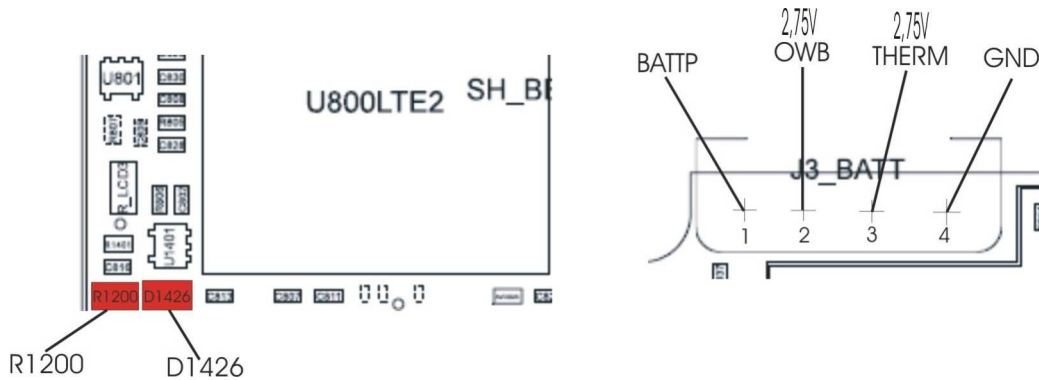
- Verify OWB (J3_BATT-2) while PCB is connected to EMU_USB cable. It should be 2.775V. Check also J3 for broken part.
- If it is low, check D1426 and R1200 (4,7k).
- If they are ok check U250 inform to make U250 cold with coolant-spray. **U250 could have internal interruptions at product code 03/06 to 27/06!!!!**
- If the voltage OWB stays low, it should be a problem with the Neptune (U800).

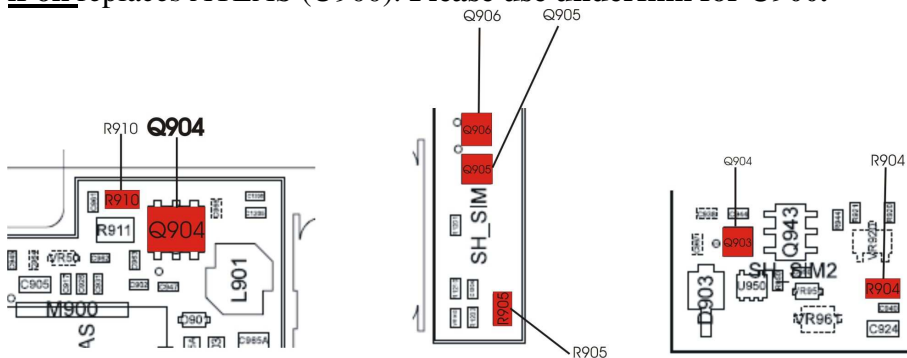
If there no off current, check the whole path for the charging current. Make a battery/charger phasing to see, if only the charger current or also the battery-phasing is affected. For a charger current problem only:

Check Q903, Q904, Q905, Q906, R904, R905, R910, J3 for broken contact **if ok** replaces ATLAS (U900). **Please use underfilm for U900.**

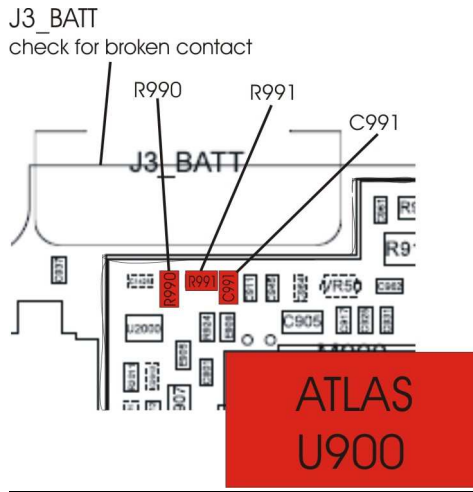
Check BATT_Therm at J3-3, it should be 2,7Vdc. If it is not check R990, R991 and C990 for low resistance.

if ok replace the ATLAS (U900) .**Please use underfilm for U900**

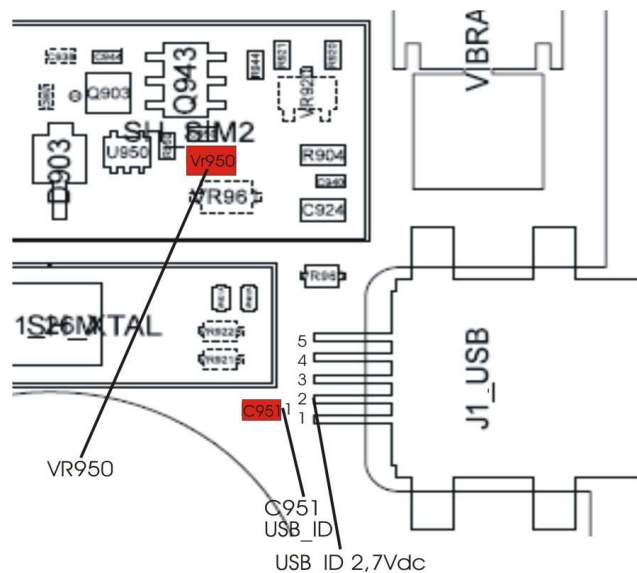
If display indicates “Charging not possible” or the phone powers on while plugging in the charger, but is not charging. Then check the USB_ID line at J1_USB-2 with phone powered on by battery. It should be 2, 7Vdc (2,4Vdc is **not** enough!)

- **If not** check VR950.USB_ID voltage must be 2,7Vdc,if VR950 is removed
- Check voltage at C951-1 (2,7Vdc)
- **If ok** replace the ATLAS (U900) because the EMU-chip is in ATLAS integrated.
Please use underfilm for U900.

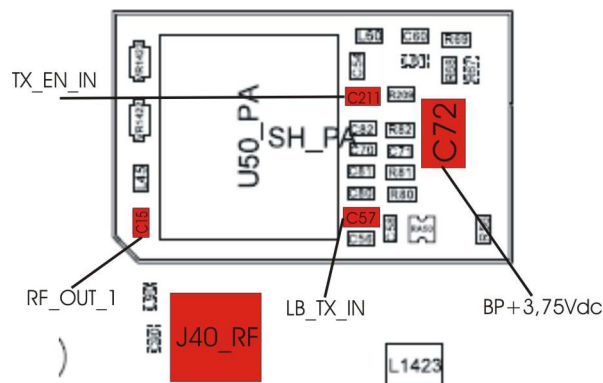
- Check RF_OUT_1 at C15
- **If ok** in size and form (if unsure compare to good radio) check J40

- **if TX at J40 is not ok** check PA input (LB_TX_IN) at C57
- if TX_EN_IN is good, following signals should be present:
- BP_3,75Vdc at C72
- RF_OUT_1
- If RF_OUT_1 is not ok, then change PA (U50)
- If TX_EN_IN was not present, change U250_SYNT

Important!! U250 could have internal interruptions at product code 03/06 to 27/06.

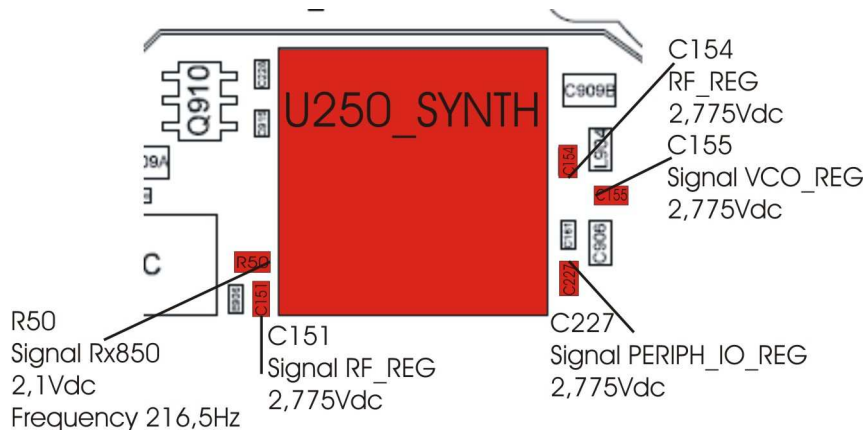
- VCO_REG at C155
- RF_REG at C154
- PERIPH_IO_REG at C227
- RF_REG at C151
- RX850 at R50

Many TX-RX failures are problems with U250_SYNT.

Important!!U250 could have internal interruptions at product code 03/06 to 27/06.

To change U250 you should work with the tool for resolder.

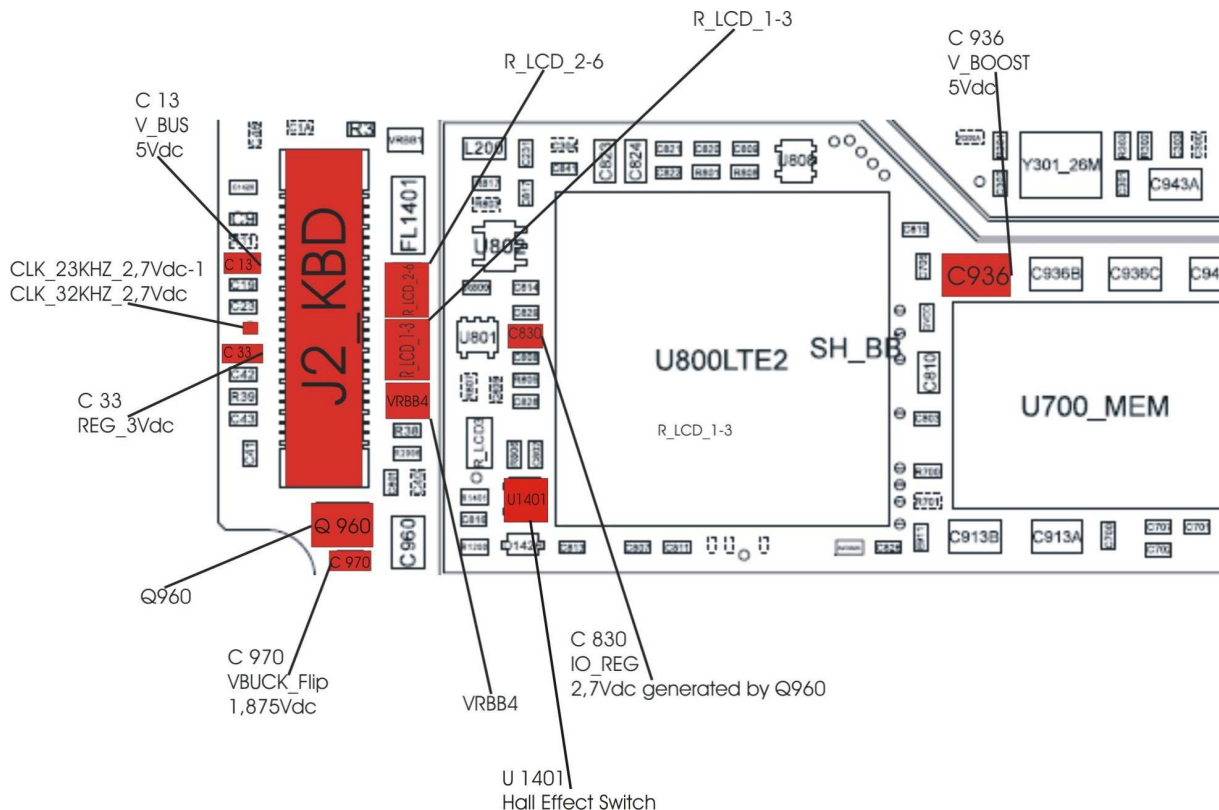
- ATI_RESETB_2,7V at C801
- V_BOOST_5V at C 936
- REG_3V at C33
- CLK_32KHZ_2_7V at CLK_32KHZ_2_7V-1
- VBUCK_FLIP_1,875V at C970
- VBUS_5V at C13

The voltages can be ok without a flip connected, but can break down, if a flip is plugged in, although the flip is ok!

- Q960 for broken part
- IO_REG_2,7Vdc at C830 generated by Q960
- VRBB 4 for broken part
- R_LCD 1-6 solder short
- R_LCD 2-6 solder short
- U 1401 for defective part

If all of these are ok, it should most likely be a problem with Neptune (U800)

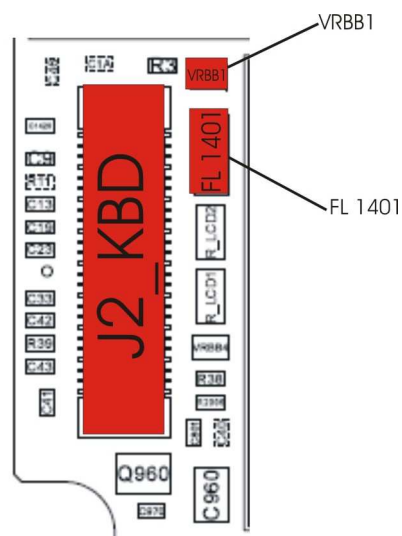
Due to the keypad matrix architecture with 8 rows in 4 columns it is quite useful to verify which keys (if not all) are affected. By knowing which keys are not working, it is possible to find out which row or column is affected. You can either use Ohm Meter to check the resistance to GND for verification, which line is affected. By using the FL Viewer it can be tracked which filters the signal passes until it reaches the Neptune.

- FL 1401
- VRBB1
- J2_KBD for loose pins or solder short

If the keypad connector/Filters are ok it's probably a problem with the Neptune (U800).

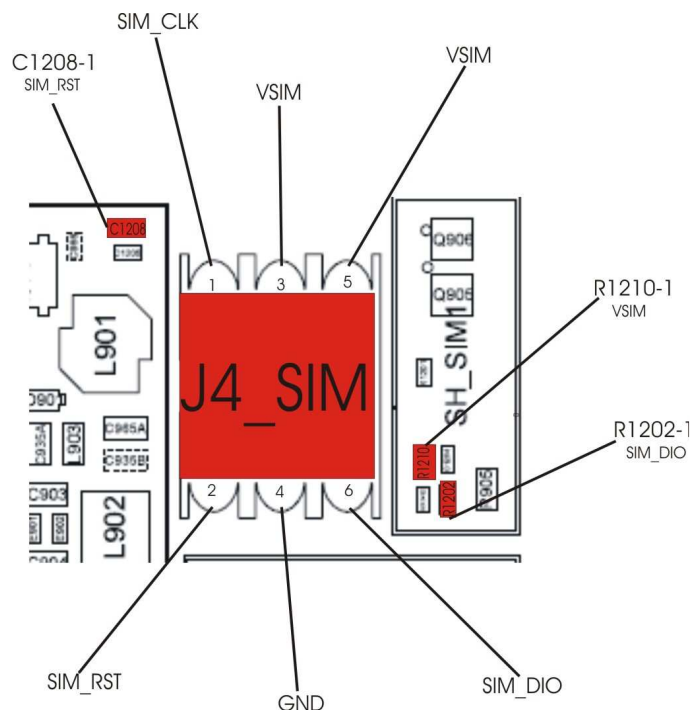
The most problems of V3i SIM card are caused by a tombstoned part R 805 near Neptune.

- VSIM at E 909-1, C 828-1
- If far** less then 30 kOhm to GND, it could be a defective ATLAS (U900)
 - SIM_DIO at R 1210-2, VR 1412-1
 - SIM_RST at R 805-2, C 1208-2
 - SIM_CLK at R1201-1

If any of these has far less then 30 kOhm to GND, it could be a defective Neptune (U800). Before replacing the Atlas (U900) or the Neptune (U800) make sure that none of the associated capacitors or resistors has low resistance to GND.

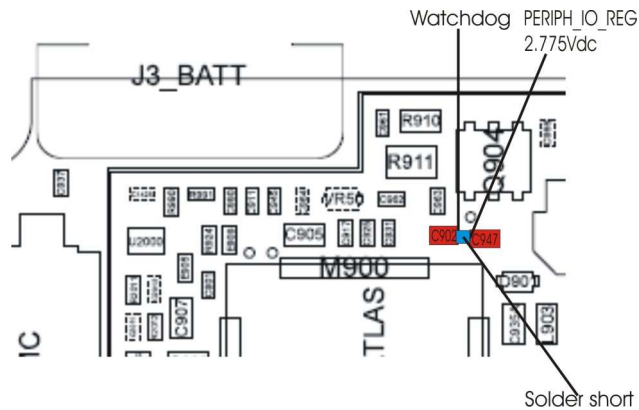
In case the phone draws current but switches off after a few seconds, you can force the phone not to switch off, by setting the **Watchdog C902**. By just solder across C 902-1 and C 947-1 (PERIPH_IO_REG 2,775Vdc) the WATCHDOG signal will be pulled to HIGH (PERIPH_IO_REG 2,775Vdc) and the ATLAS will not switch off its power regulators. You will then be able to measure all the voltages or to do a thermal troubleshooting by using coolant-spray.

The second way to check the voltages is to use a switch in the plus line of your power supply. You can put the probe to the test points of each voltage and view the voltages appearing for a short time (half a second) during each switching action.

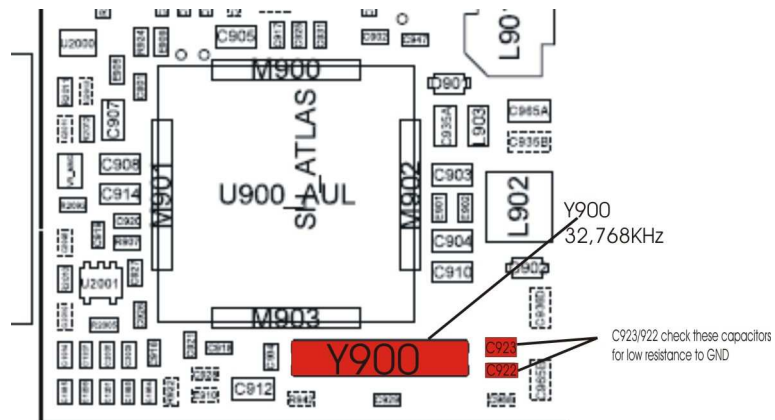
If radio draws no current at all (also not for a short time) it's most likely a problem with the 32.768 KHz clock generated by Y900

- replace Crystal Y900
- **If** unsuccessful, replace ATLAS (U900). **Please use underfilm for U900.**
