Title: Troubleshooting-Guide Z3 Level 3

### Troubleshooting Guide Z3---Level 3

# MOTORIZR™ Z3

This document was created to assist analyzers troubleshooting on Motorola GSM Phones. All information was collected during the repair in the Repair Entitlement Group Flensburg

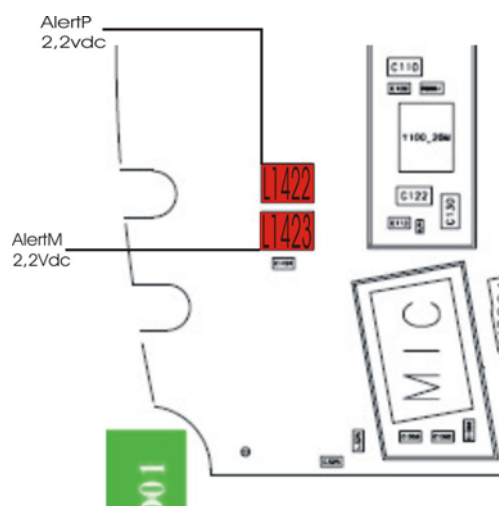
Figure 12

We have seen some phones which are unable to play ring tones via the multimedia menu. After selecting a ring tone the phone goes into playback mode, but freezes – the timer is not counting, or the melody plays to fast. In those cases, if a Master reset/Master clear does not fix the issue it is most likely a problem with the PCAP ([U900](#)).

Check [ALERTP+](#) ([M1401-1](#)) and [ALERTM-](#) ([M1401-2](#)) – both should have around 2.2Vdc

- **if not** check [L1422/L1423](#) for high impedance/misplaced part;  
[C1065/C1067/C1064/C1066/C7650/C7651](#) for low resistance/misplaced part
- [ALERTP](#) and [ALERTM](#) was generated at [U900](#)
- **if ok**, change [PCAP2](#) ([U900](#))

The alert signal is amplified by the PCAP2 ([U900](#)) and generated by the [U800](#), so if the [PCAP2](#) ([U900](#)) alert audio path is ok there could be a problem with the [U800](#) not generating the alert signals. **Then send the PCB to an authorized level 4 service center.**

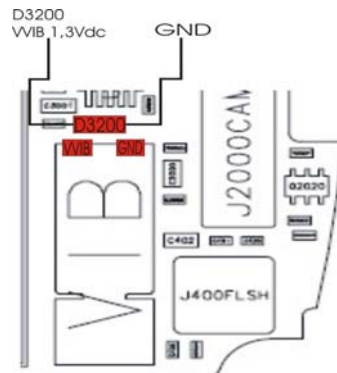
Figure 13

Turn on vibrator using Repair Studio/Radiocomm. Measure [V\\_VIB](#) – should be about 1.3 Vdc. [V\\_VIB](#) is provided via [D3200](#) by the [PCAP \(U900\)](#). To verify if the vibrator is defective a simple method is to provide a supply voltage (1Vdc should be enough) via test probes directly on the vibrator [VIB](#) (radio in off state!). It should be rotating, if not change the vibrator [VIB](#). Otherwise change [PCAP \(U900\)](#).

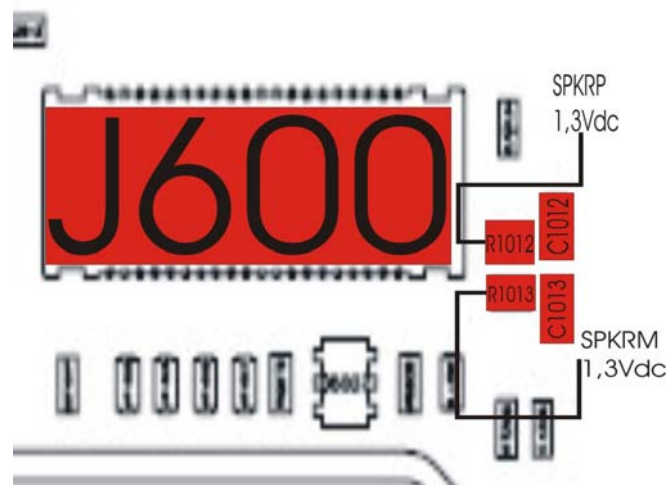
Figure14

First step on every audio related problem is to identify which audio paths are affected. If audio signals in loop are ok, there could be an audio problem in a network call. Then it is most likely a problem with the [U800](#). **Then send the PCB to an authorized level 4 service center.**

Check [SPKRP-](#) at [R1012](#) and [SPKRM+](#) at [R1013](#) – both should have around 1.5Vdc

- **if not** check [J600](#) for solder shorts, [C1012/C1013](#) for low resistance
- **if ok**, check Flip assembly connector [J600](#) for bad soldered pins/damaged part
- **if ok**, change [PCAP2 \(U900\)](#)
- mostly audio problems are found by damaged flex-assy

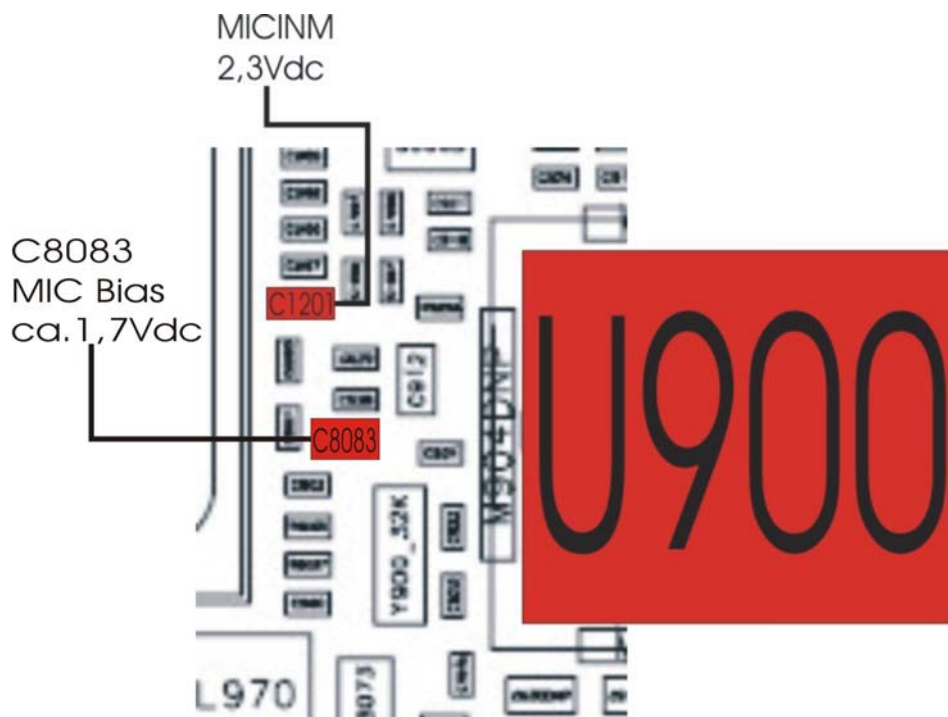
Figure 15

Check the [MIC BIAS](#) at [C8083](#) – both should have around 1,7Vdc

- **if not** check [C8083/C968/C969/C1203/C1202](#) for low resistance
- **if ok** check [MIC](#)
- **if ok** change [U900](#)

Check [MICUNM](#) at [C1201](#) – both should have around 2,3Vdc

- **if not** check [C1201/C967/C966/C1200](#) for low resistance
- **if ok** check [MIC](#)
- **if ok** change [U900](#)

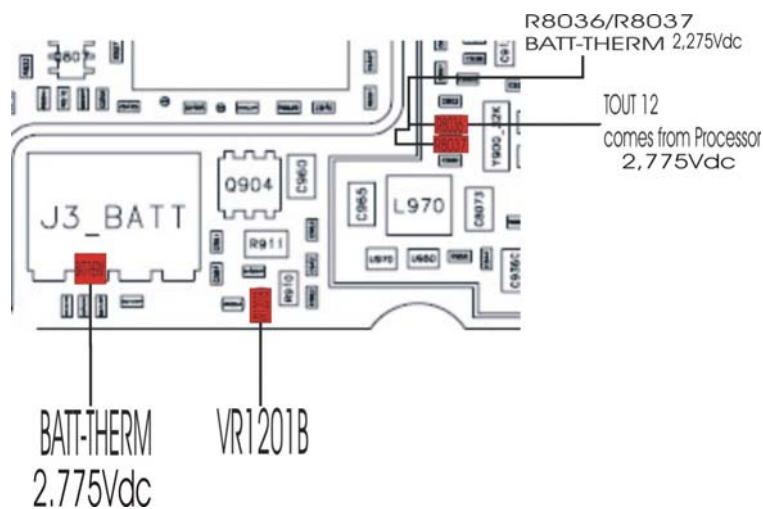
Figure 16

- verify [BATT\\_THERM \(J3 BATT-2\)](#) while PCB is connected to USB cable. It should be 2.775Vdc. If it is low
- check [VR1201](#) for low impedance, [R8036/R8037](#) (39k/20k).
- **if ok** check [TOUT 12](#) at [R8036-1](#). It should be 2,775Vdc
- **if not ok** Then send the PCB to an authorized level 4 service center.

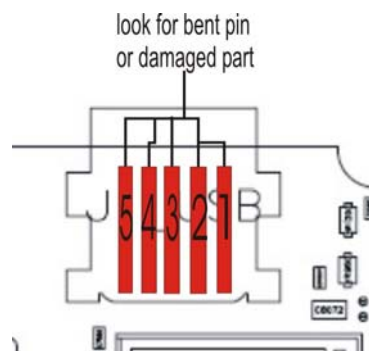
Figure 17

Customer complaint: no charging

- check [J1 USB](#) connector for bent pin

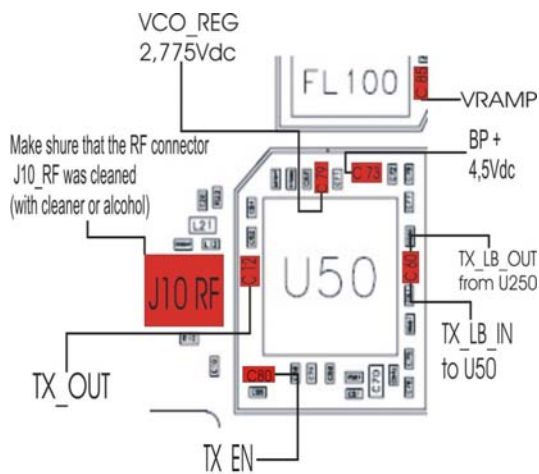
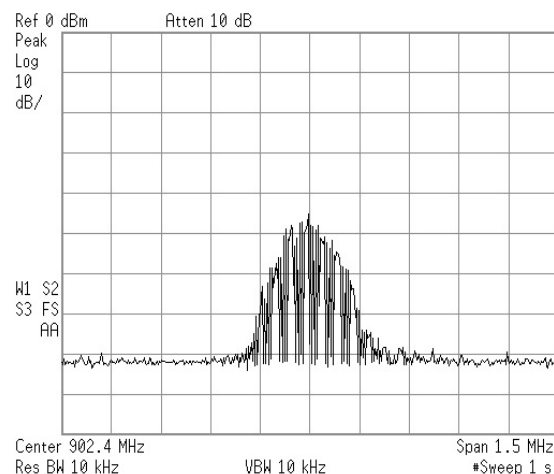
- check [TX\\_LB](#) from [U250](#) at [C60](#)
- **if ok** in size and form
- check [U50 TX\\_out](#) at [C12](#)
- **if ok** check [J10\\_RF](#)
- **if not ok** check [VCO\\_REG](#) 2,775Vdc at [RS 79](#), check [VRAMP](#) at [C85](#)
- check [TX\\_EN](#) at [C80](#)
- **if ok** change [U50](#)

Signal [TX\\_LB\\_Out](#) from [U250](#)

To change [U250](#) or [U50](#) you should work with the tool for resolder.

Use Teflon kit, if you change the [U250](#) or [U50](#) to protect [U800/U700](#)

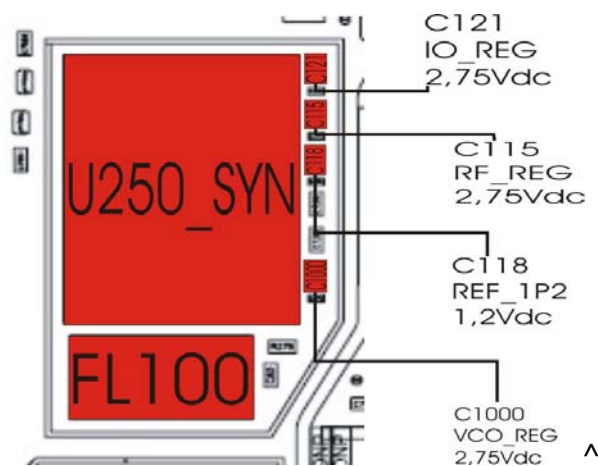
Figure 20

Inject a RF from Test Set. Check [RF\\_OUT\\_1](#) at [C12](#).

There are no test points to measure the RX-signal, because the signals go directly to [U250\\_SYNTH](#).

So you can only check the signals from [U250\\_SYNTH](#).

- [VCO\\_REG](#) at [C1000](#) 2,75 Vdc
- [RF\\_REG](#) at [C115](#) 2,75Vdc
- [IO\\_REG](#) at [C121](#) 2,75Vdc
- [REF\\_1P2](#) at [C118](#) 1,2Vdc

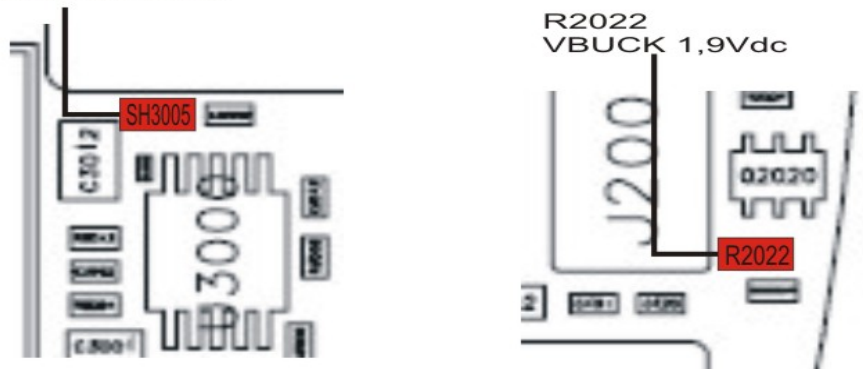
Figure 21

Make sure that the problem is not located in the flip assembly, by testing PCB with a good one and do a visual check of [J600](#)

The following supply voltages for the flip assembly should be present:

- [VBUCK](#) 1.9Vdc at [R2022](#)
- [VBOOST](#) 5Vdc at [SH3005](#)

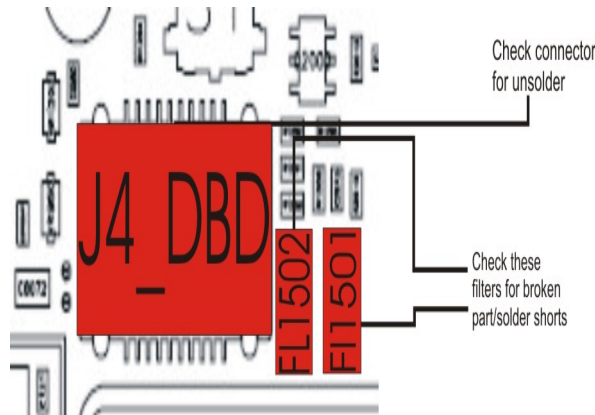
Figure 22

Due to the keypad matrix architecture with 8 rows in 3 columns it is quite useful to verify which keys (if not all) are affected. By knowing which keys are not working it is possible to find out which row or column is affected. By using the FLViewer it can be tracked which filters/capacitors the signal passes until it reaches the [U800](#).

In practice the defective part very often can be found just by visual inspection. Check:

- [FL1501](#)
- [FL1502](#)

If keypad connector/filters are ok, it's probably a problem with the [U800](#), then sends the **PCB to an authorized level 4 service center.**

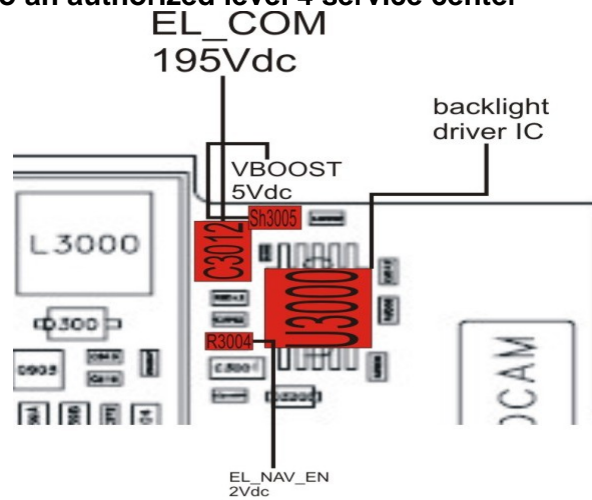
Figure 23

The backlight driver ([U3000](#)) is on the PCB. The following voltages are present

- [VBOOST](#) 5Vdc
- [EL\\_NAV\\_EN](#) 2Vdc is backlight activated
- [EL\\_COM](#) 195Vdc is backlight activated

**If not** - change [U3000](#)

- send the PCB to an authorized level 4 service center

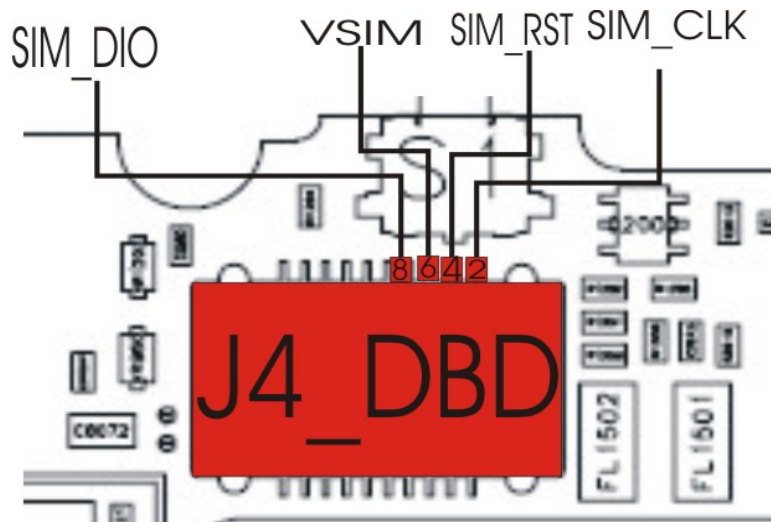
Figure 24

Measurement on the SIM interface is a little bit difficult, as no signals will be present until a SIM card and a battery are inserted. In the most cases it should be possible to figure out which part is defective by simply measure with an ohm meter following signals to GND:

- [VSIM](#) at [J4\\_DBD - 6](#), - if far less than 30 kOhm to GND it is probably because of a defective PCAP ([U900](#))
- [SIM\\_DIO](#) at [J4\\_DBD - 8](#)
- [SIM\\_CLK](#) at [J4\\_DBD - 2](#)

[SIM\\_RST](#) at [J4\\_DBD - 4](#) - if any of these has far less than 30 kOhm to GND it is most likely because of a defective processor ([U800](#)), **then send the PCB to an authorized level 4 service center.**

Before changing the [PCAP \(U900\)](#), make sure that none of the according capacitors/diodes have low resistance to GND.

Make sure, that the daughter-board is ok and the connector [J4\\_DBD](#) is good soldered!

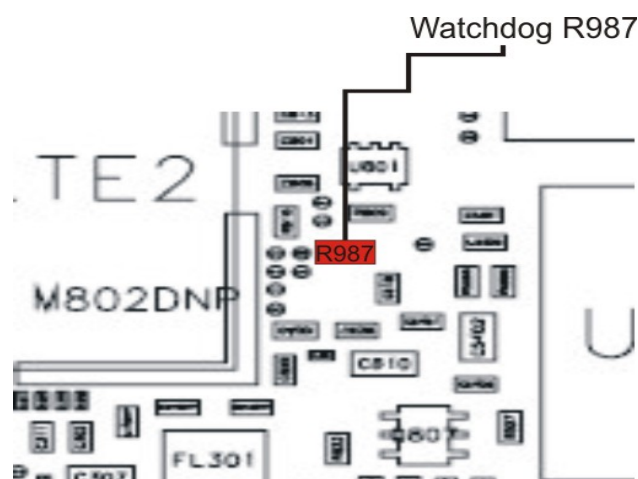
Figure 25

In case the phone draws current but switches off after a few seconds, you can force the phone not to switch off, by setting the **Watchdog R987DNP**. By placing a short resistor as [R987](#) or by just solder across the pads of [R987](#) the WATCHDOG signal will be pulled to HIGH level ([IO\\_REG 2.775Vdc](#)) and the PCAP ([U900](#)) will not switch off its power regulators. Thereby you will be able to measure or to do a thermal troubleshooting using a coolant spray.
