Title: Troubleshooting-Guide V980/V975

Doc. No: TSG_V9xx

Debug Guide V980/V975/V1050 – Level 3/4

This document was created to assist analyzers troubleshooting problems on Motorola 3G Phones. All information was collected during the repair in the Repair Entitlement Group Flensburg.

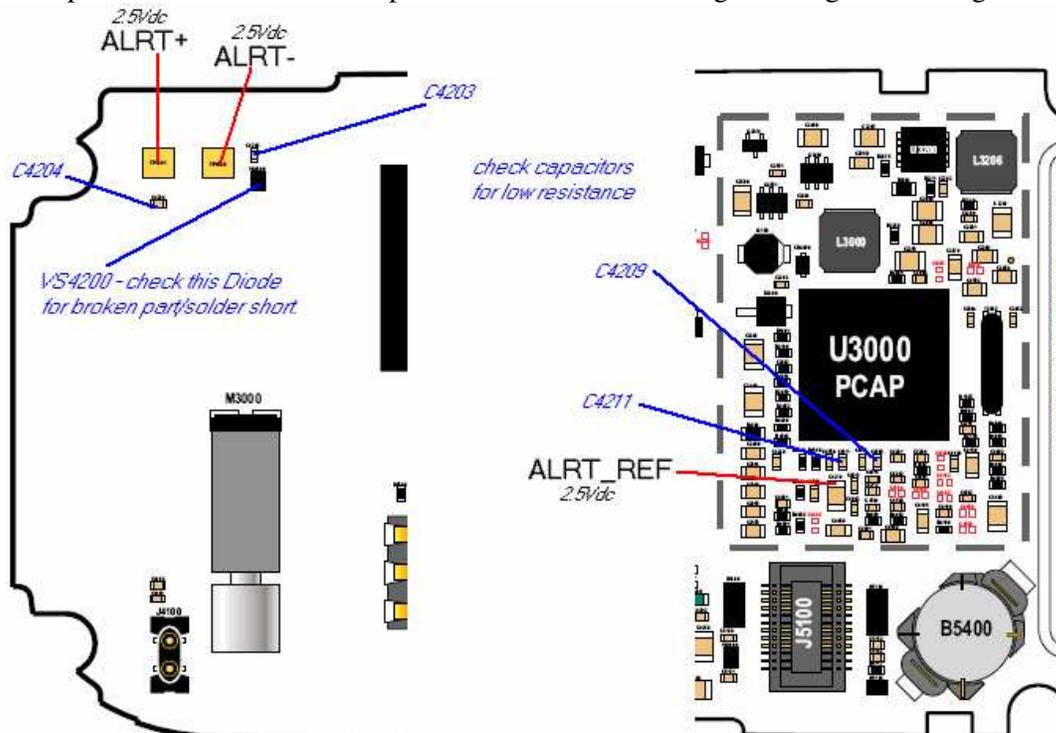
Check ALRT- (TP4200) and ALRT+ (TP4201) – both should have around 2.5Vdc

- if not check VS4200 for solder short/broken part, C4203/C4204/C4209/C4211 for low resistance
- check ALRT_REF 2.5Vdc at C4210
- check PCB on open tracks from TP4200 to U3000-F1 / TP4201 to U3000-H1
- if ok, change PCAP2 (U3000)

The alert signal is amplified by the PCAP2 and generated by the POG, so if the PCAP2 alert audio path is ok there could be a problem with the POG not generating the alert signals.

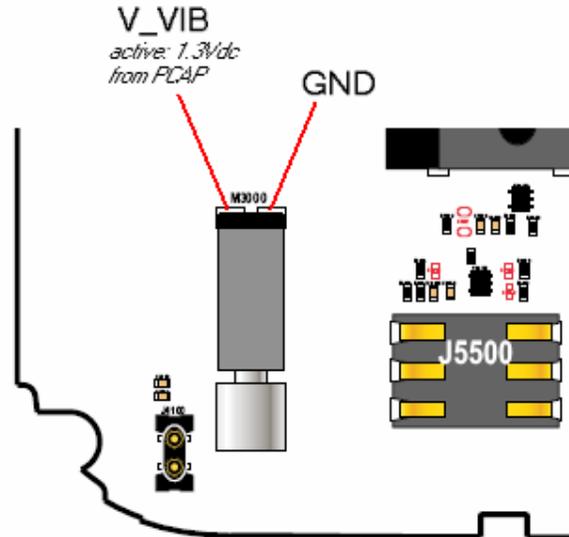
Turn on vibrator using Repair Studio/Radiocomm. Measure V_VIB – should be about 1.3 Vdc. V_VIB is provided directly by the PCAP (U3000). To verify if the vibrator is defective a simple method is to provide a supply voltage (1Vdc should be enough) via test probes directly on the vibrator M3000 (radio in off state!). It should be rotating, if not change the vibrator M3000. Otherwise change PCAP (U3000).

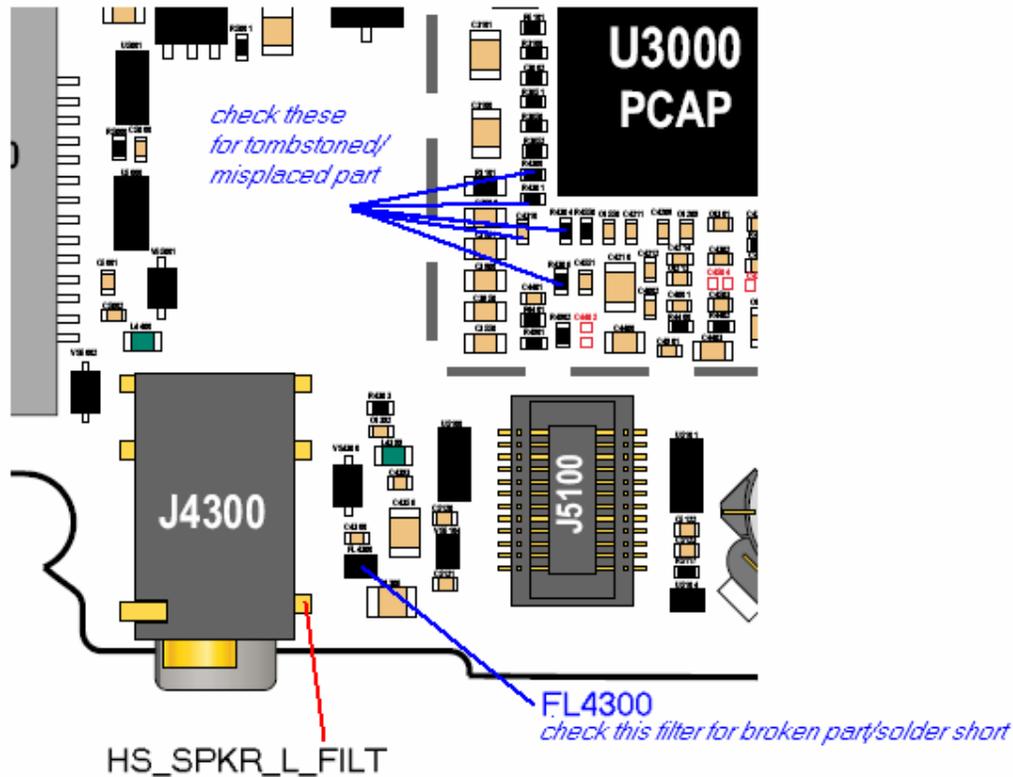
For headset detection HS_SPKR_L_FILT is used. With Headset connected HS_SPKR_L_FILT is LOW, without Headset HS_SPKR_L_FILT should be HIGH (2.8Vdc).

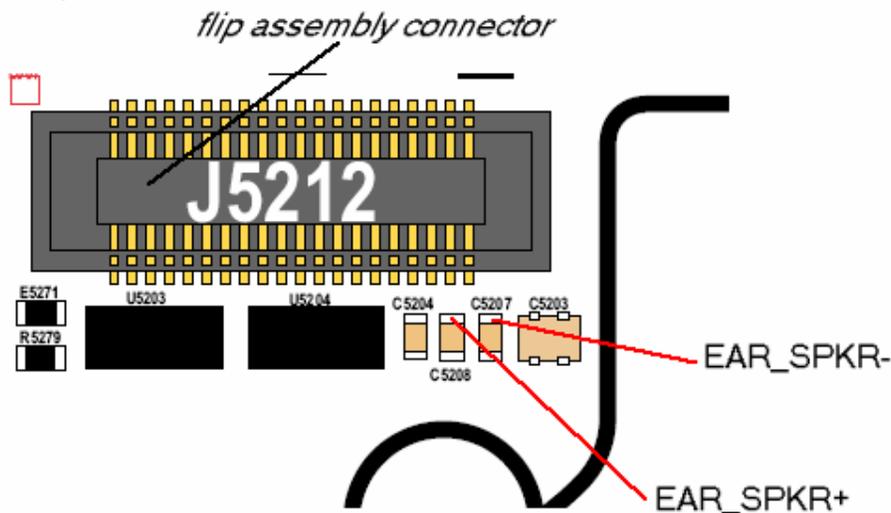
Check EAR_SPKR- at C5207 and EAR_SPKR+ at C5208 – both should have around 1.5Vdc

- if not check J5212 for solder shorts, C5207/5208 for low resistance
- (eventually) check PCB on open tracks from C5207 to U3000-J4 / C5208 to U3000-K2
- if ok, change PCAP2 (U3000)

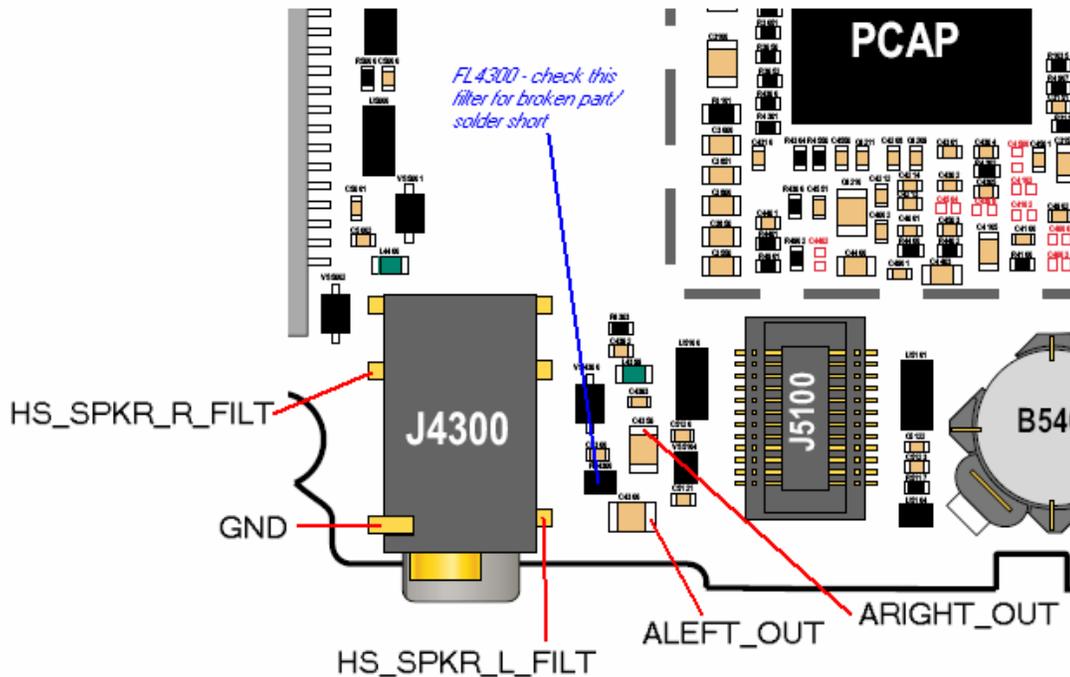
- check ALEFT_OUT at C4306/ ARIGHT_OUT at C4356
- if ok change FL4300
- if not ok change PCAP (U3000)

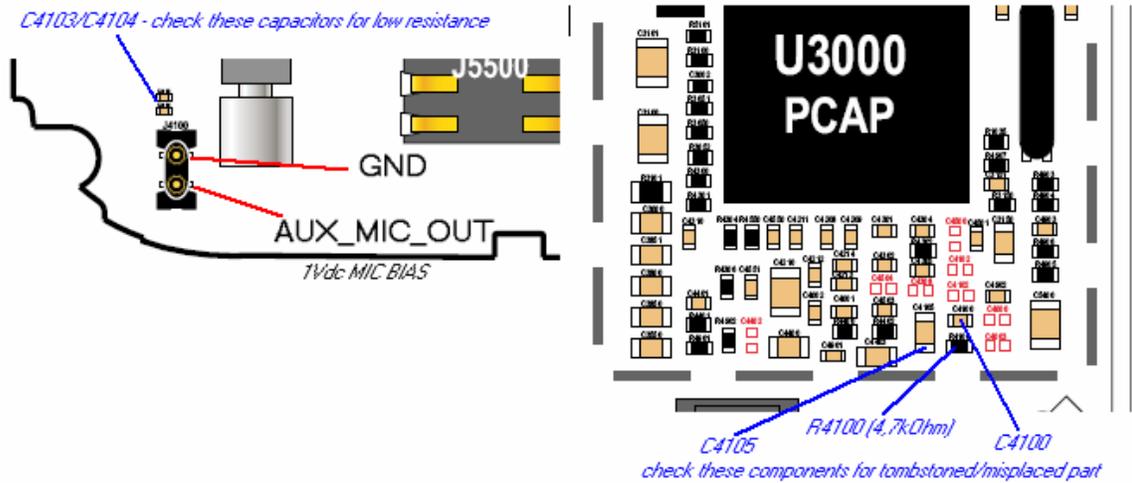
- check Mic BIAS at J4100-2 – should be around 1Vdc
- if not check C4103/C4104 for low resistance
- check R4100 (4,7kOhm), C4100, C4105 for tombstoned/misplaced part
- if ok, change PCAP2 (U3000)

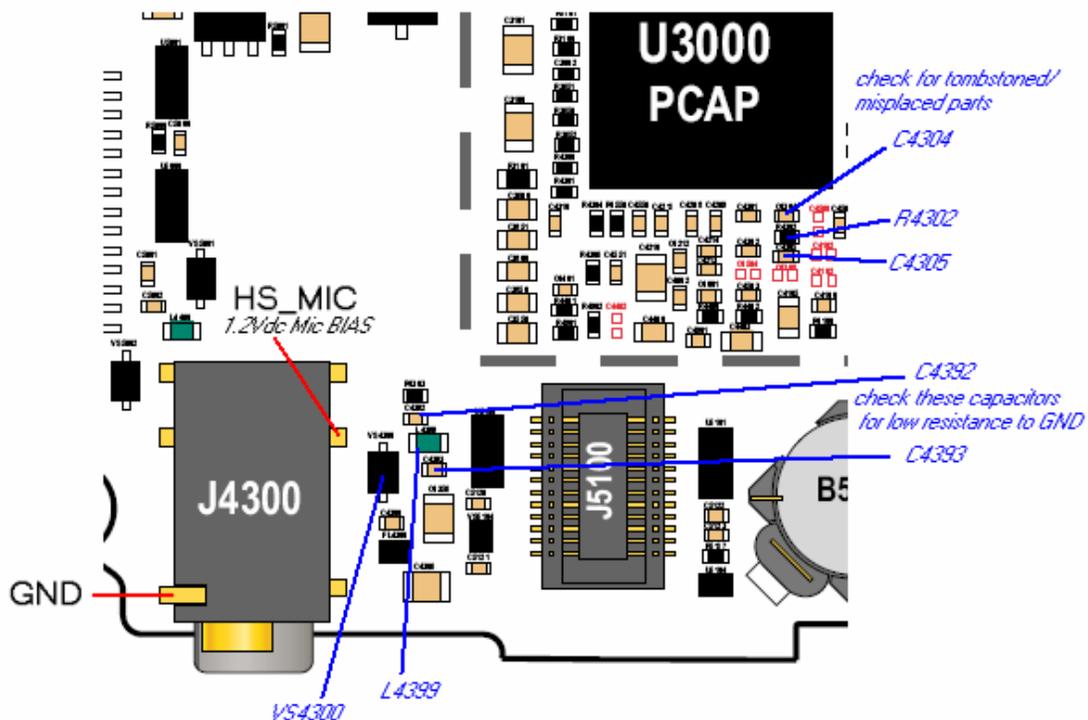
- check headset Mic BIAS at J4300-4 – should be around 1.2Vdc
- if not check VS4300/C4392/C4393 for low resistance, check R4302 (4,7KOhm), if ok change PCAP (U3000)
- if headset Mic BIAS ok
- whistle in headset microphone and follow signal from J4300-4 through L4399 through C4305 to PCAP
- if ok, change PCAP (U3000)

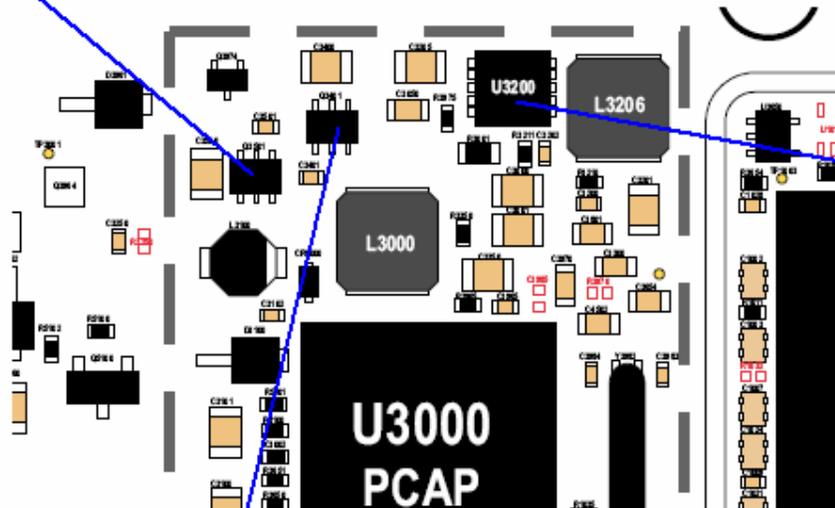
Q3501 provides VRF_RX_2.775V for Blue Module. If this part is getting warm check Blue Module for internal short

U3200 provides VMAIN_1.55V for the POG. If this part is getting warm check POG for internal short

Q3401 provides VRF_TX_2.775V for Rattler IC, GSM PA and WCDMA PA. If this part is getting warm check Rattler and PA's for internal short.

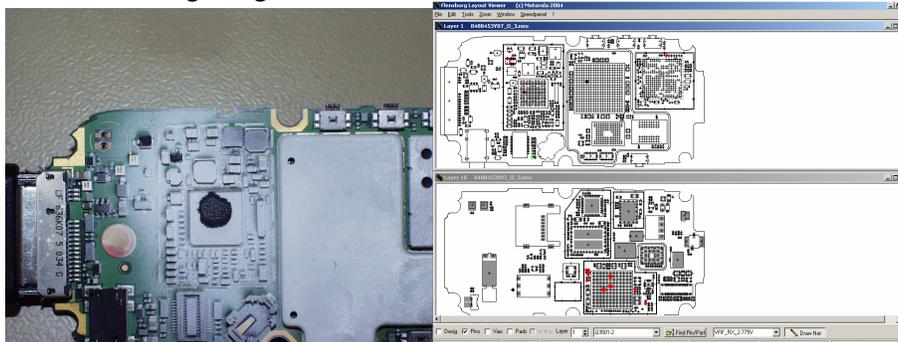
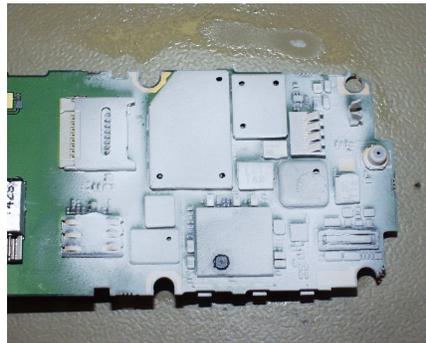
- BAT00 – radio draws about 400 mA in standby, no off current
- Q3501/U3000 are getting warm

- Q3501 provides VRF_RX_2.775V for Blue Module U900 via Short Resistor R902 (using Flensburg Layout Viewer)

- Blue Module U900 is also getting warm
- Blue Module U900 itself has an internal short. defective U900

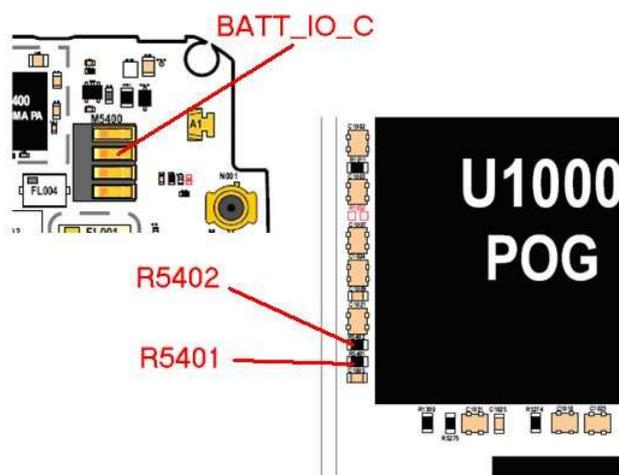
- verify BATT_IO_C (M5400-3) while PCB is connected to CE-USB cable. It should be 2.775V. If it is low
- check R5401 and R5402 (100 Ohm). If they are ok it should be a problem with the POG U1000

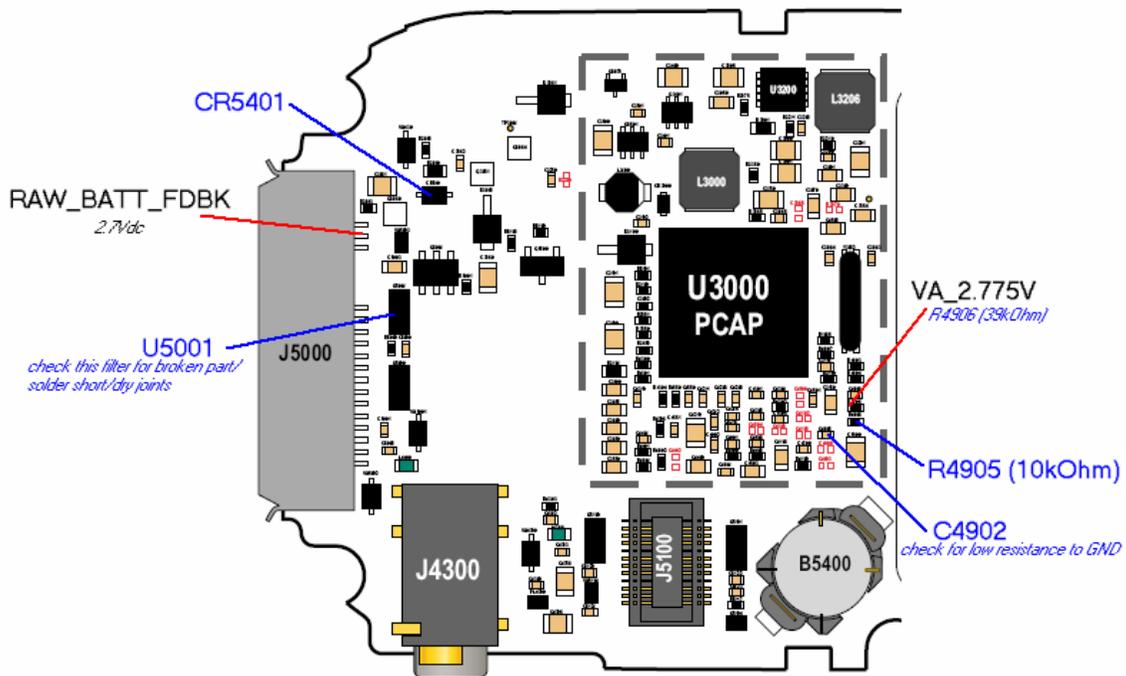
If display indicates “Charging not possible”, check RAW_BATT_FDBK at J5000 with attached CE-Connector. It should be around 2.7Vdc.

- If not check U5001/CR5401, R4905 (10KOhm), C4902 for low resistance to GND, R4906 (39 KOhm) – VA_2.775Vdc – if ok change PCAP (U3000)

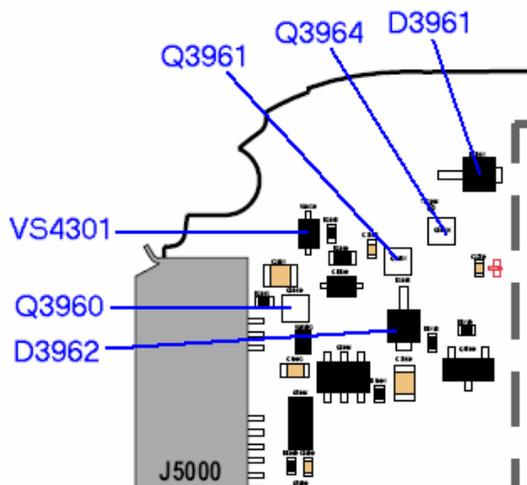
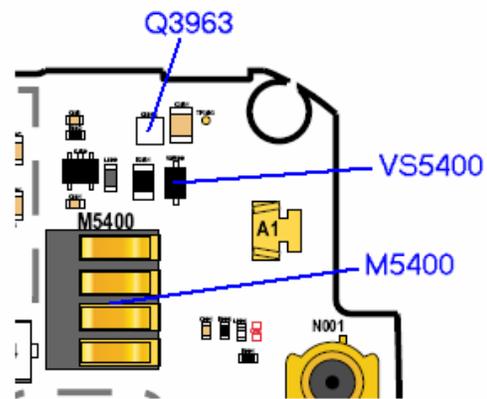
- If ok check whether there is a high current consumption or an off current via battery. If so please follow troubleshooting as described in the BATxx section of this document.
- Check Q3960, Q3961, Q3963, Q3964, D3962, D3961, VS5400, VS4301
- If ok change PCAP (U3000)

check all of these for damaged/tombstoned/misplaced part or dry joints

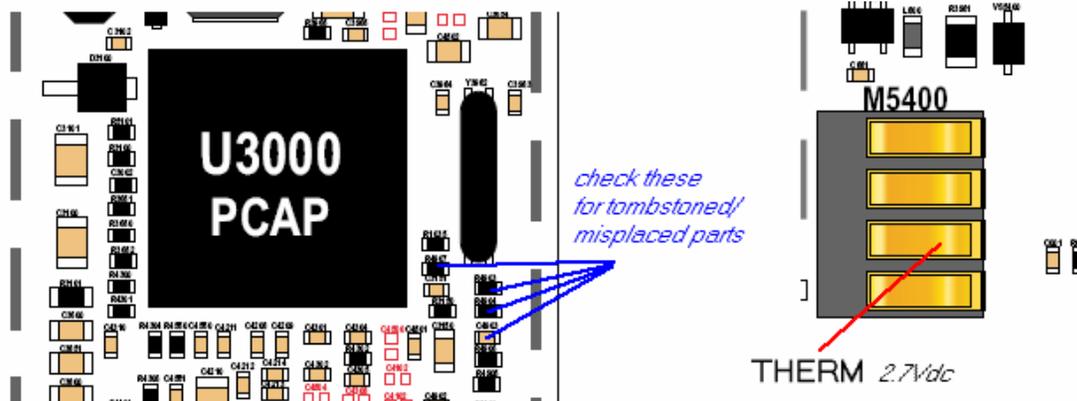
Check THERM at M5400-2, it should be 2.7Vdc. If it is not check R4907, R4903, R4904, C4903 for tombstoned/misplaced parts. If ok, change PCAP (U3000)

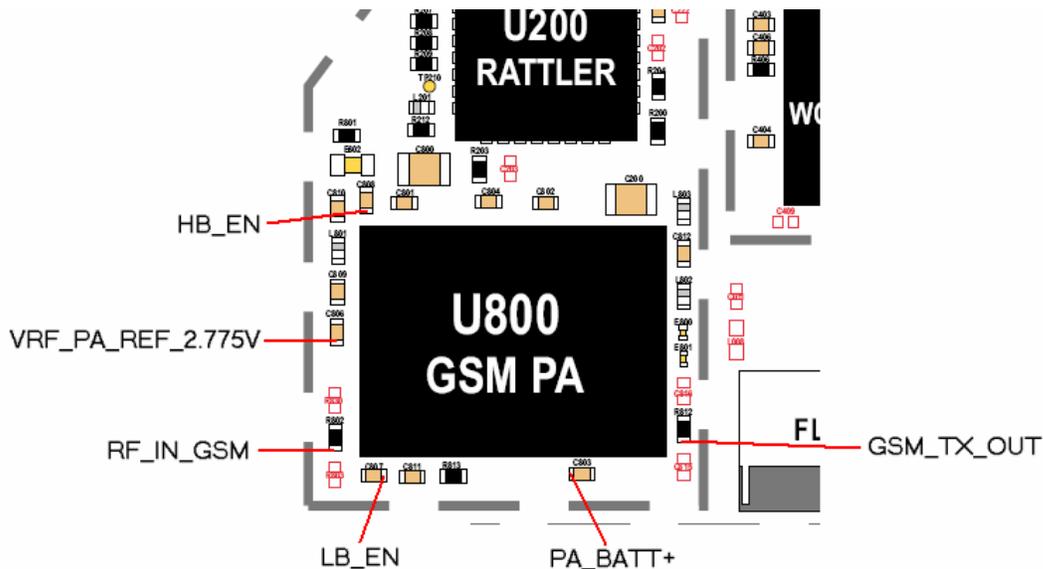
- Check GSM_TX_OUT at R812 – if ok in size and form (if unsure compare to good radio) check FL001
- if not ok check RF_IN_GSM at R802
- if RF_IN_GSM is good following signals should be present:
 - VRF_PA_REF_2.775V at C806
 - PA_BATT+ at C803
 - LB_EN at C807 (pulsed 3V at 217Hz) – signal from Harmony

- There are two more signals coming from Harmony directly to the PA, but without test points, which are TX_EN_2V7 and 9E_MODE

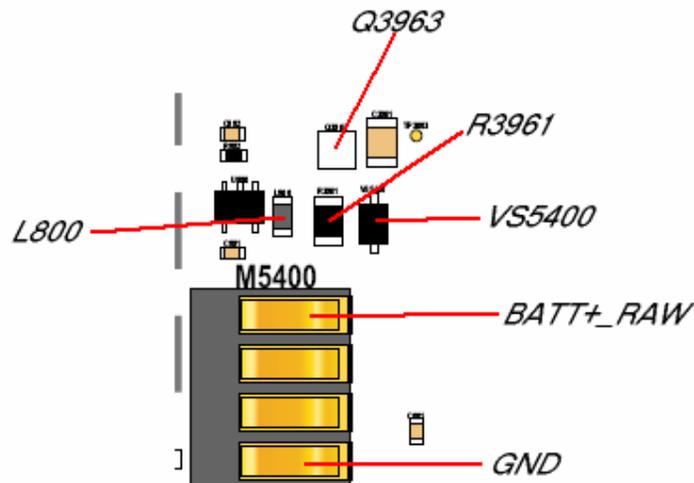
If PA_BATT+ is missing check L800, R3961 and VS5400.

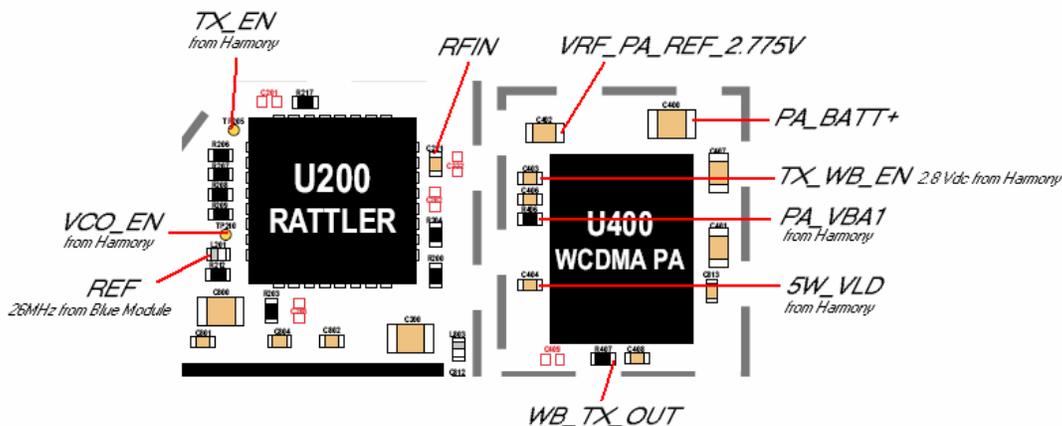
- check WB_TX_OUT at R407 – if ok in size and form (if unsure compare to good radio) check FL003,FL001
- if not ok check RFIN at C221
- if RFIN is good check supply voltages VRF_PA_REF_2.775V at C402 and PA_BATT+ at C400, TX_WB_EN at C403 about 2.8Vdc (WCDMA TX Enable signal from Harmony). If all of these are present it should be most likely a defective WCDMA PA U400.
- If RFIN is bad check TX_EN (2.7Vdc from Harmony), VCO_EN (2.7Vdc from Harmony), REF (26 MHz clock from Blue Module). If all of these are present it is most likely a defective or bad soldered Rattler IC (U200) or a problem with the Harmony (U100)

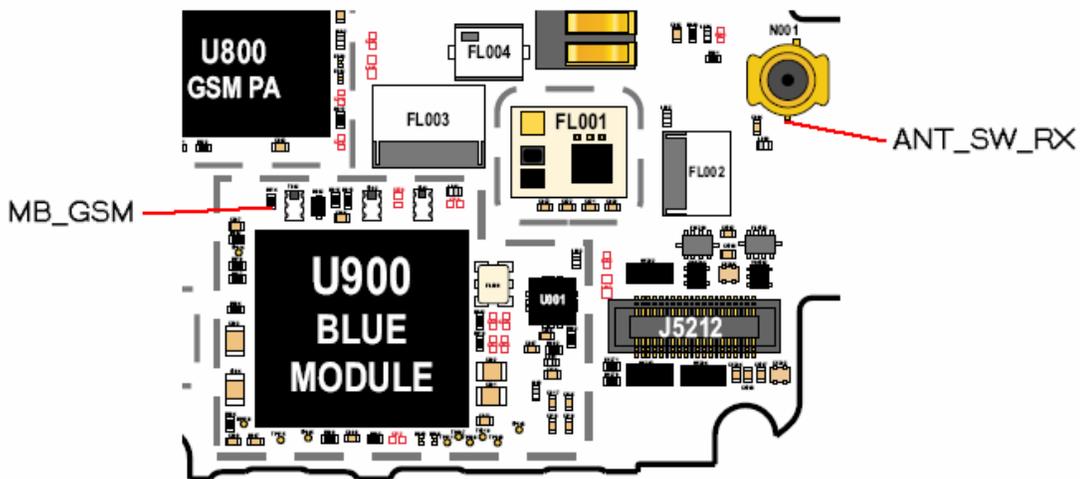
Inject a RF from Test Set. Check ANT_SW_RX at antenna switch N001-1. Check for presence of MB_GSM at R914.

- If not ok change FEM FL001
- If ok there is most likely a problem with the Blue Module U900 or the Harmony U100

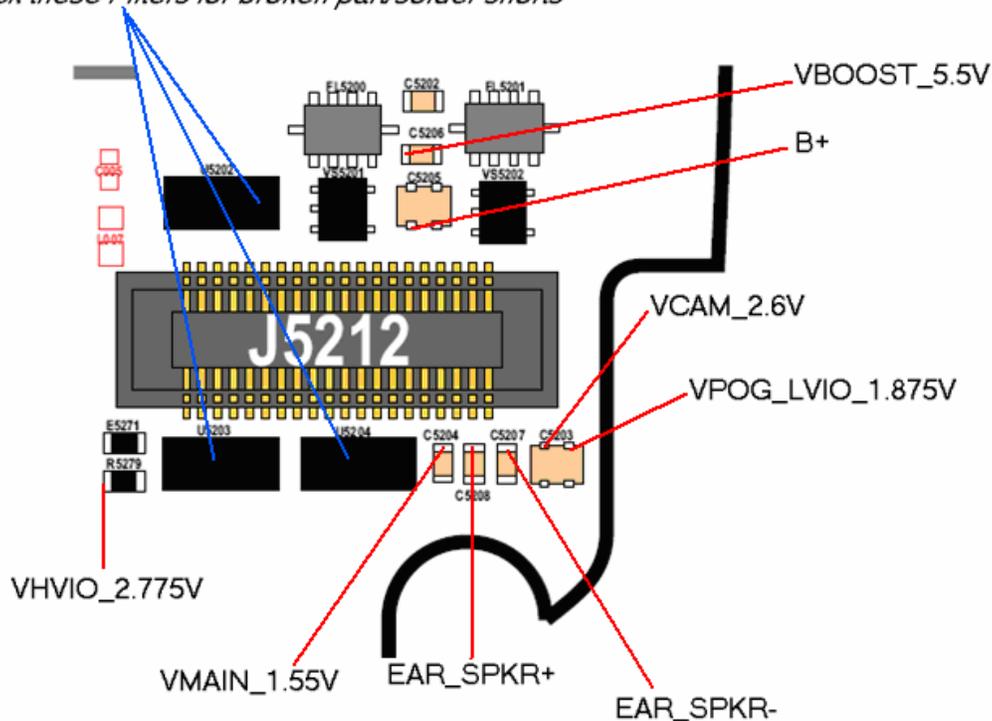
- Filters U5202/U5203/U5204 (look especially for broken part!)
- Diodes VS5200/VS5202
- Filters FL5200/FL5201
- U5200/U5201 (sometimes they are bad soldered)

check these Filters for broken part/solder shorts

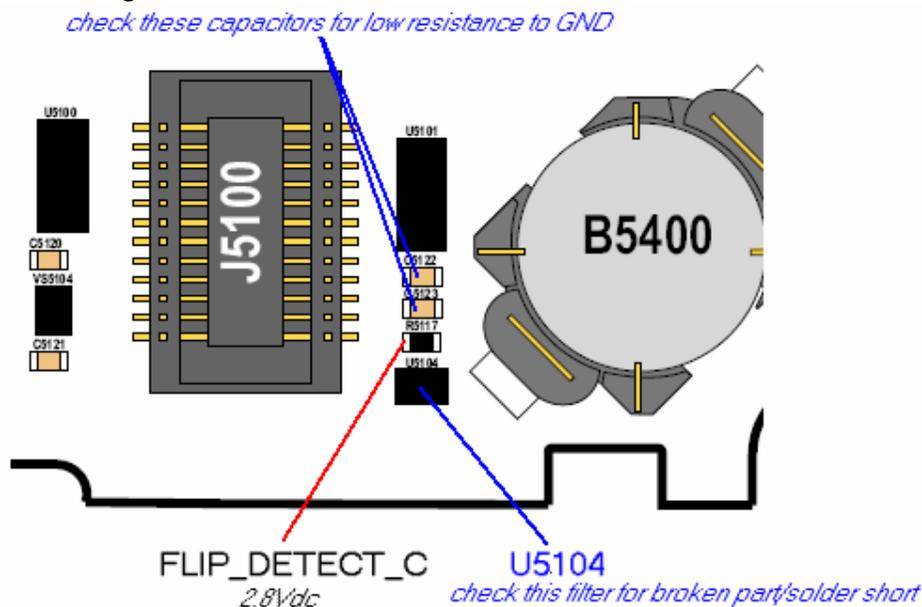
Check FLIP_DETECT_C at R5117 – should be 2.8Vdc (High), if it is low check

- C5122/C5123 for low resistance to GND
- Check Filter U5104 for broken part/solder short
- Remove Filter U5104
- Check FLIP_DETECT_C at R5117 again
- If FLIP_DETECT_C is 2.8Vdc (High) now, the Filter U5104 was defective
- If not, change the POG

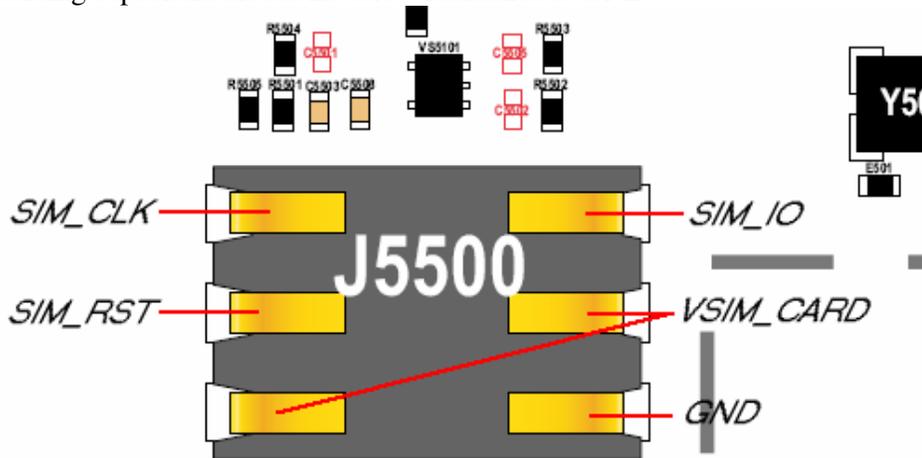
- VSIM_CARD at J5500-2,J5500-6 - if far less than 30 kOhm to GND it is probably because of a defective PCAP (U3000)
- SIM_IO at J5500-1
- SIM_CLK at J5500-4
- SIM_RST at J5500-5 - if any of these has far less than 30 kOhm to GND it is most likely because of a defective POG (U1000)

Before changing the PCAP (U3000) or the POG (U1000) make sure that none of the according capacitors/diodes have low resistance to GND.

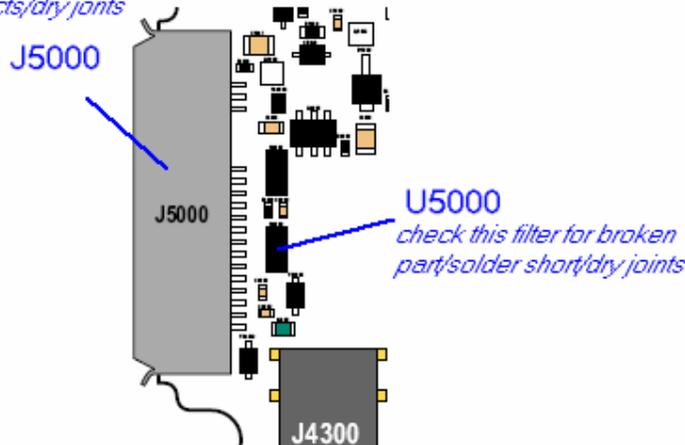
- Visually check CE Connector for mechanical defects or contamination on contacts, bad soldered pins or solder shorts
- Visually check ESD filter U5000 for solder shorts/broken part

check for contamination on contacts/mechanical defects/dry joints

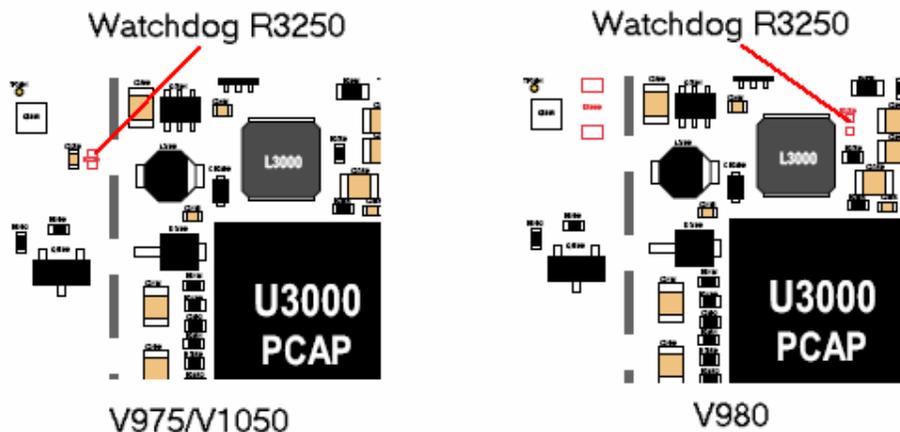
In case the phone draws current but switches off after a few seconds, you can force the phone not to switch off, by setting the **Watchdog R3250DNP**. By placing a short resistor as R3250, or by just solder across the pads of R3250 the WATCHDOG signal will be pulled to HIGH level (VLVIO_1.875V) and the PCAP will not switch off its power regulators. Thereby you will be able to measure or to do a thermal troubleshooting using a coolant spray.

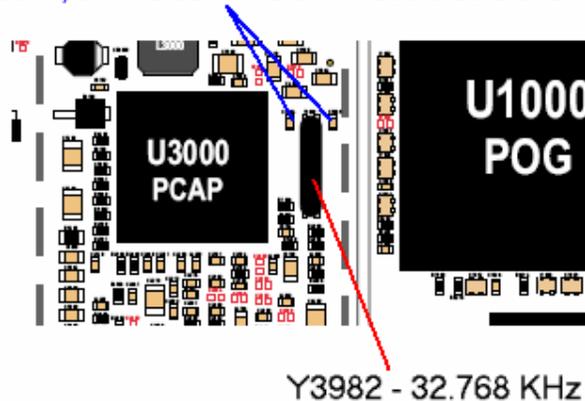
If radio draws no current it's most likely a problem with the 32.768 KHz clock generated by Y3982

C3983/C3984 check these for low resistance to GND

- change Crystal Y3982
- if unsuccessful change PCAP (U3000)

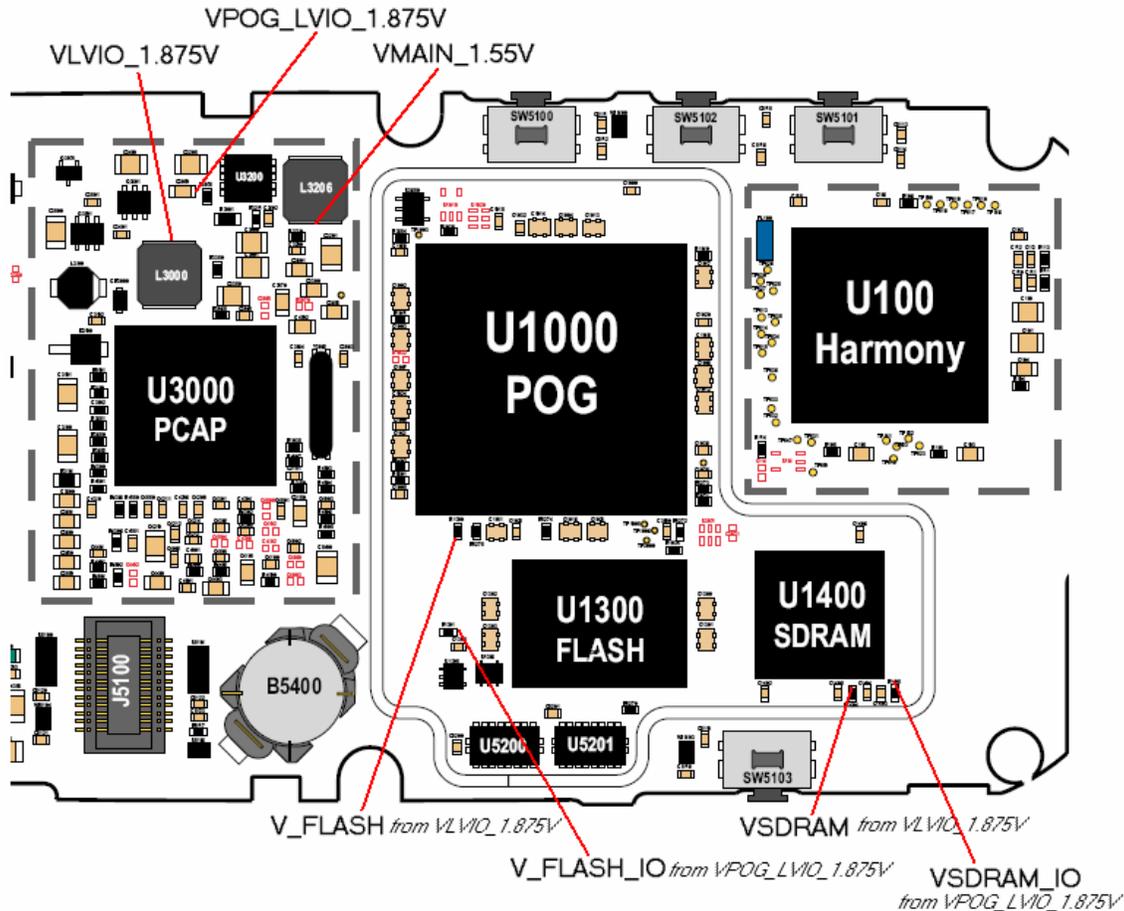
- VLVIO_1.875V which become V_FLASH after passing Short R1300 /VSDRAM after passing Short R1404
- VPOG_LVIO_1.875V which become V_FLASH_IO after passing Short R1301/ VSDRAM_IO after passing Short R1405
- VMAIN_1.55V
- 32.768KHz clock at Y3982

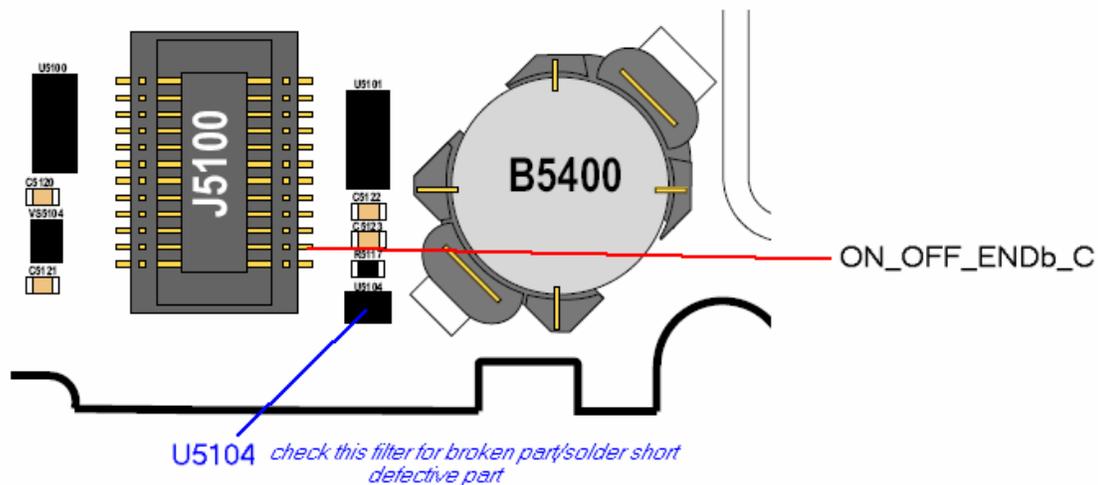
Check U5104 for broken part/solder short. If it seems visually ok, it might be a defective part.

- change U5104
- if unsuccessful change PCAP (U3000)
