Title: Troubleshooting-Guide **W220 Level 3**

Doc. No: tsg\_gsm\_w220\_level3

## Troubleshooting-Guide Level 3

# W220

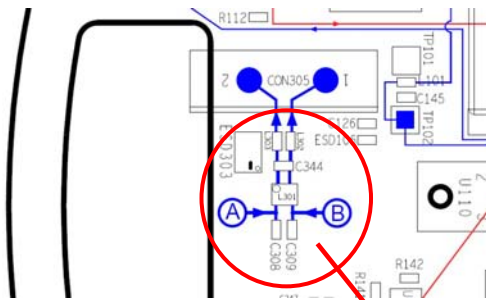
**Low-pass filter and ESD-protection**

If the alert isn't working, the easiest way to isolate the failure is at first to replace the alert. It's bonded in the alert housing and really simple to replace.

If the alert is not the cause, check the parts direct to the contacts of the alert. This circuit filters out the high band noise and **ESD303** is an ESD-protect. Maybe there's too less solder or a broken/tombstone part. But mostly the melody IC **U101** is defective. When replacing the part please take care of the flash IC **U501** placed directly beside **U101**, use cooling shields!

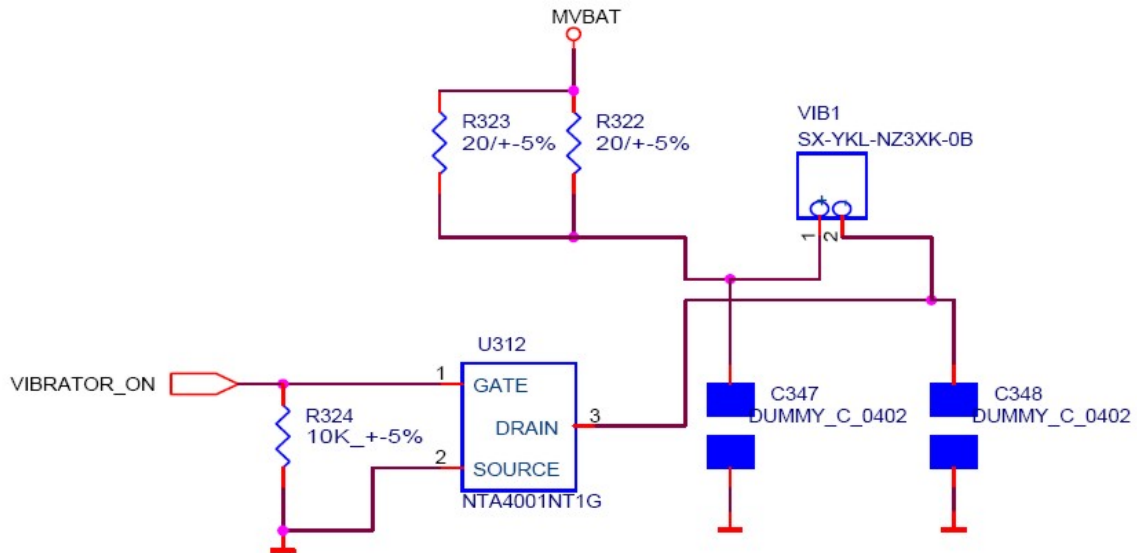
The vibrator is switched on by receiving a control-signal **VIBRATOR\_ON** from pin H13 of calypso **U201**. This signal controls the MOSFET **U312**, which switches contact 2 of the vibrator to GND. The voltage **MVBAT** goes to pin 1 of vibrator.

The **VIBRATOR\_ON** signal should be pulsing at ~2,8 V (in the CIT the vibrator works only pulsed). If it's missing or too low, replace **U201** and **U501**, because the signal comes directly from **U201**. If the signal is OK, replace **U312**, because the MOSFET doesn't switch contact 2 of vibrator to GND.

In the case that the vibrator works too low automatically after startup, check **U312** as well. It switches the vibrator on permanently with a low voltage (permanent internal resistance).

At first – of course – replace the vibrator. If the failure still exists it's useful to perform some measurements. To make this possible, place the PCB into a complete front housing and connect it with the charger and external voltage from the power-supply. It's not possible to use the modified rear housing in this case, just press the contact of + onto the battery-contact.

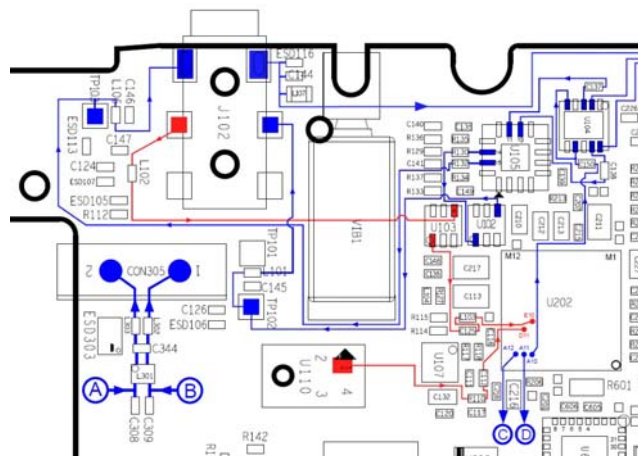
The internal audio-path goes directly from pins A11 and A12 of **U202** to pins A6 and B6 of **CON301**. So in the most cases, when audio doesn't work at all, **U202** is defective and has to be replaced. There aren't any measurements to perform. Very often the switching between headset and internal audio doesn't work correctly. In that case assemble the PCB without rear housing first, plug in the charger and switch the phone on. Now you can measure the signal **EP\_STATUS** (to **U201 CalypsoLite**), which is set to high (2,8 V). When inserting the headset plug, it changes to low, and the headset is activated. If not, the internal mechanical switch is defective – replace headset-connector **J102**!

If the switching is OK, check **U102** and **U103** (electrical switch) and replace them (it's more efficient to replace both at once).

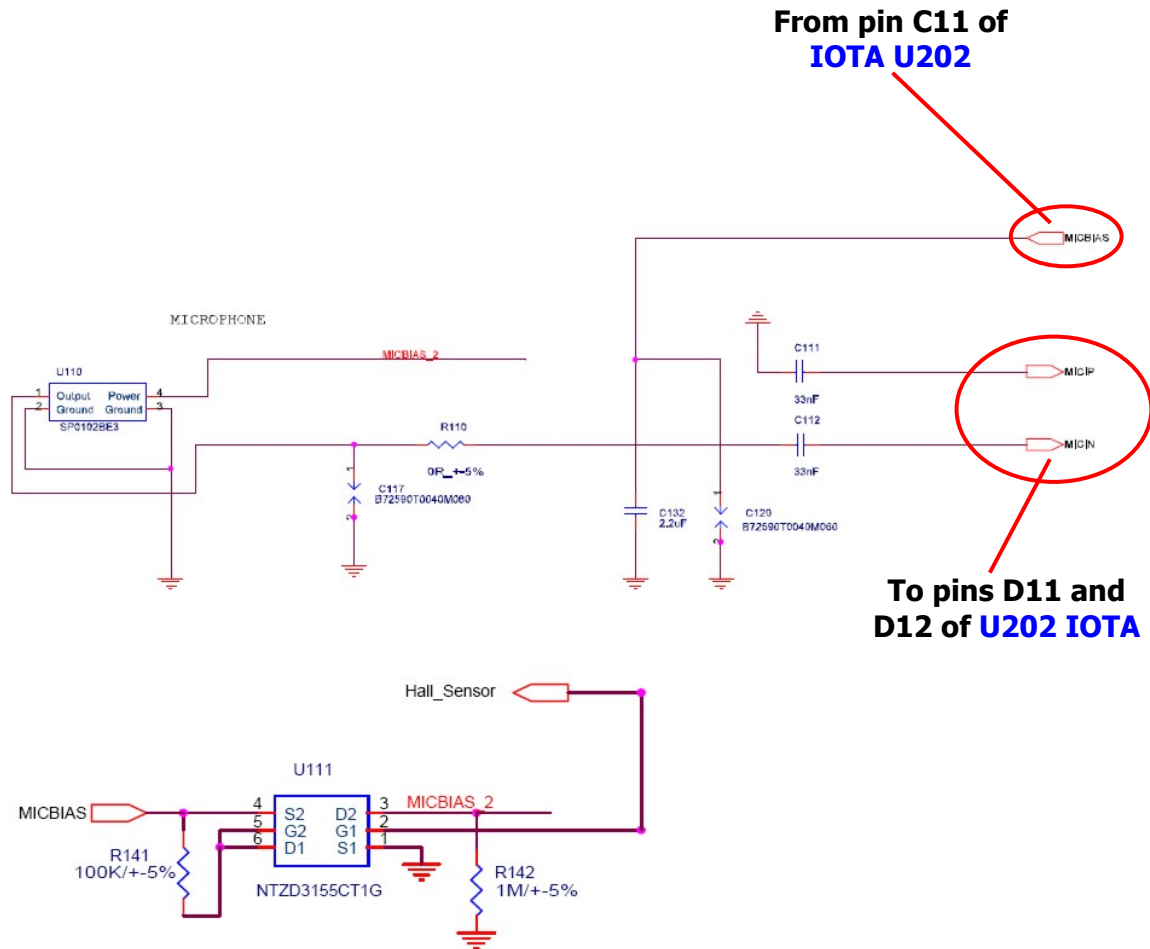
**AUD07/08 (no/distorted mic)**

If the internal microphone **U110** works distorted and low, replace **U110**. We never figured out any other failure at this defect.

If the microphone doesn't work at all, the cause is generally a defect of **U110** as well. We never made any measurements, because there's no need to.

We recommend presoldering a new **U110** before placing on the PCB! Make sure not to use too much solder, because the hole to receive the noise could be closed during the soldering (because **U110** is placed upside down).

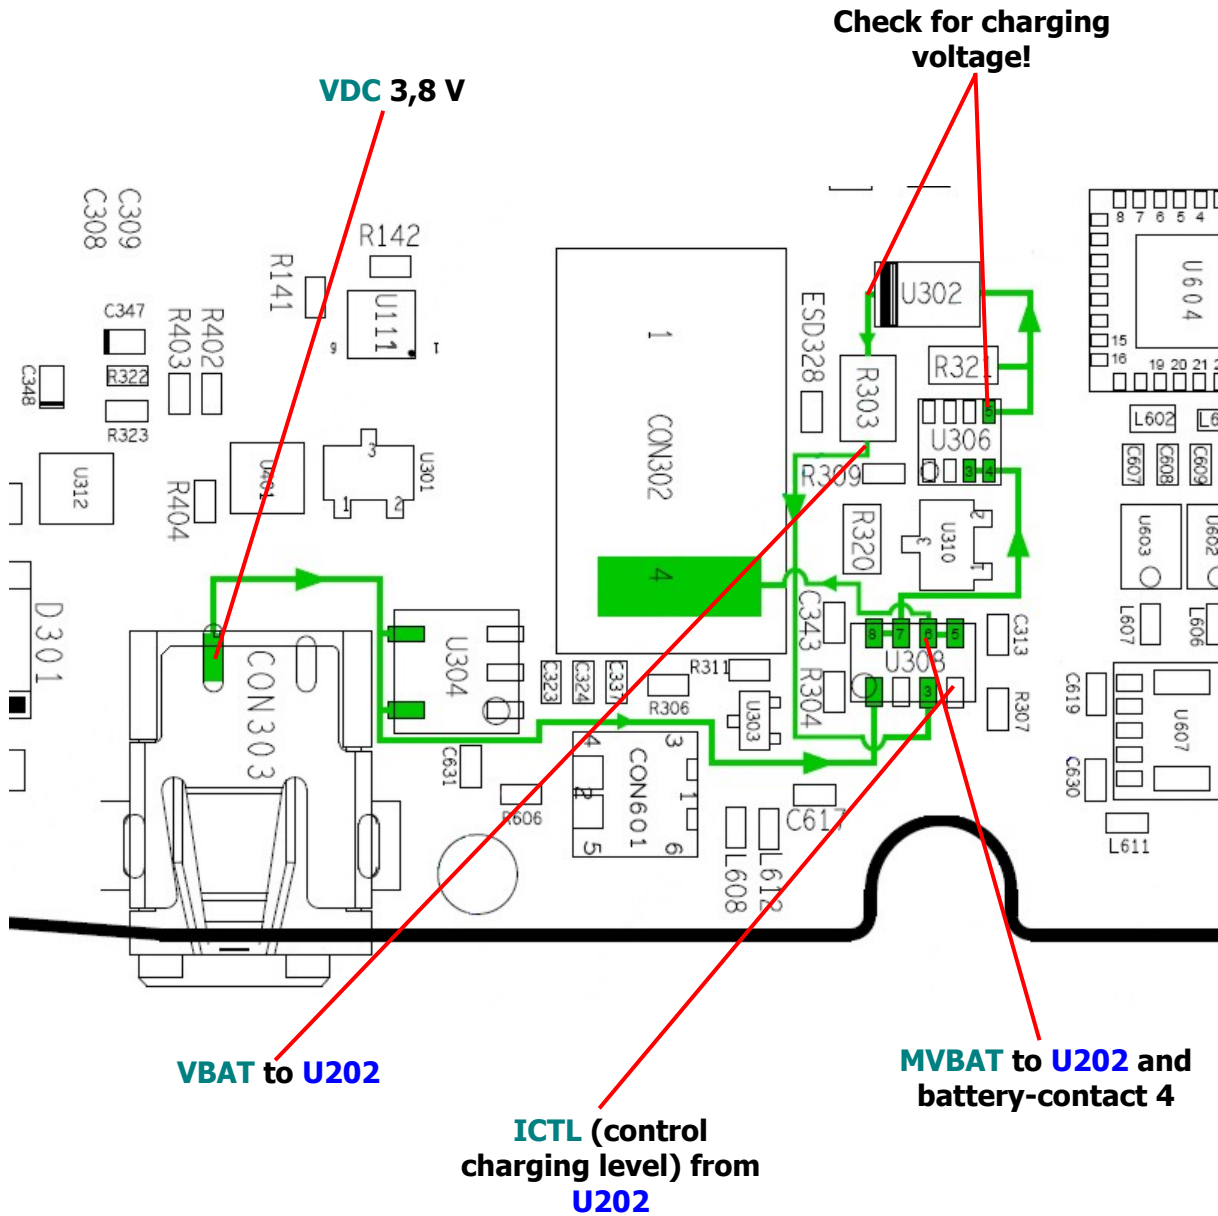
During the NPI-process mostly the over-current limiter **U306** was defective; the voltage was not present at pin 5. Sometimes the diode **U302** (rectifier diode to avoid reverse current) was defective as well.

If **MVBAT** is present on battery-contact 4, check **ICTL** from **U202** at pin 4 of **U308**. If it's not present, replace **U202 IOTA**!

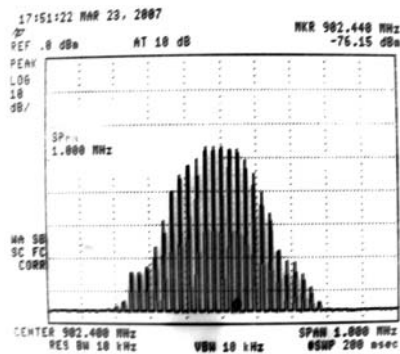
**TX-signal good**

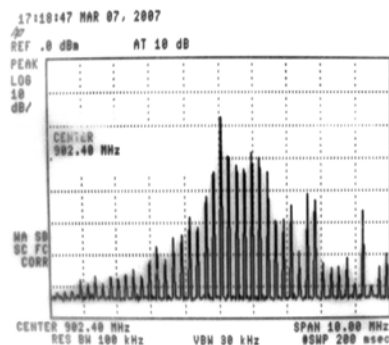
**TX-signal bad**  
**(defective PA U605)**

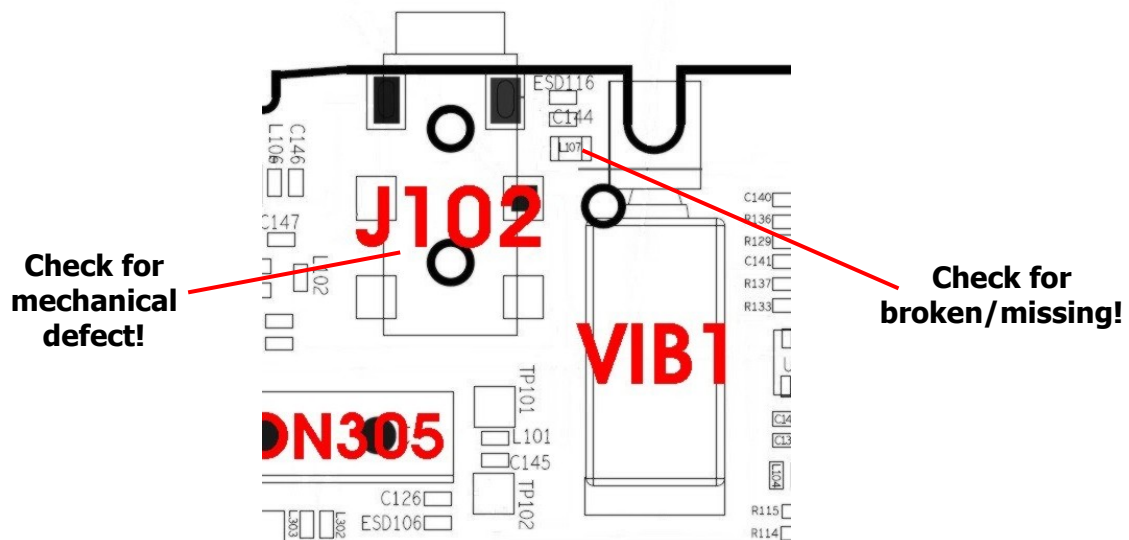
To confirm this failure, you just have to connect the phone with charger and foxlink-cable and try to read out the phone with MST. Normally this wouldn't work! This problem is caused by a defect of the headset-connector **J102** (check!) or parts around it. Mostly the defect is visible.

We received some transceivers that could not be detected by MST, because of a broken **L107**. It's placed parallel to **C144** from pin 5 of **J102** to GND. We suspect that **L107** could be damaged when the housing gets opened.

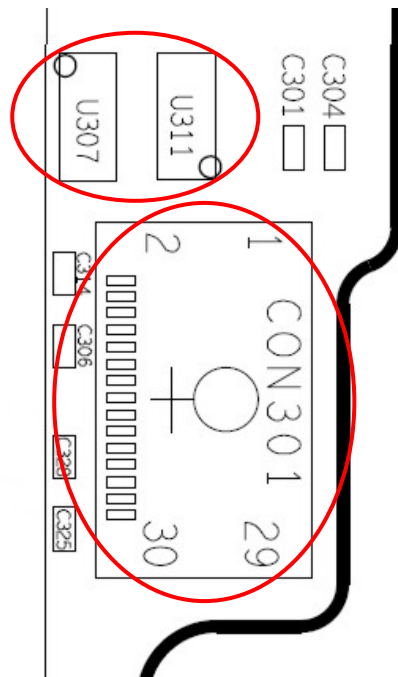
**CON301** Pin 27 to GND

If any connection is open ( $\infty \Omega$ ), the PCB has an internal interruption and has to be replaced (forward PCB to a **Level 4 Hub!**).

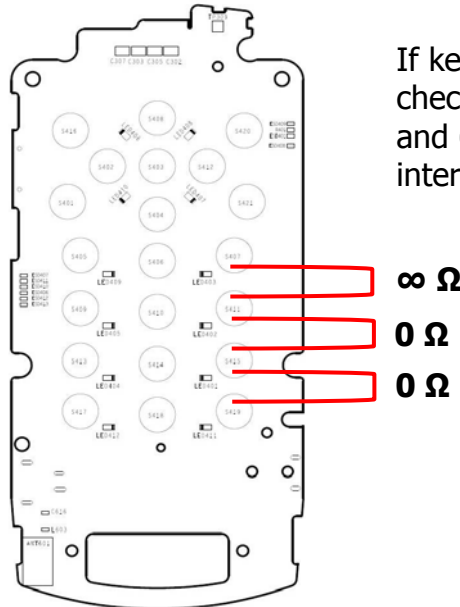
**Example:**

If keys 6, 9 and # aren't working, check the connection between key 3 and 6. There should be an interruption.

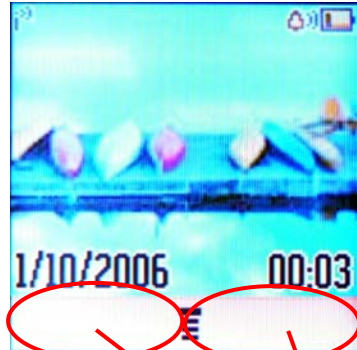
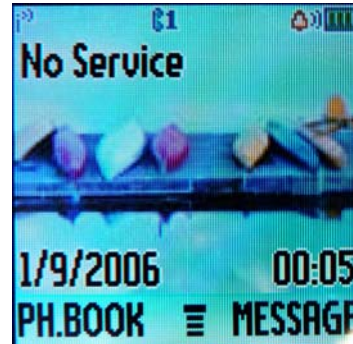
We received a high quantity of transceivers with a corrupt function of the menu. You can recognize this failure just after the phone has started up. When the request to type in the SIM pin, there's no text displayed. The graphics appear on the screen, but if you access the menu, no text is displayed. This is a software bug!

**Menu options are missing!**

**Attention:** Very often the master clear-function of MST doesn't work properly! Sometimes you have to perform the master clear via the menu of the phone. That's problematic, when the menu is corrupt, just remember this sequence: In the main menu choose menu 'settings'. Now press 5 times the down-button and afterwards the menu-button. After that press one time up and the menu-button to choose the menu 'initial settings'. Type in the security-password (default is 1234) and press the left soft-key to affirm. After the restart the failure is fixed!

**After fixing this failure we recommend to perform a SW-update to the newest available software to eliminate such bugs!**

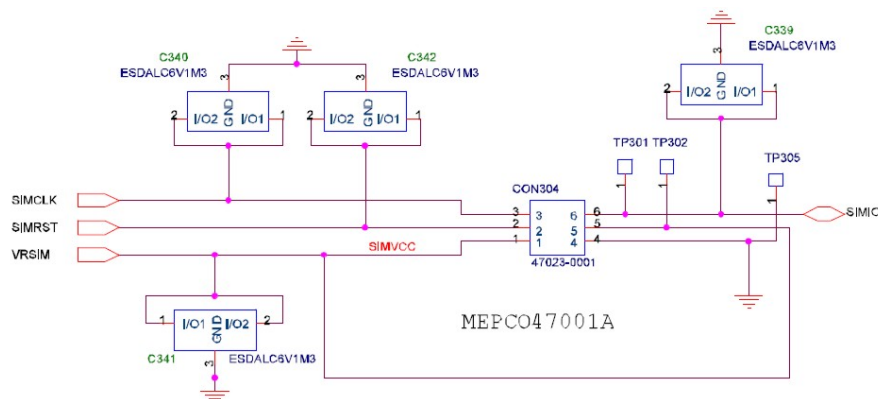
**SIM01**

In case of SIM-card problems very often we received transceivers with a broken SIM-card reader **CON304** (SIM03) or bent pins. Check this at first! The next step is to check the signals at **CON304**.

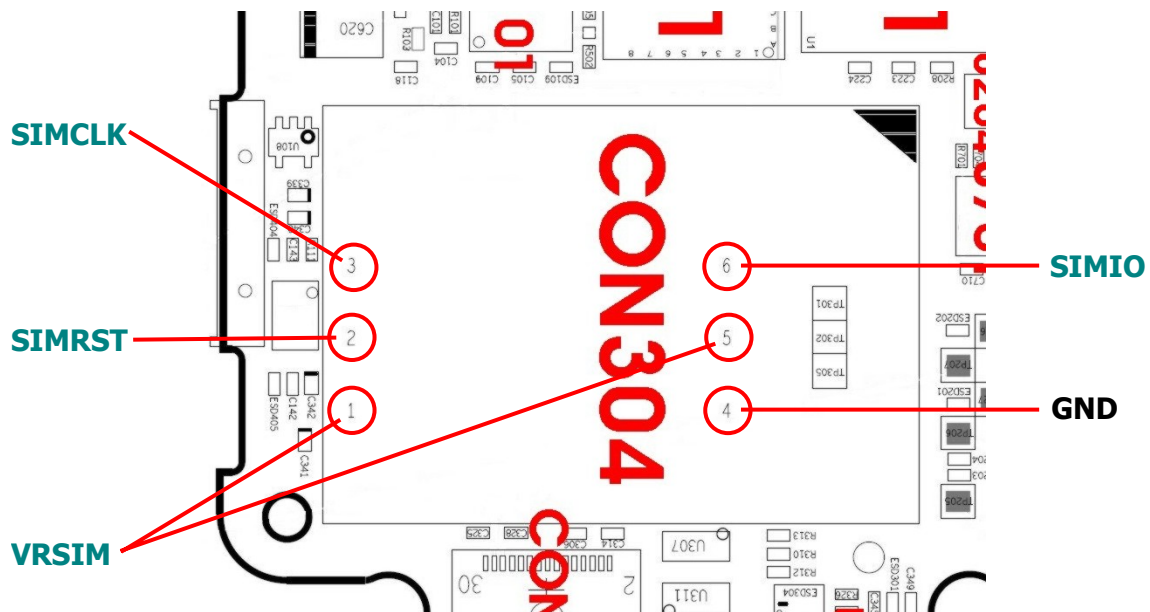
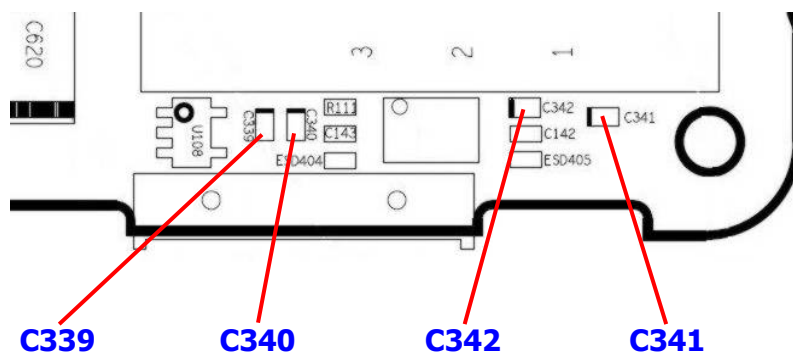
If any signal or voltage is missing, and all external parts like the capacitors are proper, replace **U202 IOTA** due to a defect of the SIM card digital interface.

As well check these parts for defects:

When unsuccessful, **U201 CalypsoLite** is defective (forward PCB to a **Level 4 Hub!**).
