Doc. No: TSG_W220

Title: Troubleshooting-Guide W220

DEBUG GUIDE W220 LEVEL 3

Repair Support Information
Writing by: Juan Ortiz

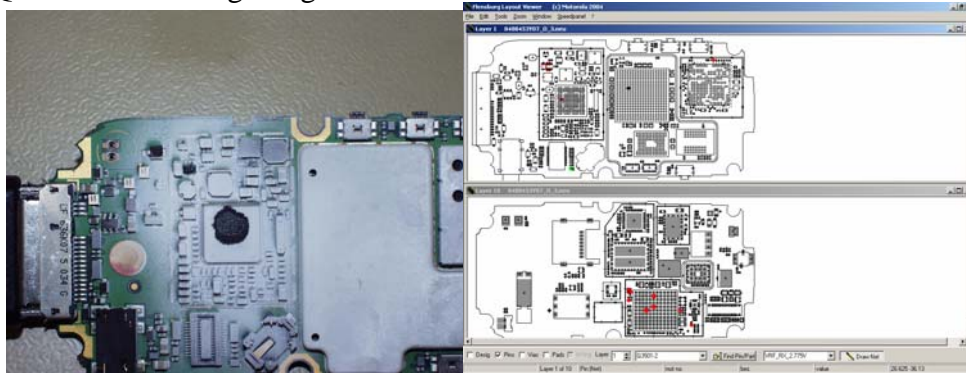
- BAT00 – radio draws about 400 mA in standby, no off current
- Q3501/U3000 are getting warm

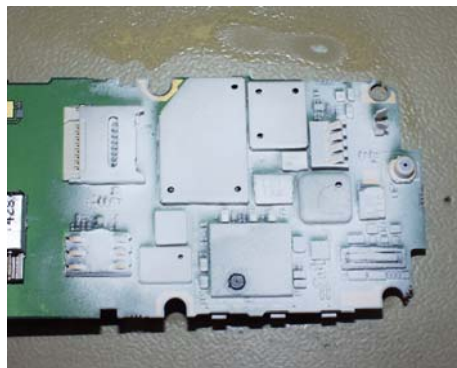
- Q3501 provides VRF_RX_2.775V for Blue Module U900 via Short Resistor R902 (using Flensburg Layout Viewer)
