# Moto X Field Service Trouble Shooting Guide

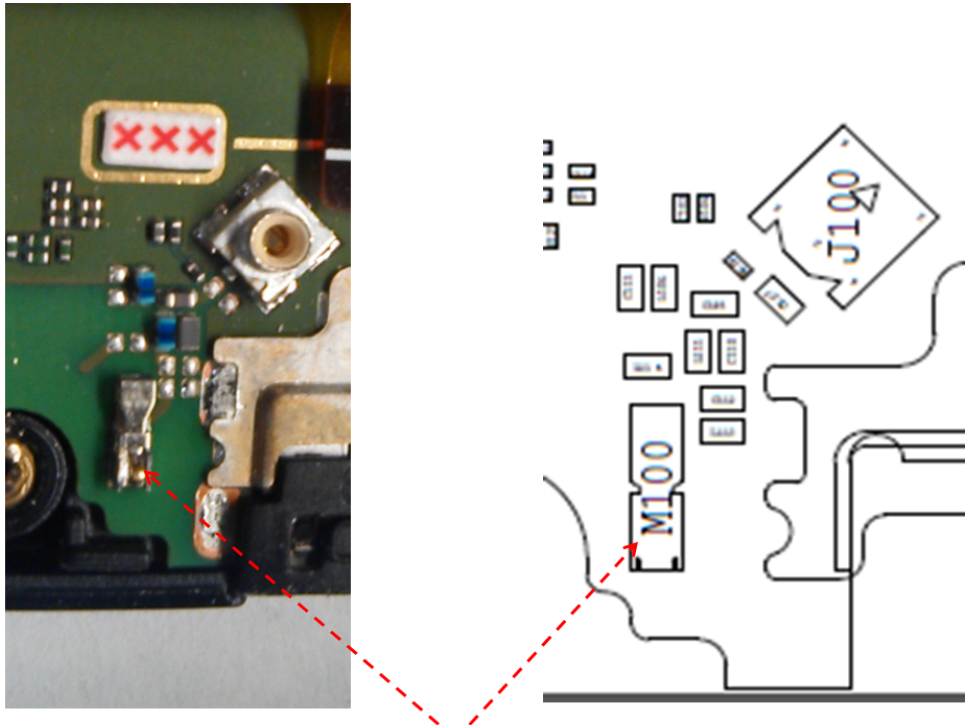
Step 3: if Step 2 does not resolve issue, check if universal contact on the PCB is damaged. Is it touching the antenna pad? If the contact is twisted or not making contact, this is a problem. The contact should look like this picture below:

This is the clip to check

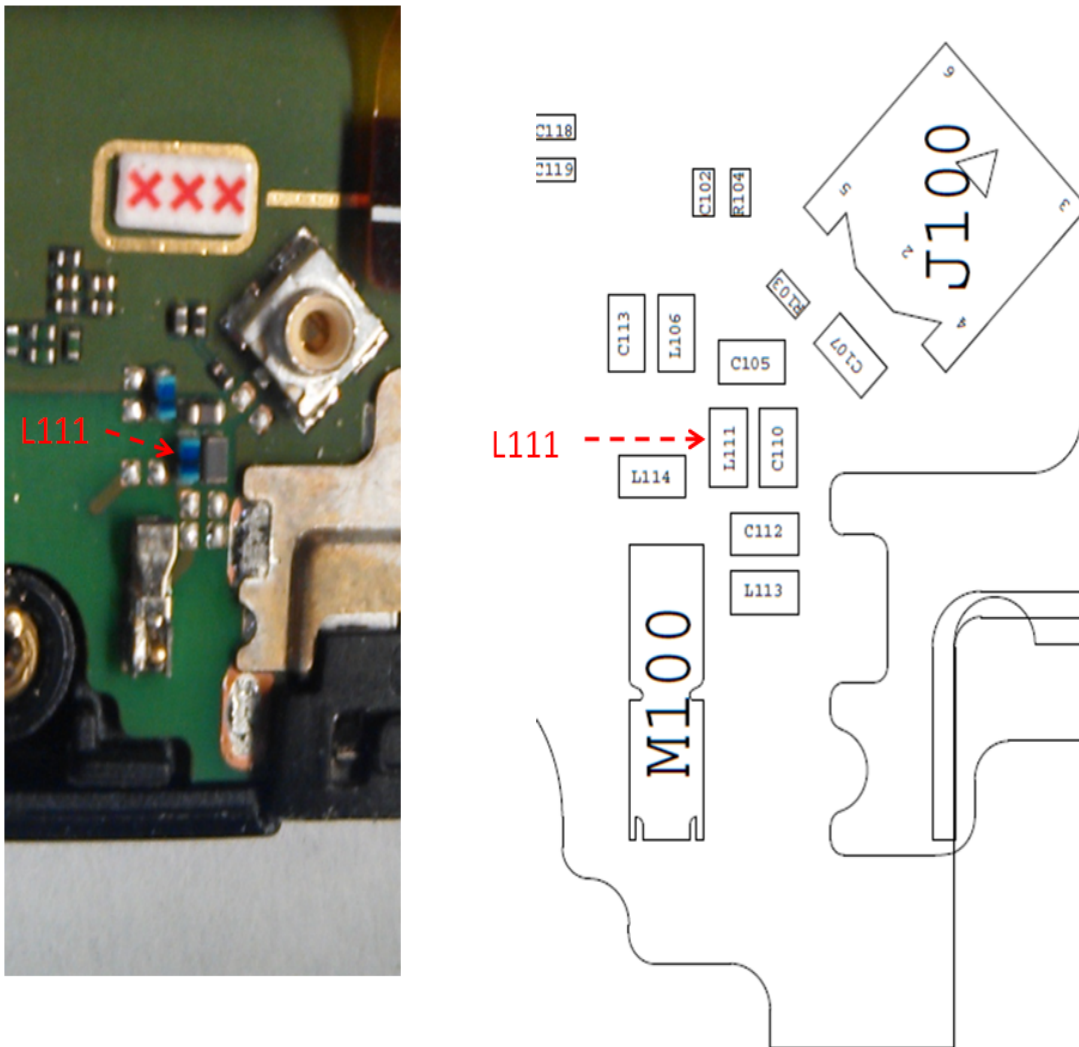
Figure: Component L111

Step 5: If Step 4 does not resolve the problem check if components L111 is placed in the circuit. In addition, you may have to check the component under a microscope to ensure that the body of the part is not cracked.

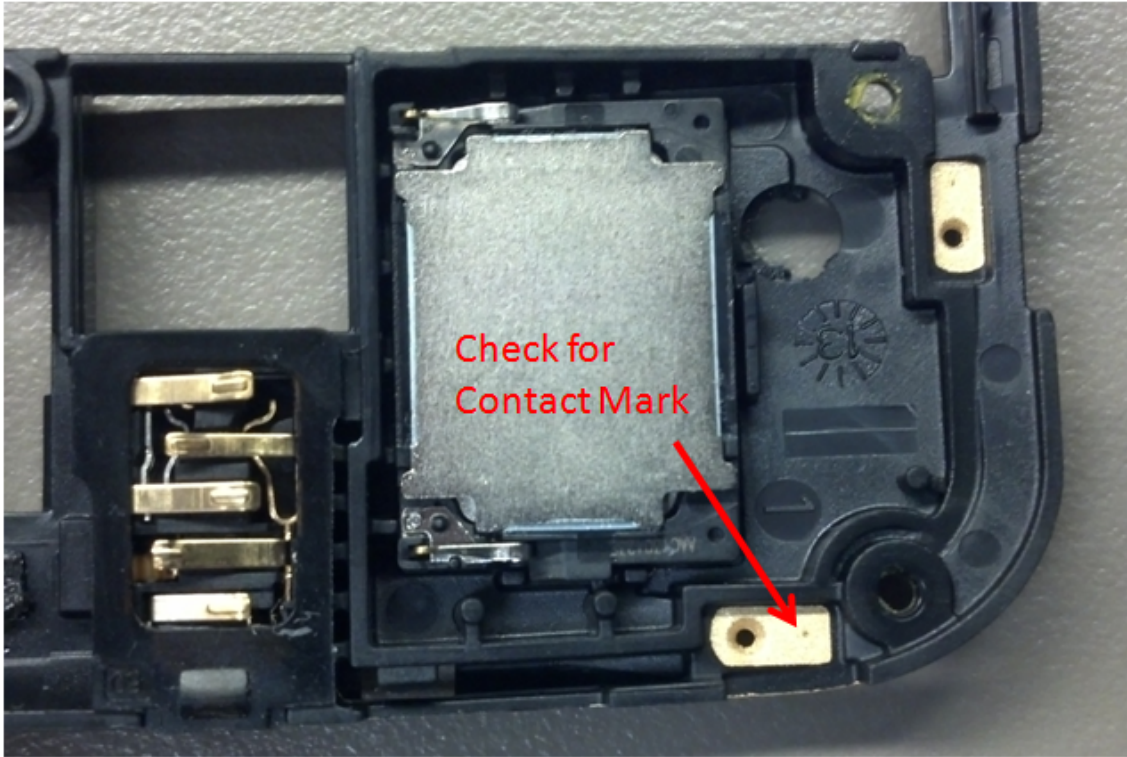
Figure: Contact Pad of Antenna 3

Step 2: If the failure persists, check the Antenna 3 universal contact, M170. If it is missing, misplaced, or damaged, place/replace the part and retest. Also check the contact pad of Antenna 3 on the diversity antenna carrier for a visible mark where the contact was touching the pad. If no mark is present, replace the universal contact M170 and retest.

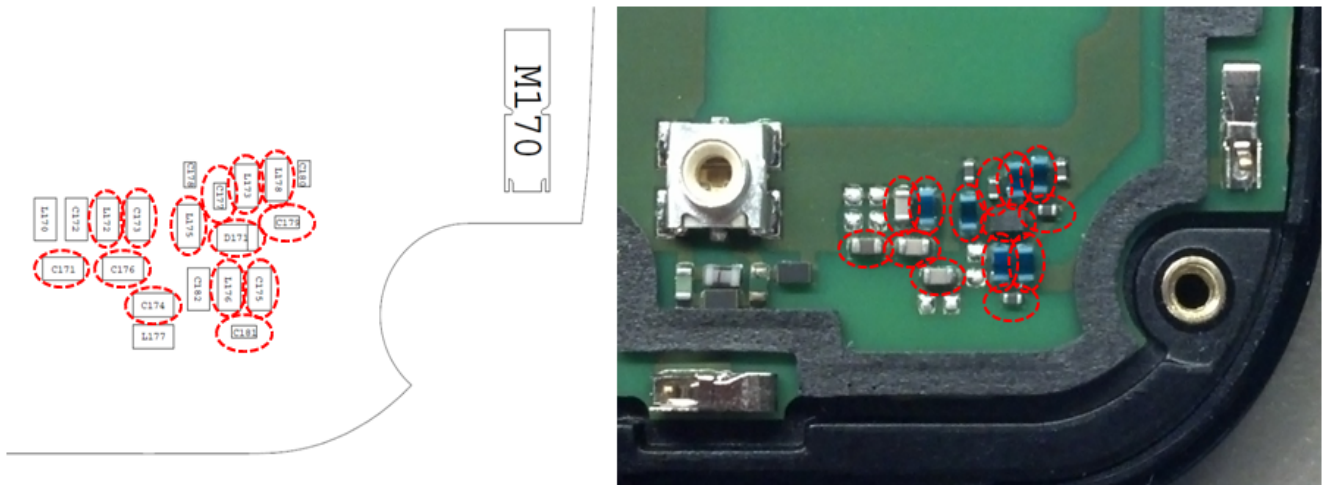
Figure: Antenna 3 Matching Components and PIN Diode Biasing Components

Step 3: If Step 2 does not resolve the issue, check all Antenna 3 matching components and PIN diode biasing components: C171, L172, C176, C173, C174, C181, C175, L176, L173, C177, D171, L175, L178, and C179. If any component is missing, misplaced, or damaged, place/replace the part and retest.

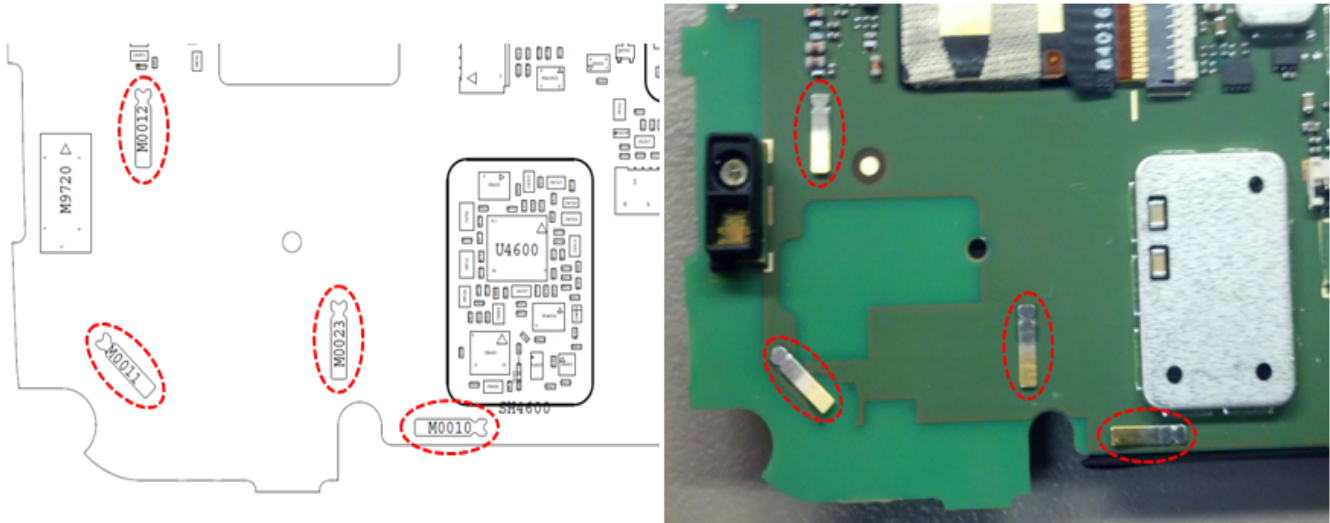
Figure: PCB Grounding Clips Near Antenna 3 Matching

Step 4: If Step 3 does not resolve the issue, check the PCB grounding clips on the display side of the PCB: M0010, M0011, M0012, and M0023. If any clip is missing, misplaced, or damaged, place/replace the part and retest.

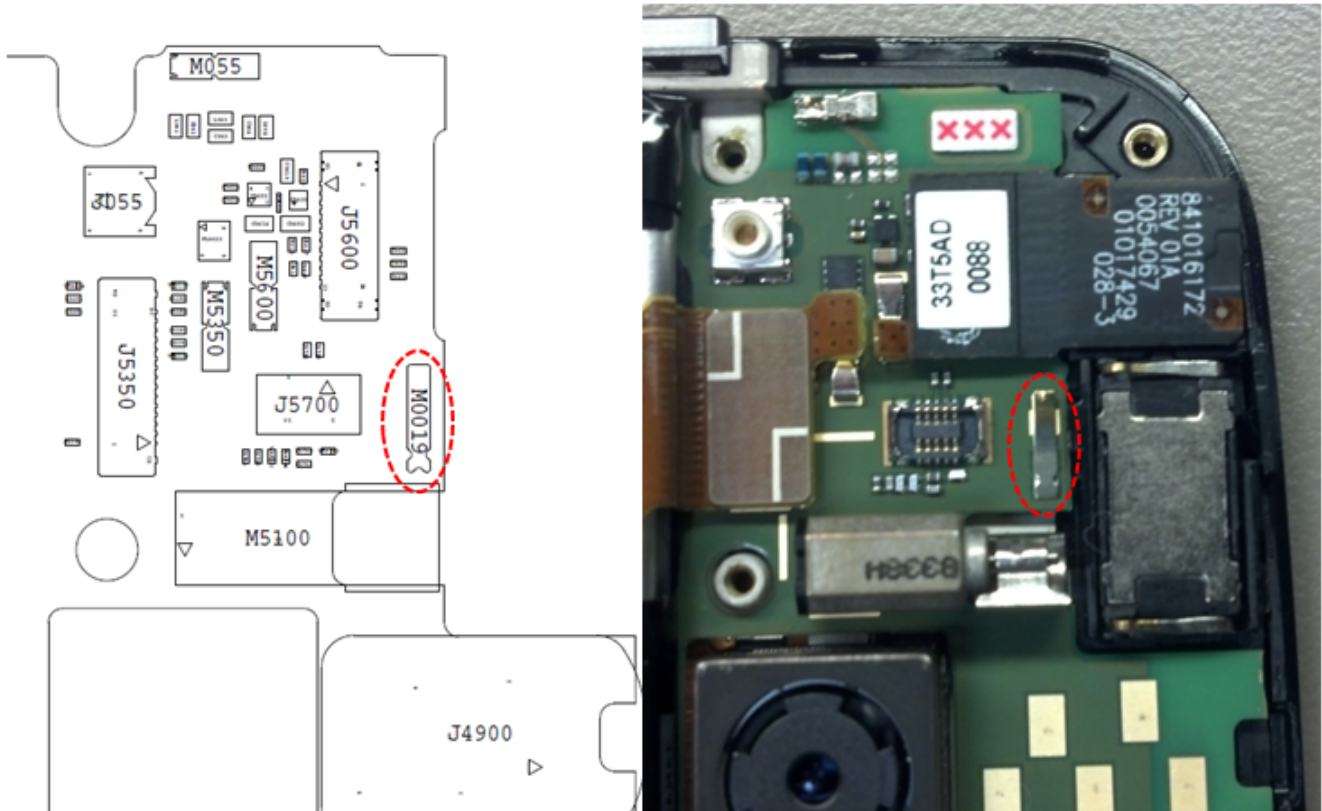
Figure: Grounding Clip Between PCB and Audio Flex Bracket

Step 5: If Step 4 does not resolve the issue, check the grounding clip between the PCB and the audio flex bracket, M0019. If the clip is missing, misplaced, or damaged, place/replace the part and retest.

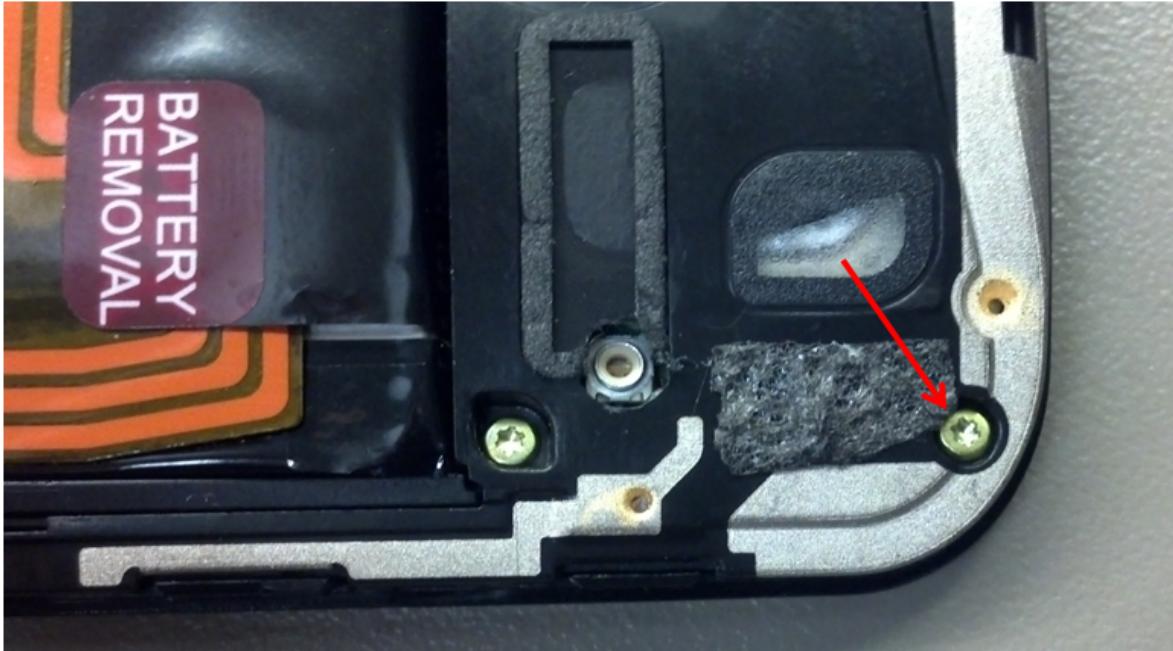
Figure: Screw Holding Diversity Carrier near Antenna 3 Feed

Step 6: If Step 5 does not resolve the issue, check the screw holding the antenna carrier to the front housing near the Antenna 3 feed. If the screw is missing or not fully inserted, place/replace the screw and retest.

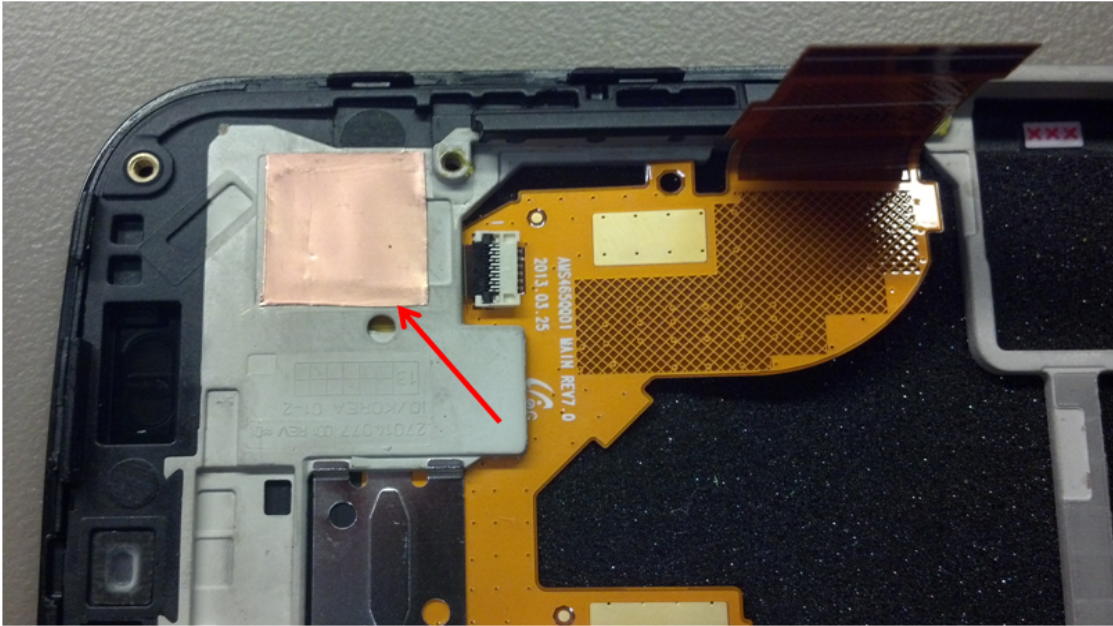
Figure: Copper Tape over Touch IC on Chassis

Step 7: If Step 6 does not resolve the issue, check the square piece of copper taped placed over the touch IC on the chassis. If the copper tape is missing, misplaced, or not fully adhered, place/replace the copper tape and retest.

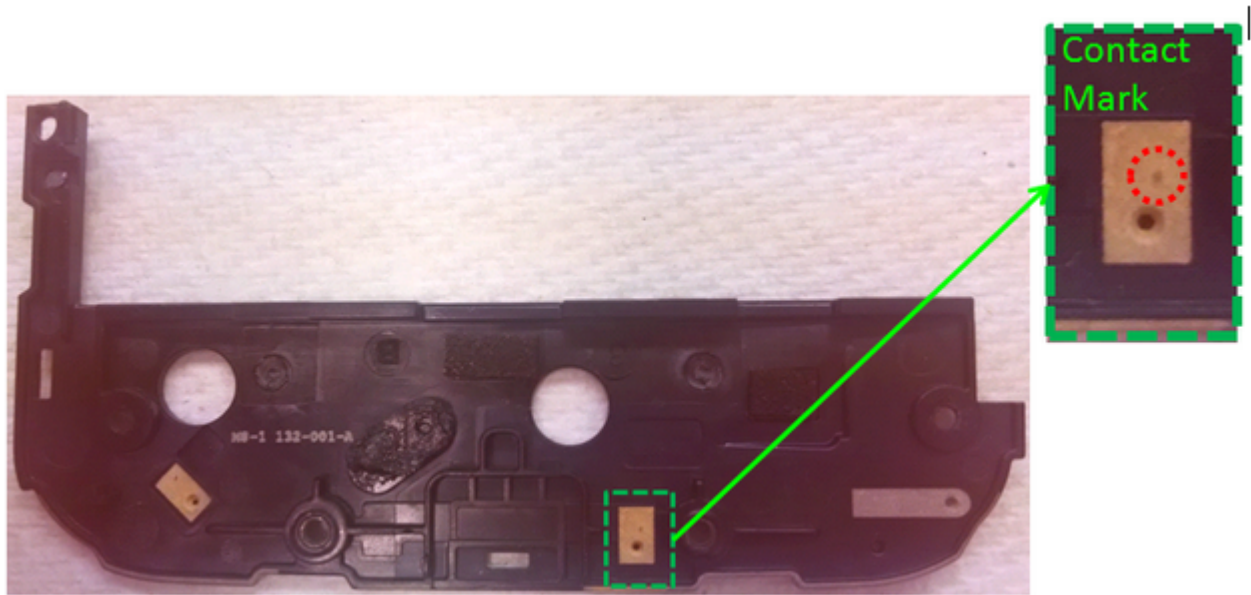
Step 3: if Step 2 does not resolve issue, check if universal contact (RefDes = M100) on the PCB is damaged. Is it touching the antenna pad? If the universal clip is twisted or not making contact, this needs to be replaced :

Figure: Contact marks visible on feeding pad from universal clip for WCDMA Antenna

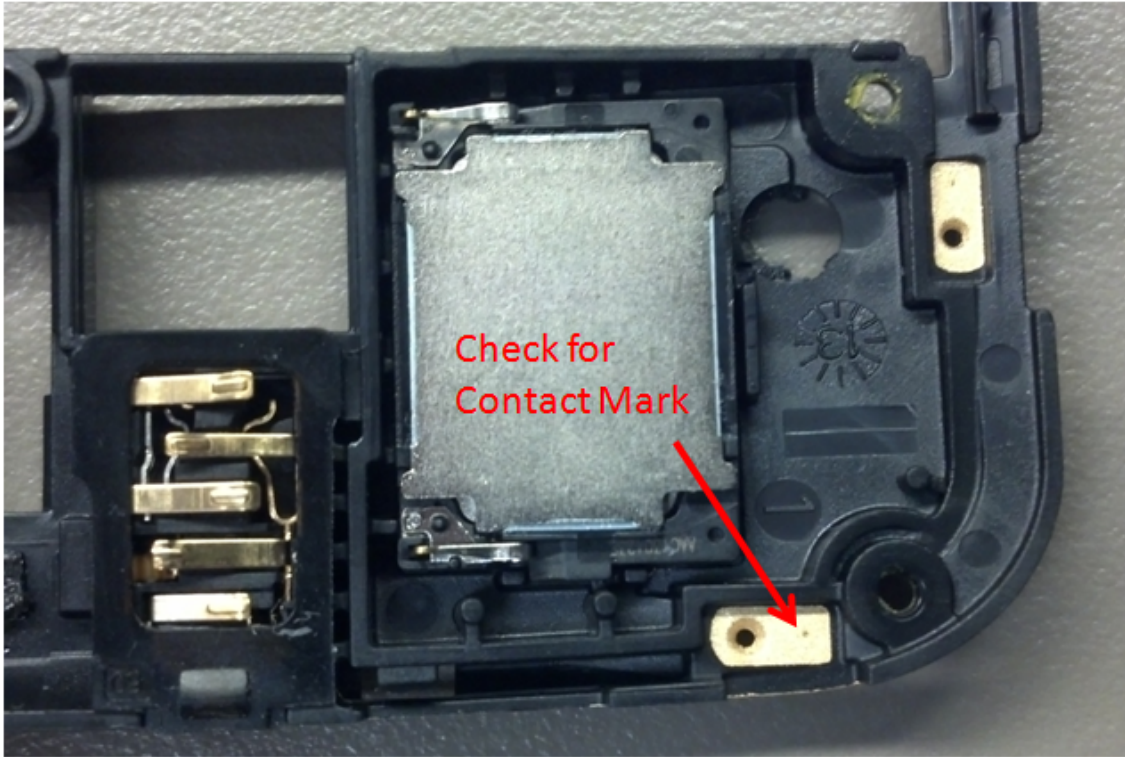
Figure: Contact Pad of Antenna 3

Step 2: If the failure persists, check the Antenna 3 universal contact, M170. If it is missing, misplaced, or damaged, place/replace the part and retest. Also check the contact pad of Antenna 3 on the diversity antenna carrier for a visible mark where the contact was touching the pad. If no mark is present, replace the universal contact M170 and retest.

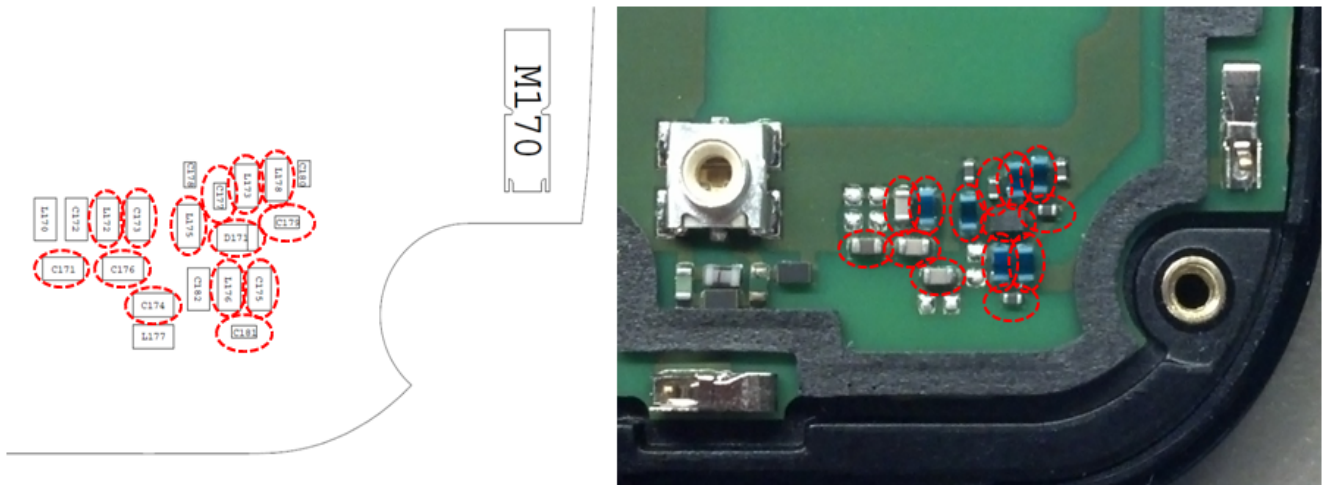
Figure: Antenna 3 Matching Components and PIN Diode Biasing Components

Step 3: If Step 2 does not resolve the issue, check all Antenna 3 matching components and PIN diode biasing components: C171, L172, C176, C173, C174, C181, C175, L176, L173, C177, D171, L175, L178, and C179. If any component is missing, misplaced, or damaged, place/replace the part and retest.

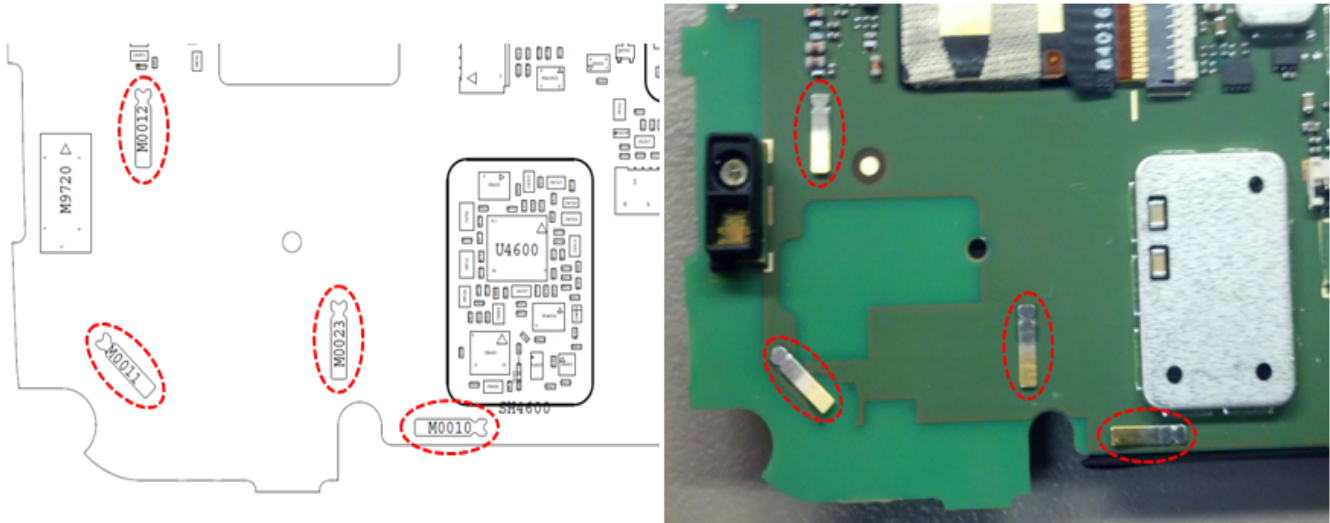
Figure: PCB Grounding Clips Near Antenna 3 Matching

Step 4: If Step 3 does not resolve the issue, check the PCB grounding clips on the display side of the PCB: M0010, M0011, M0012, and M0023. If any clip is missing, misplaced, or damaged, place/replace the part and retest.

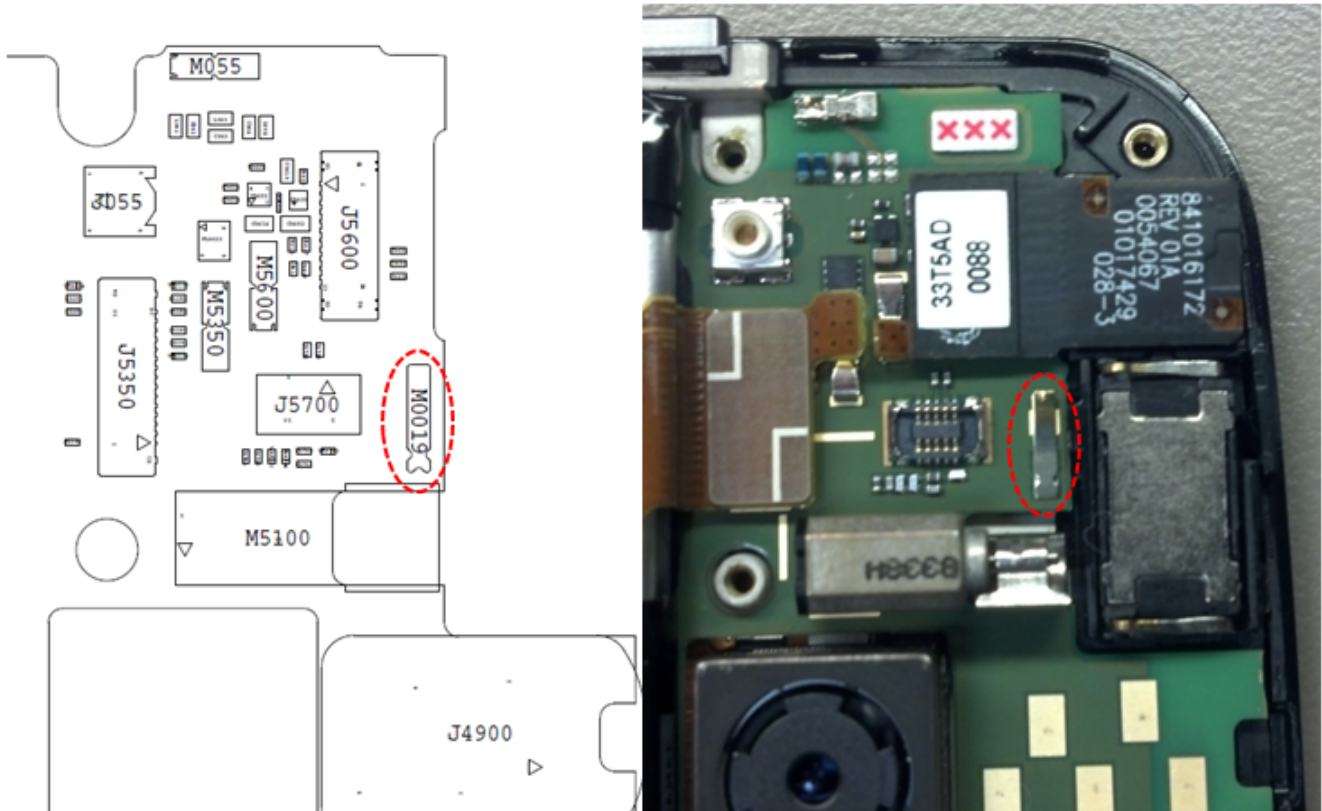
Figure: Grounding Clip Between PCB and Audio Flex Bracket

Step 5: If Step 4 does not resolve the issue, check the grounding clip between the PCB and the audio flex bracket, M0019. If the clip is missing, misplaced, or damaged, place/replace the part and retest.

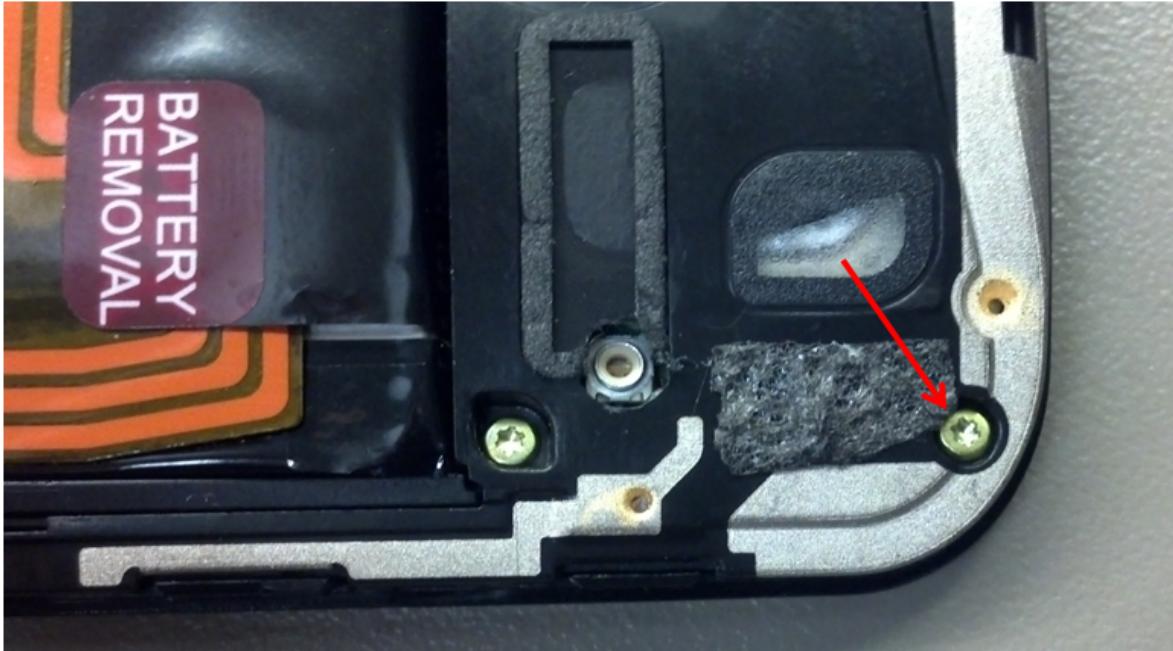
Figure: Screw Holding Diversity Carrier near Antenna 3 Feed

Step 6: If Step 5 does not resolve the issue, check the screw holding the antenna carrier to the front housing near the Antenna 3 feed. If the screw is missing or not fully inserted, place/replace the screw and retest.

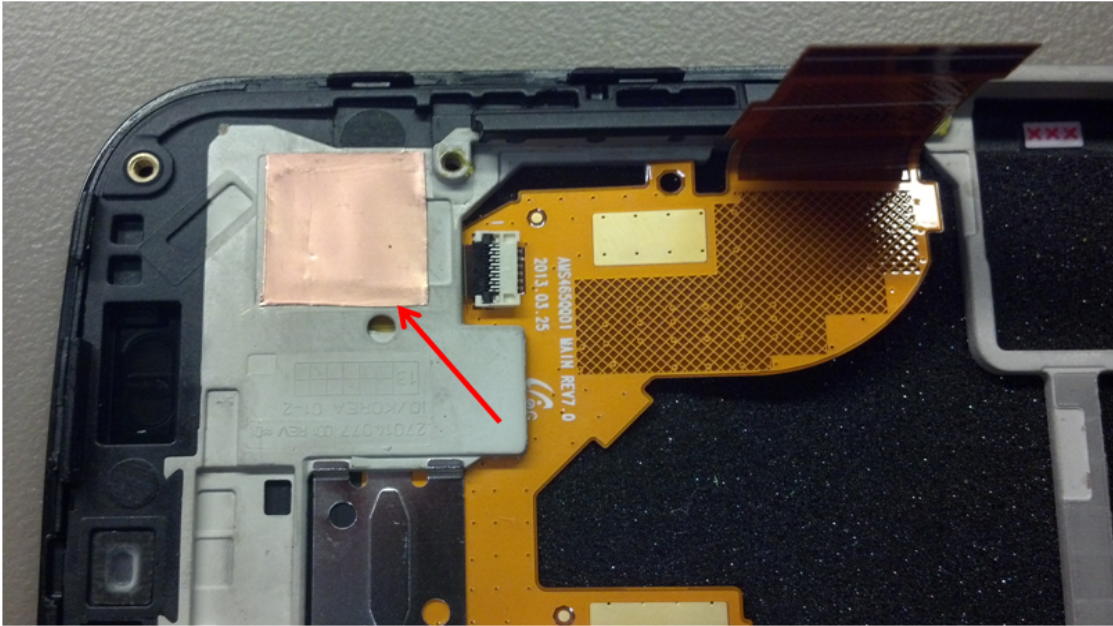
Figure: Copper Tape over Touch IC on Chassis

Step 7: If Step 6 does not resolve the issue, check the square piece of copper taped placed over the touch IC on the chassis. If the copper tape is missing, misplaced, or not fully adhered, place/replace the copper tape and retest.

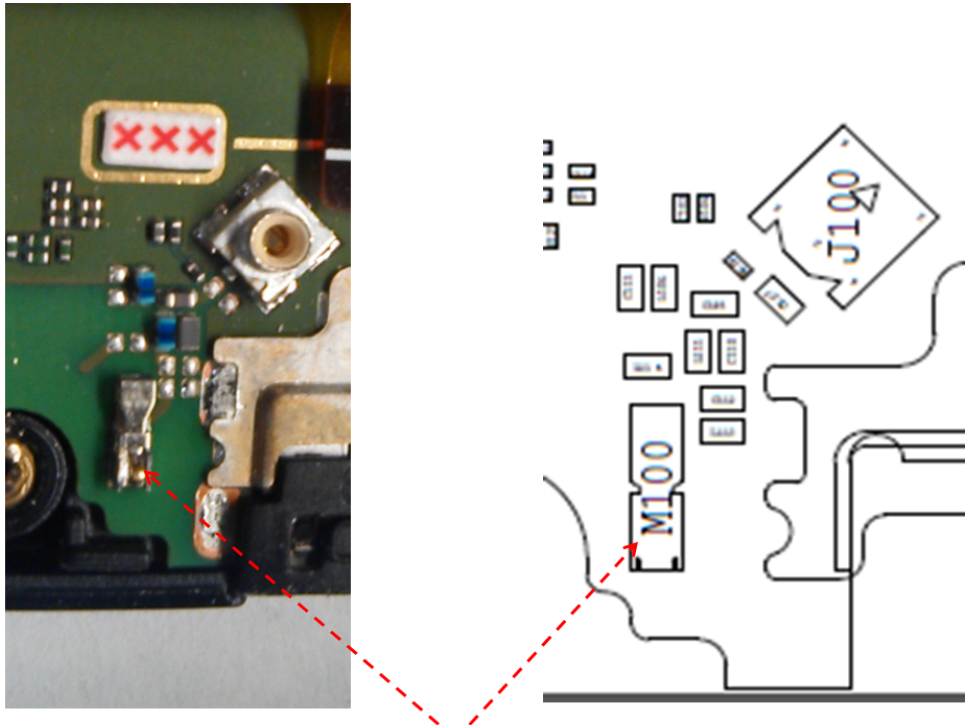
Step 3: if Step 2 does not resolve issue, check if universal contact on the PCB is damaged. Is it touching the antenna pad? If the contact is twisted or not making contact, this is a problem. The contact should look like this picture below:

This is the clip to check

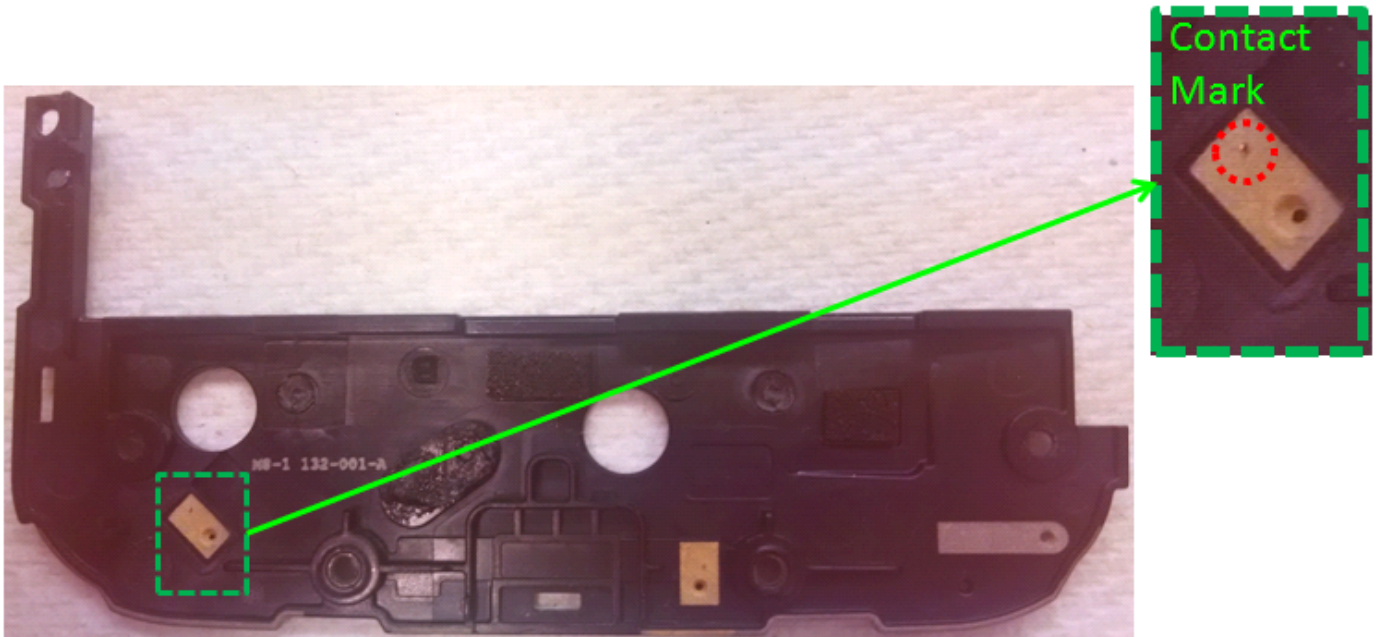
Step 3: if Step 2 does not resolve issue, check if universal contact (RefDes = M130) on the PCB is damaged. Is it touching the antenna pad? If the universal clip is twisted or not making contact, this needs to be replaced :

Figure: Contact marks visible on feeding pad from universal clip for LTE B17 Antenna

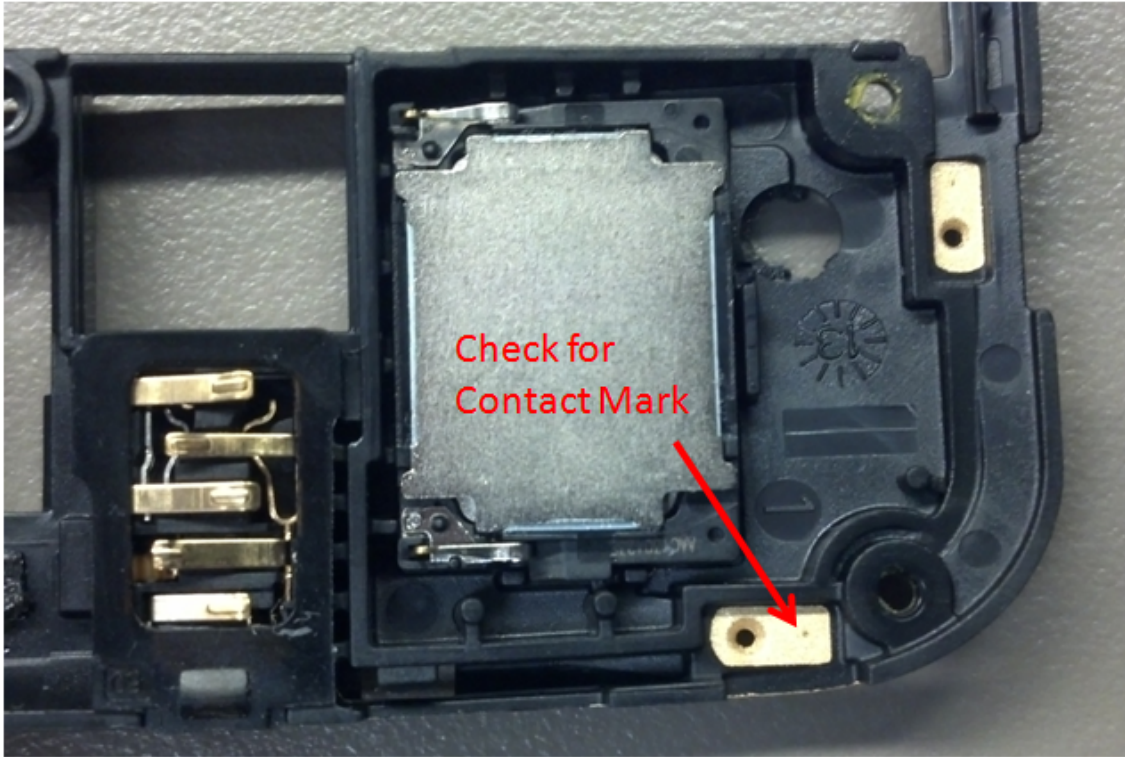
Figure: Contact Pad of Antenna 3

Step 2: If the failure persists, check the Antenna 3 universal contact, M170. If it is missing, misplaced, or damaged, place/replace the part and retest. Also check the contact pad of Antenna 3 on the diversity antenna carrier for a visible mark where the contact was touching the pad. If no mark is present, replace the universal contact M170 and retest.

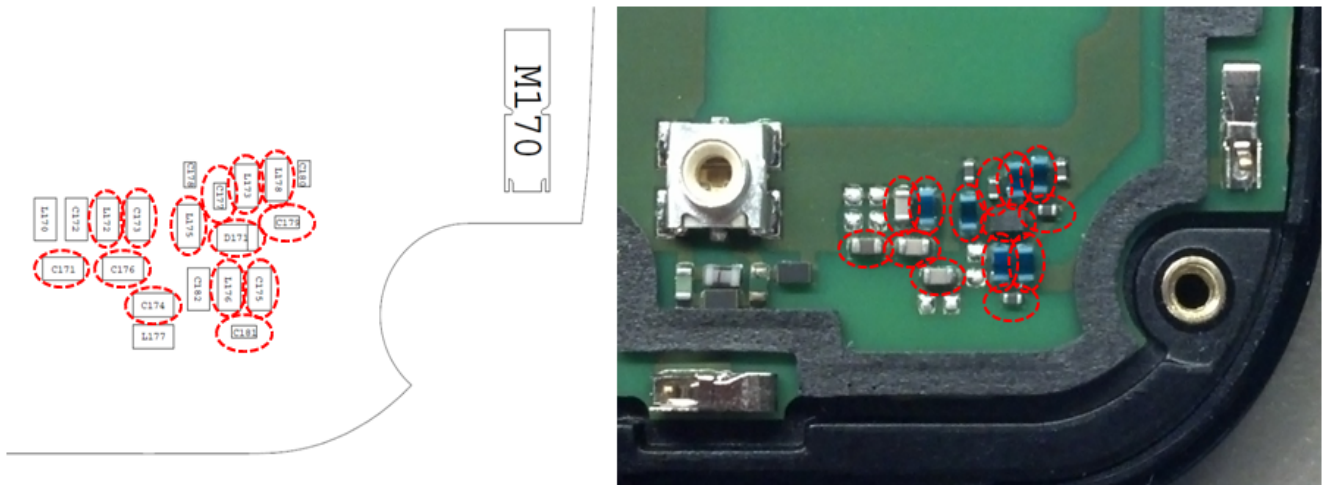
Figure: Antenna 3 Matching Components and PIN Diode Biasing Components

Step 3: If Step 2 does not resolve the issue, check all Antenna 3 matching components and PIN diode biasing components: C171, L172, C176, C173, C174, C181, C175, L176, L173, C177, D171, L175, L178, and C179. If any component is missing, misplaced, or damaged, place/replace the part and retest.

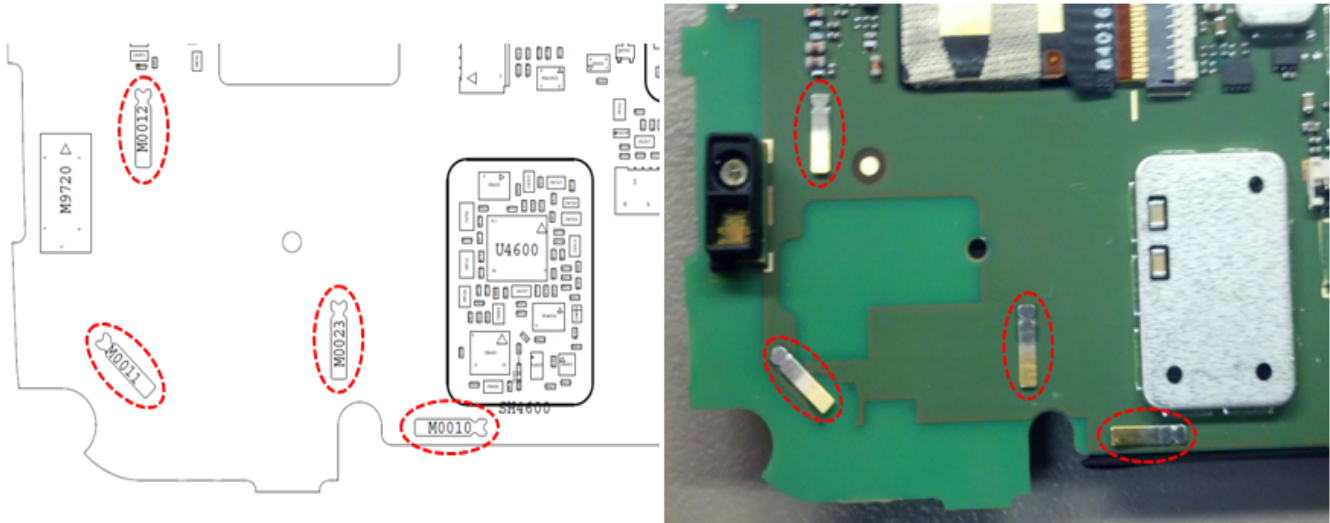
Figure: PCB Grounding Clips Near Antenna 3 Matching

Step 4: If Step 3 does not resolve the issue, check the PCB grounding clips on the display side of the PCB: M0010, M0011, M0012, and M0023. If any clip is missing, misplaced, or damaged, place/replace the part and retest.

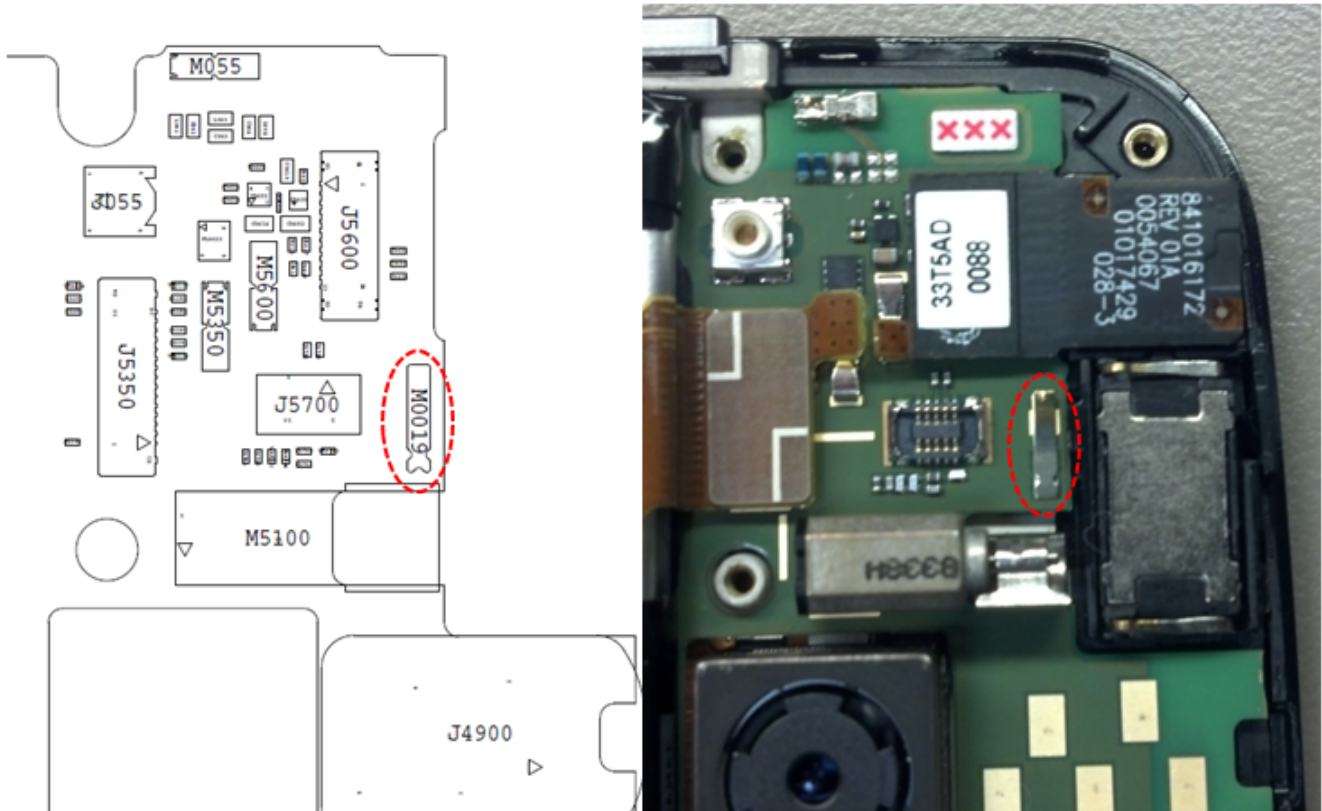
Figure: Grounding Clip Between PCB and Audio Flex Bracket

Step 5: If Step 4 does not resolve the issue, check the grounding clip between the PCB and the audio flex bracket, M0019. If the clip is missing, misplaced, or damaged, place/replace the part and retest.

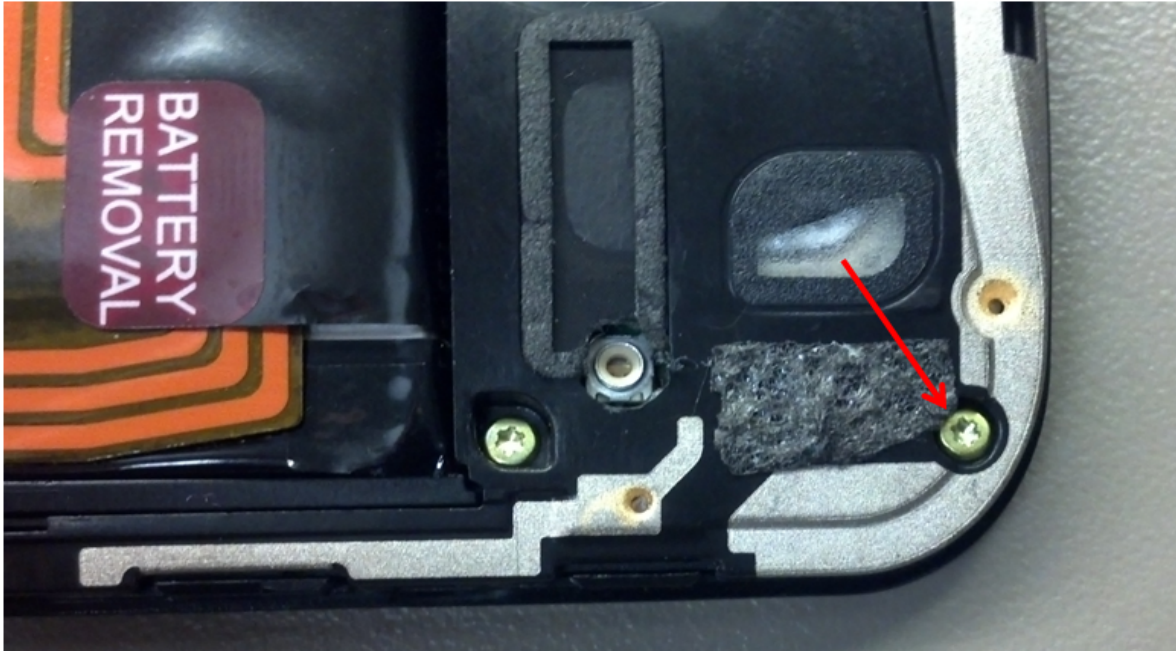
Figure: Screw Holding Diversity Carrier near Antenna 3 Feed

Step 6: If Step 5 does not resolve the issue, check the screw holding the antenna carrier to the front housing near the Antenna 3 feed. If the screw is missing or not fully inserted, place/replace the screw and retest.

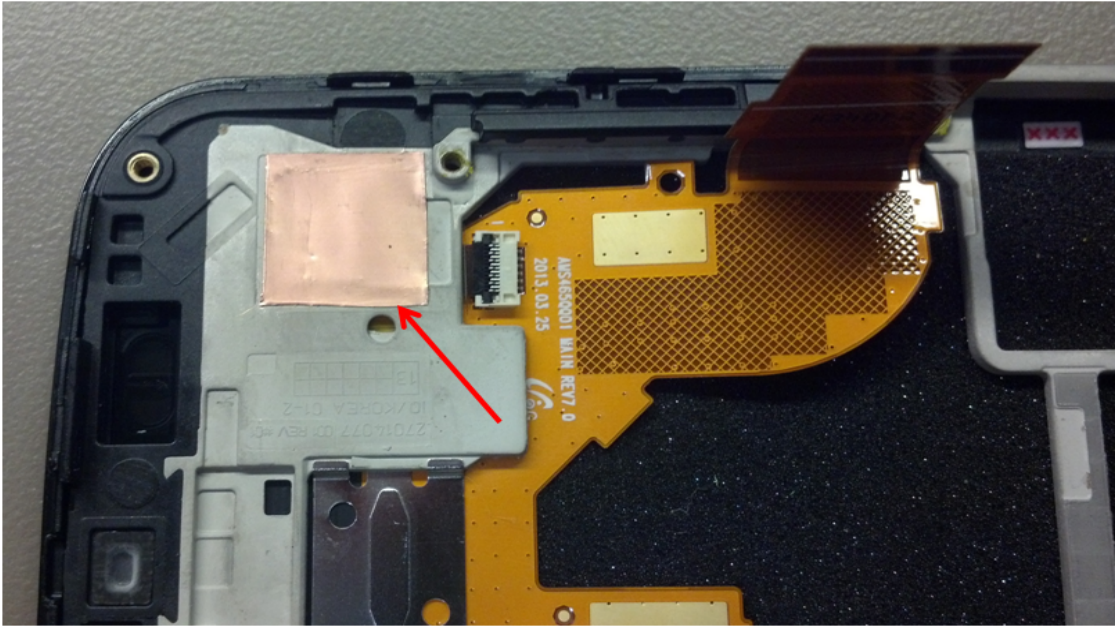
Figure: Copper Tape over Touch IC on Chassis

Step 7: If Step 6 does not resolve the issue, check the square piece of copper taped placed over the touch IC on the chassis. If the copper tape is missing, misplaced, or not fully adhered, place/replace the copper tape and retest.

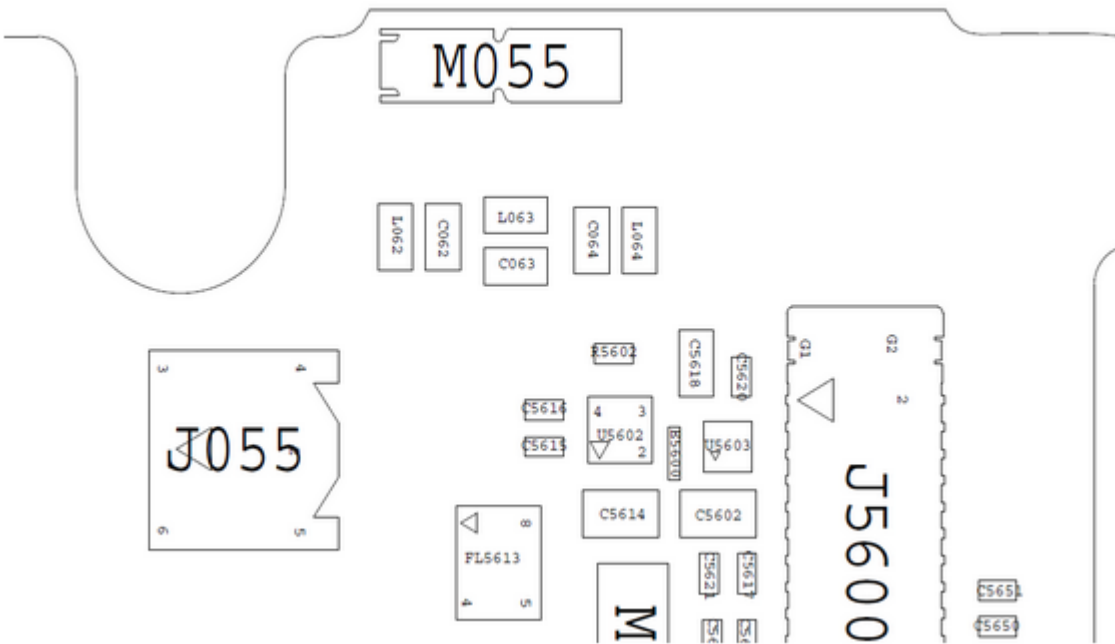
Figure: Ant 5 Overlays

Step 2: If failure persists, check if the antenna feed contact (M055, see figure above) is in good condition.

Step 4: If failure persists, check if matching components are soldered properly (L064, L063, C062, see figure overlays above).

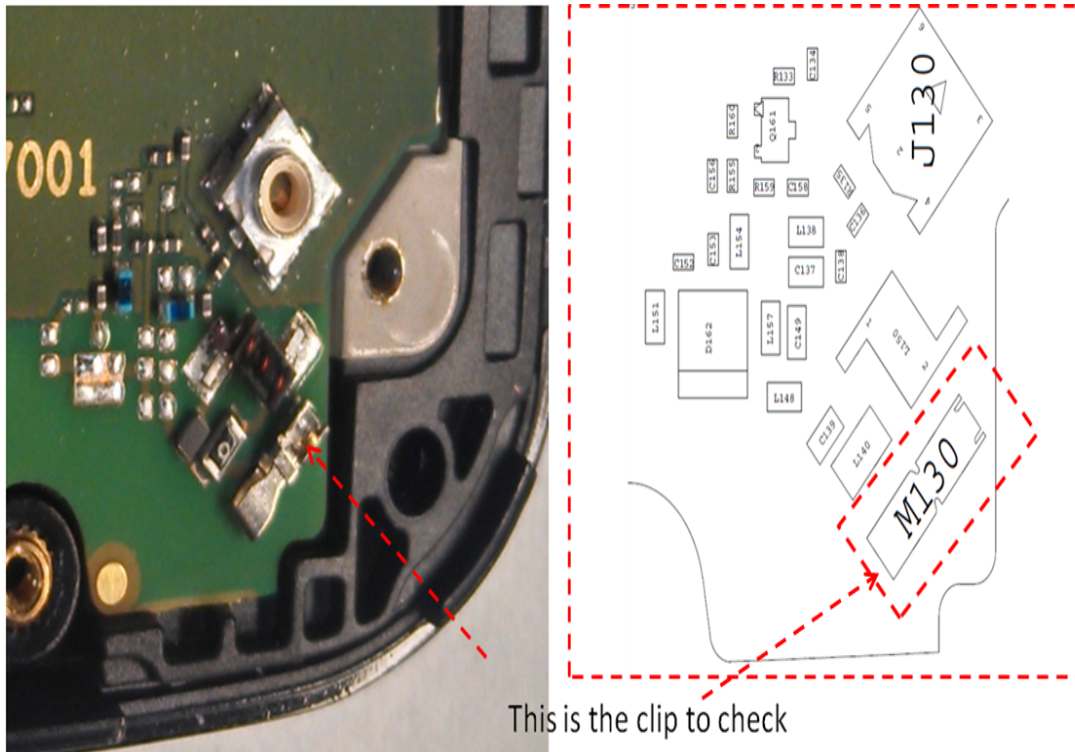
Figure: Antenna clip

Step 3: if Step 2 does not resolve issue, check if universal contact on the PCB is damaged. Is it touching the antenna pad? If the contact is twisted or not making contact, this is a problem. The contact should look like this picture below:
