B2X Service Repair Information:	Reboot issue displaying "optimizing apps"
Info ID:	SRI-EMEA-2015-13
Countries:	EMEA
Carrier:	-
Repair Level:	L2
Affected Models:	xPlay / Nexus6 / XT1100

Problem

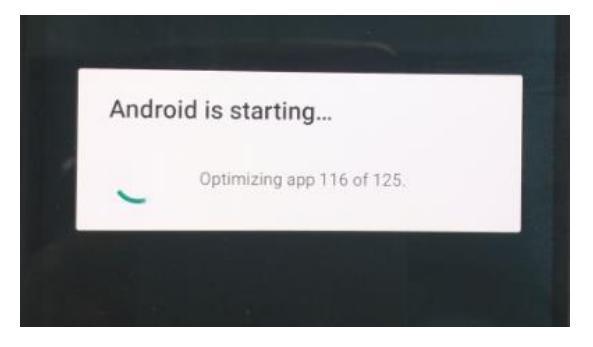
This process document will give instruction of Nexus6 flashing process when customer devices returned for repair with a reboot issue by optimizing apps displayed in the phone.

MASC have to perform an additional Motoservice step under "enhanced flash" option by using the recipe board swap to fix power up issue !

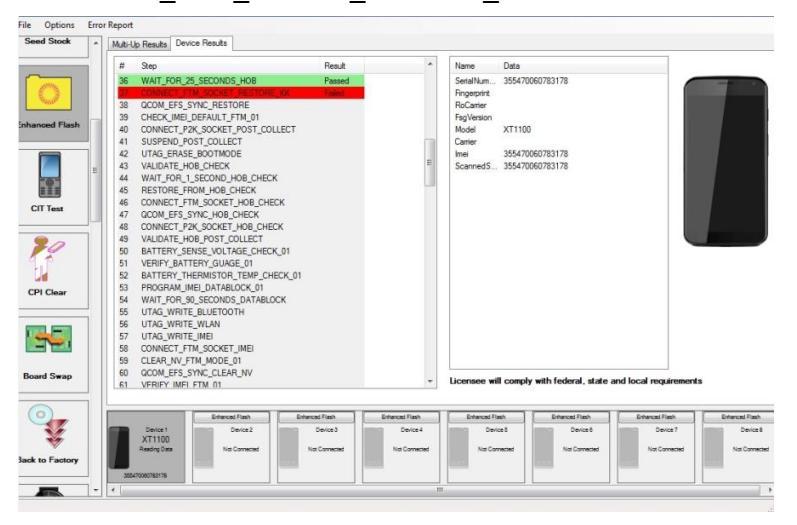
6. The phone will power up to the welcome screen and fail at Motoservice process step 37 with issue "CONNECT_FTM_SOCKET_RESTORE_KK".

7. Connect the phone in fastboot mode and run the kill switch option in MotoService
