# **XT1225/XT1254 BASEBAND TROUBLESHOOTING GUIDE**

**Sept 18, 2014**

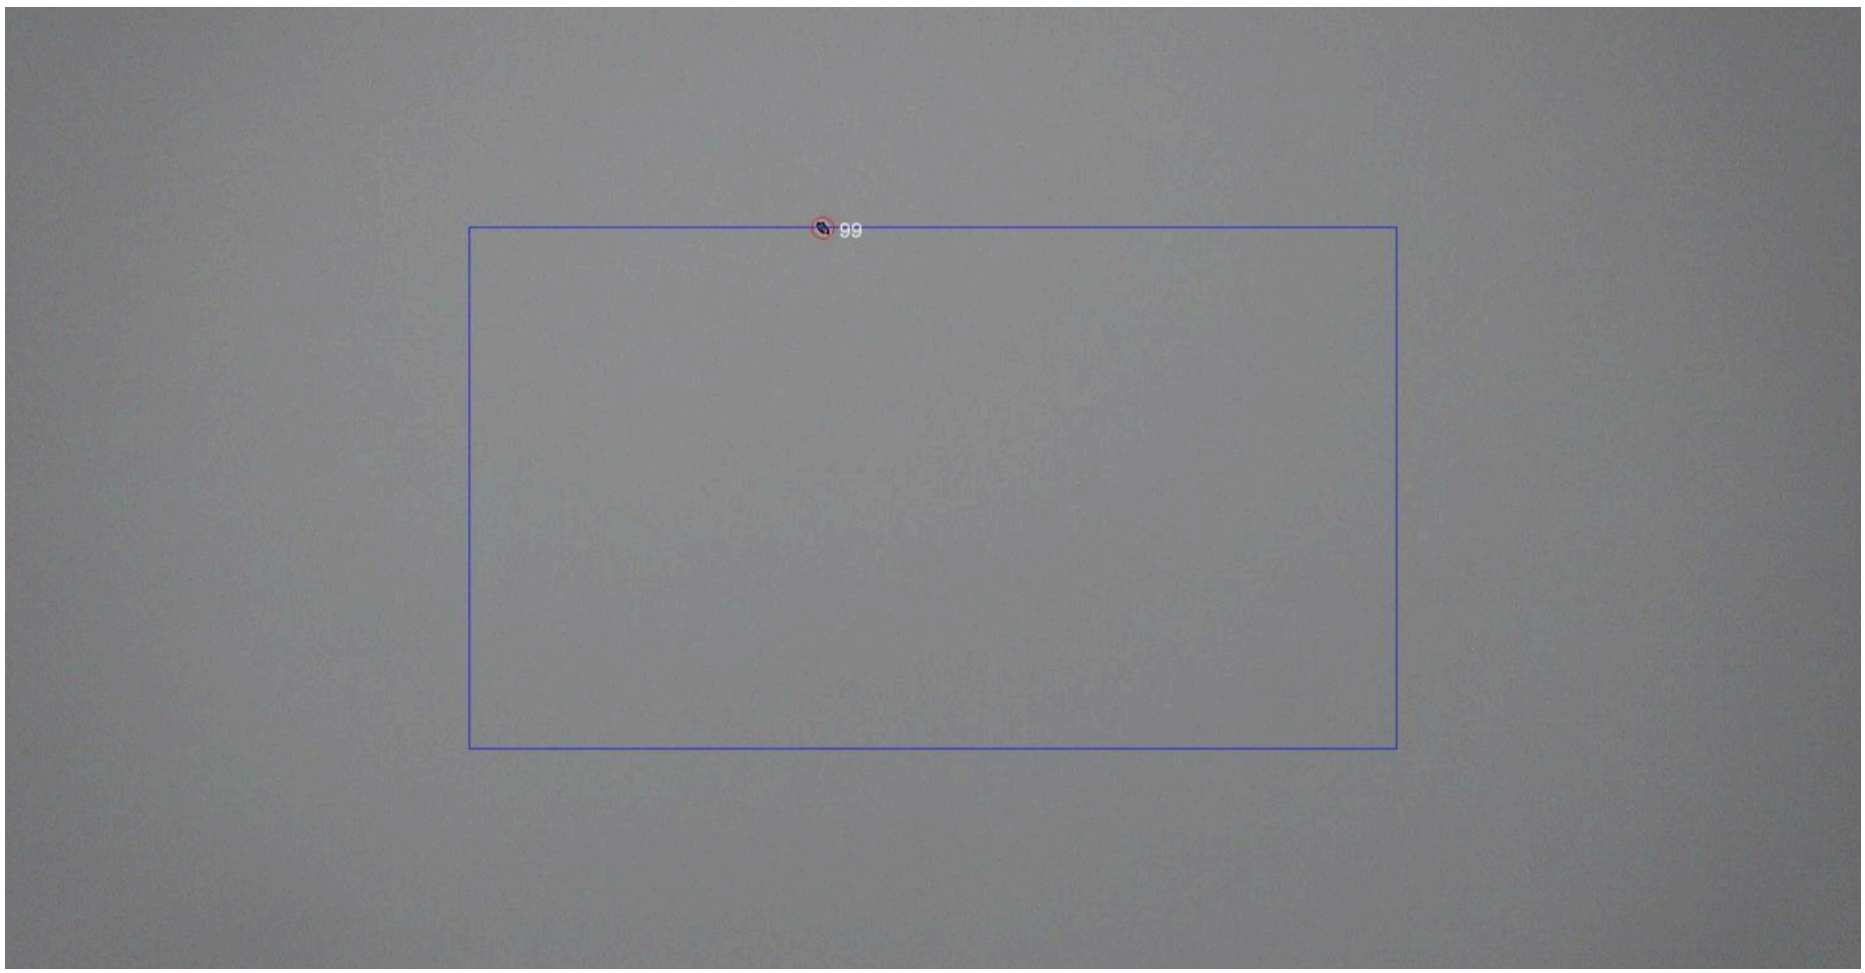
**Blemish Example #1**

Blemish failure due to FM. This FM is most likely beneath the lens.

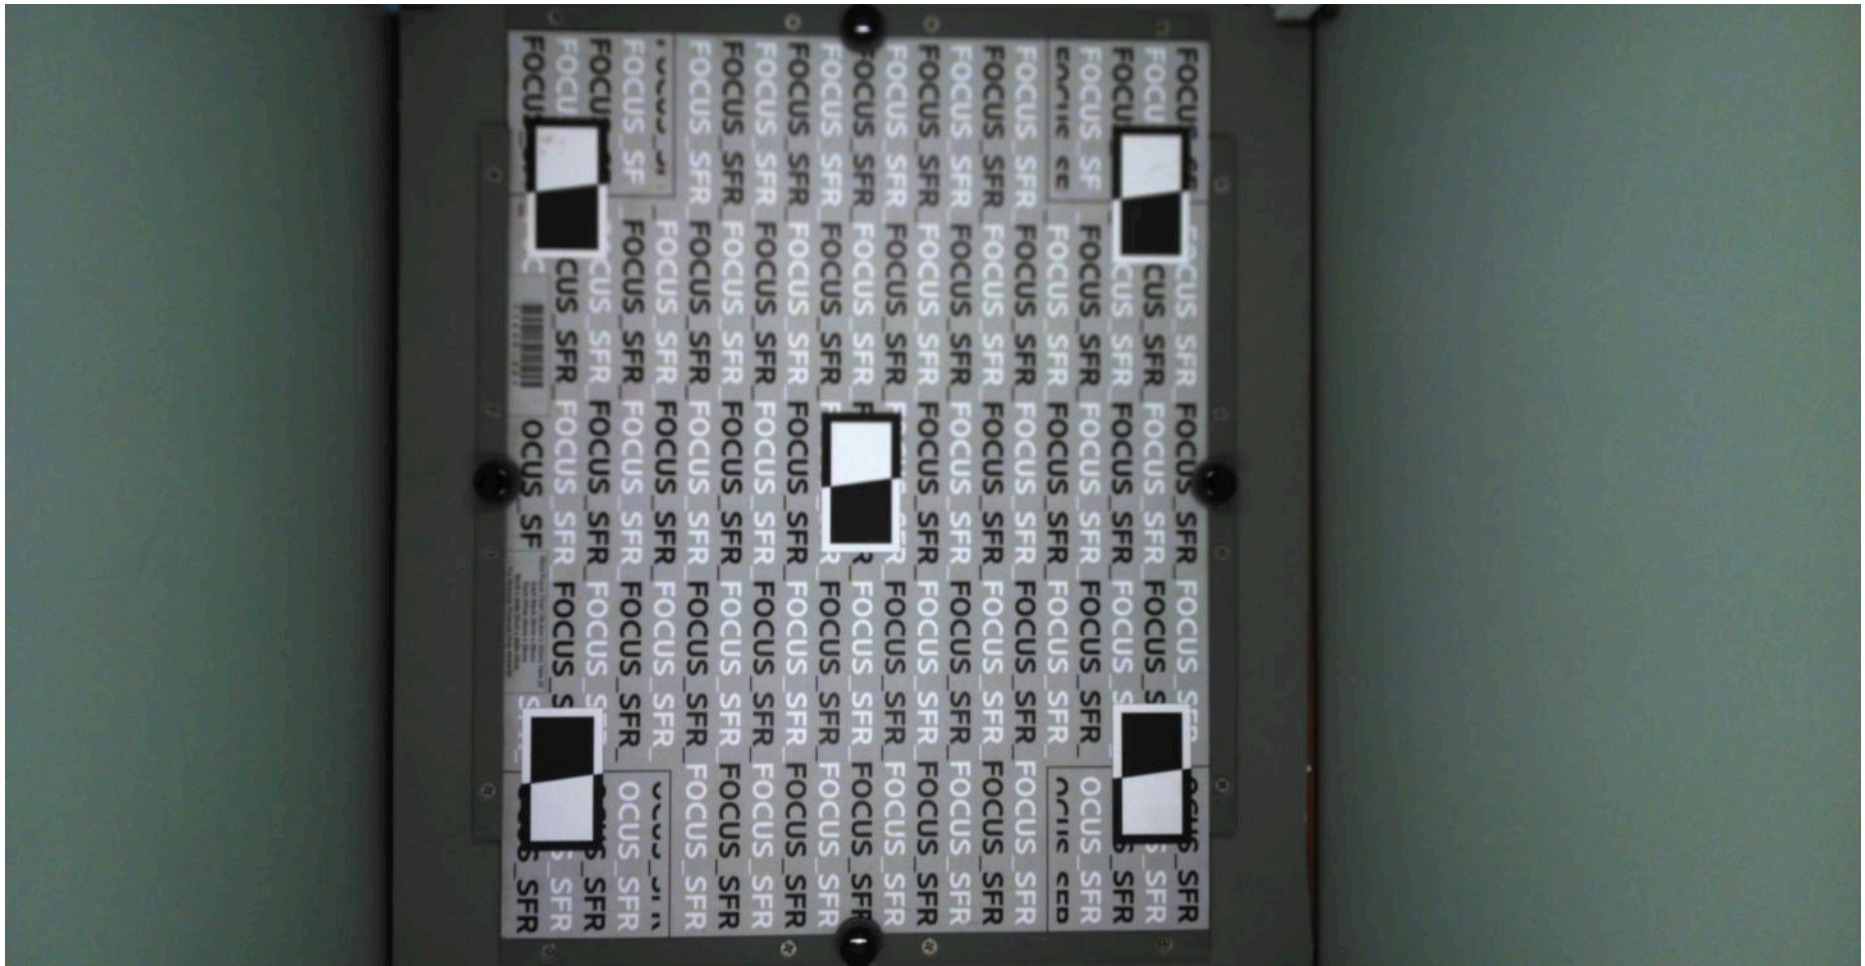
## Placement Error Example

This picture shows a really severe case of the focus chart not being centered within the camera's view. This case is most likely caused by operator error when placing the phone into the test chamber.

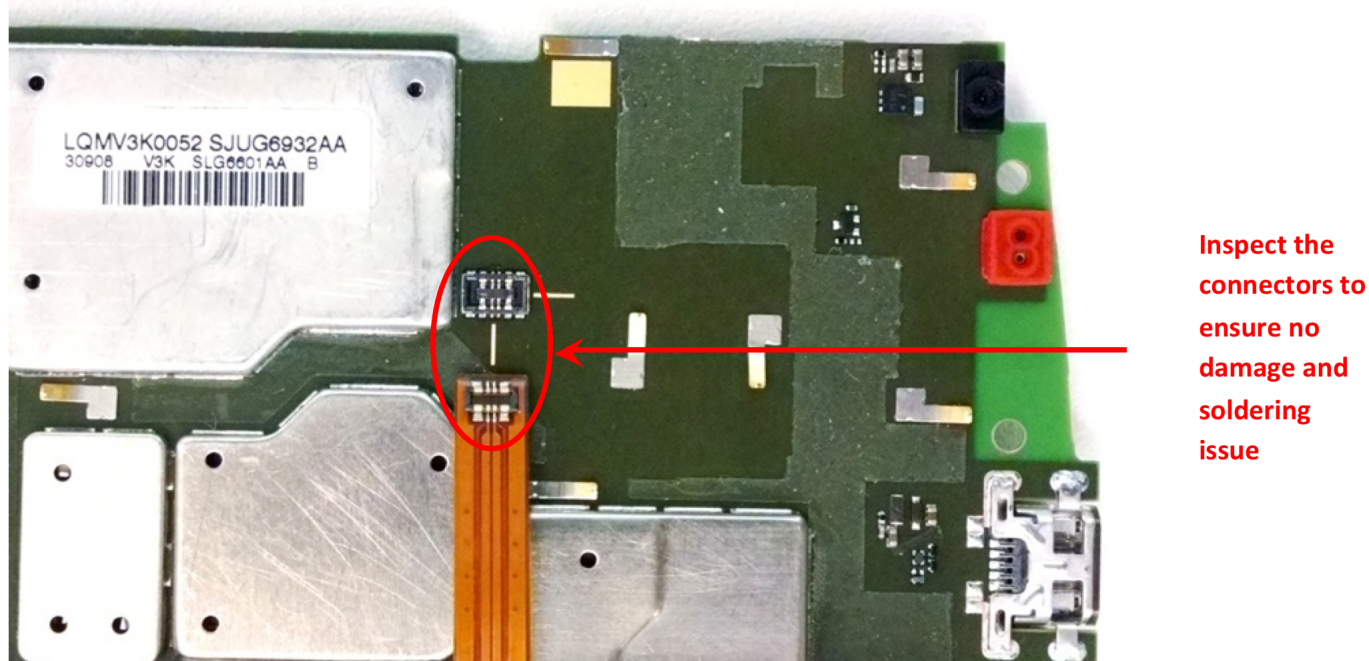
2. Verify NFC antenna connector is not damaged on flex or on PCB. There may be soldering defects, such as shorts, broken pads. There may also be broken pins within the connector. Often broken pins can occur through improper insertion of connector.

3. Replace NFC antenna to see if it follows antenna itself.
4. Ensure NFC antenna matching components are not damaged.
