Moto X Play/DROID MAXX 2 BASEBAND TROUBLESHOOTING GUIDE V1.0

Moto X Play/DROID MAXX 2
BASEBAND TROUBLESHOOTING GUIDES

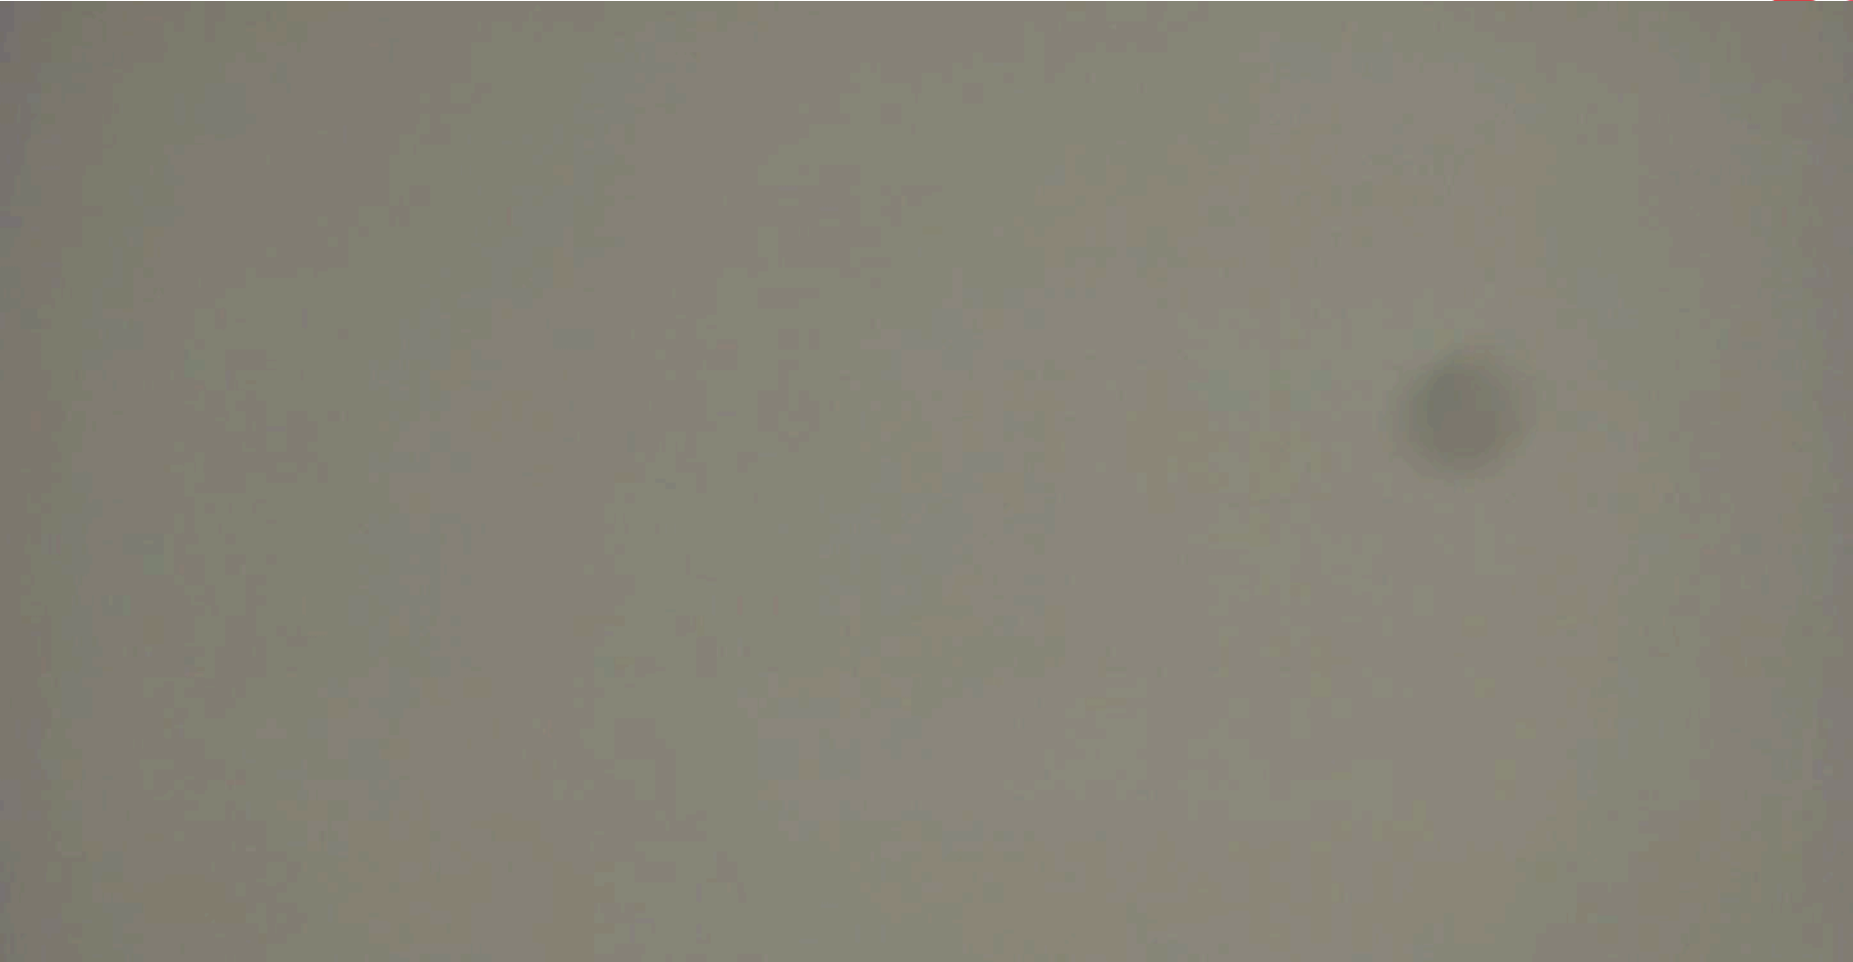
Blemish Example #1

Blemish failure due to FM. This FM is most likely beneath the lens.

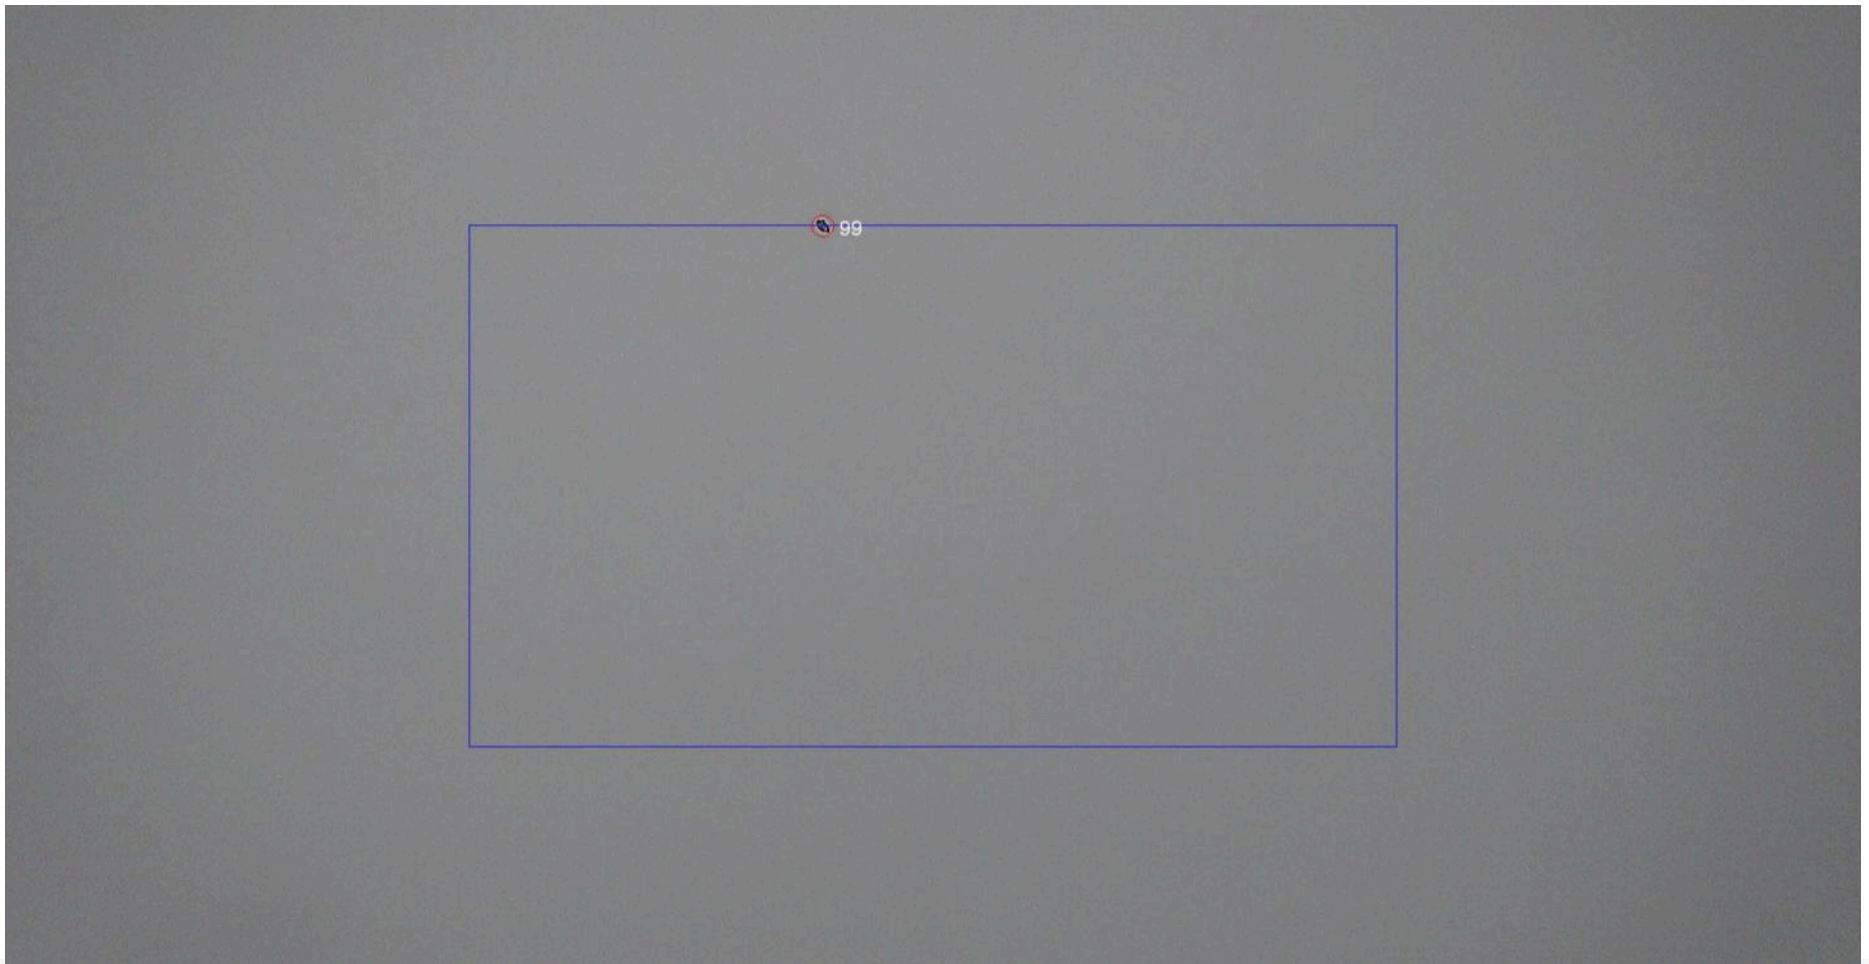
Blemish Example #2

Blemish failure due to FM. The blue box and red circle are part of the annotated image. Annotated images end with `_BLEMISH` in the file name. These annotations are drawn by the analysis software and not part of the real image. The blemish that is circled however is real and indicates FM or a defect in the lens.

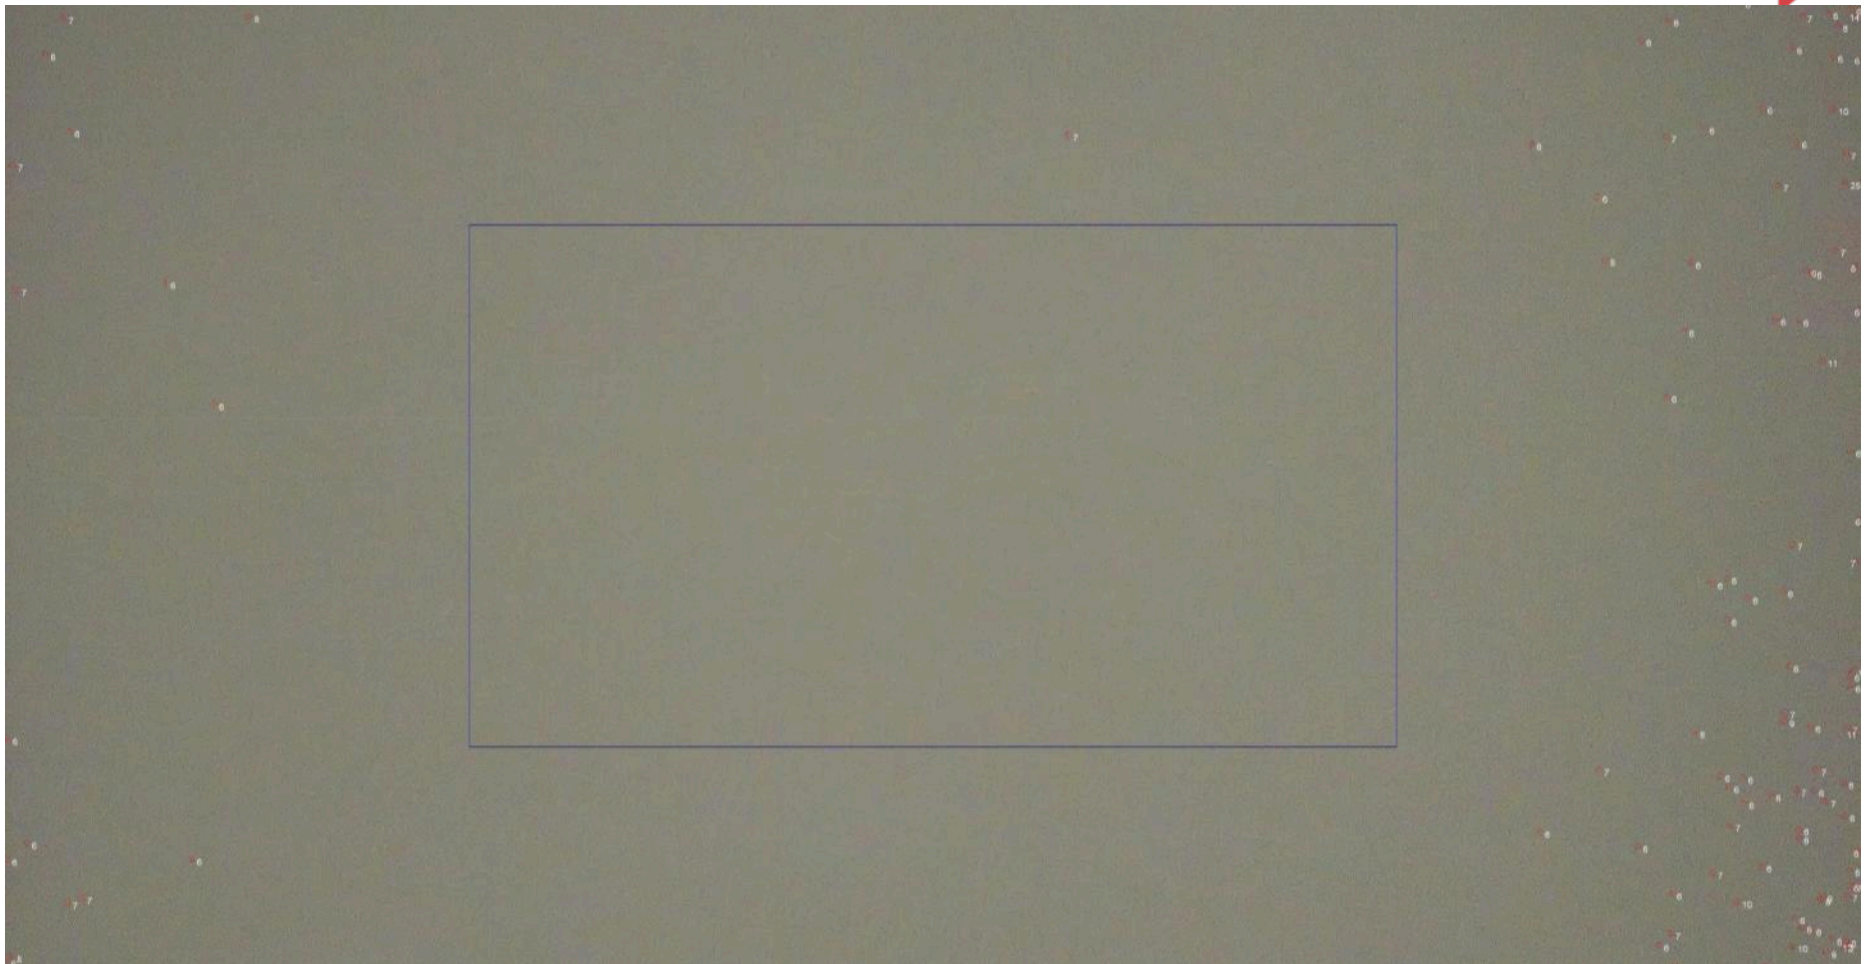
Blemish Example #3

Blemish failure due to noise. There are no particles or lens defects in this module, but the noise is so bad that it is getting mistaken for blemishes. This is most likely a problem with the sensor.

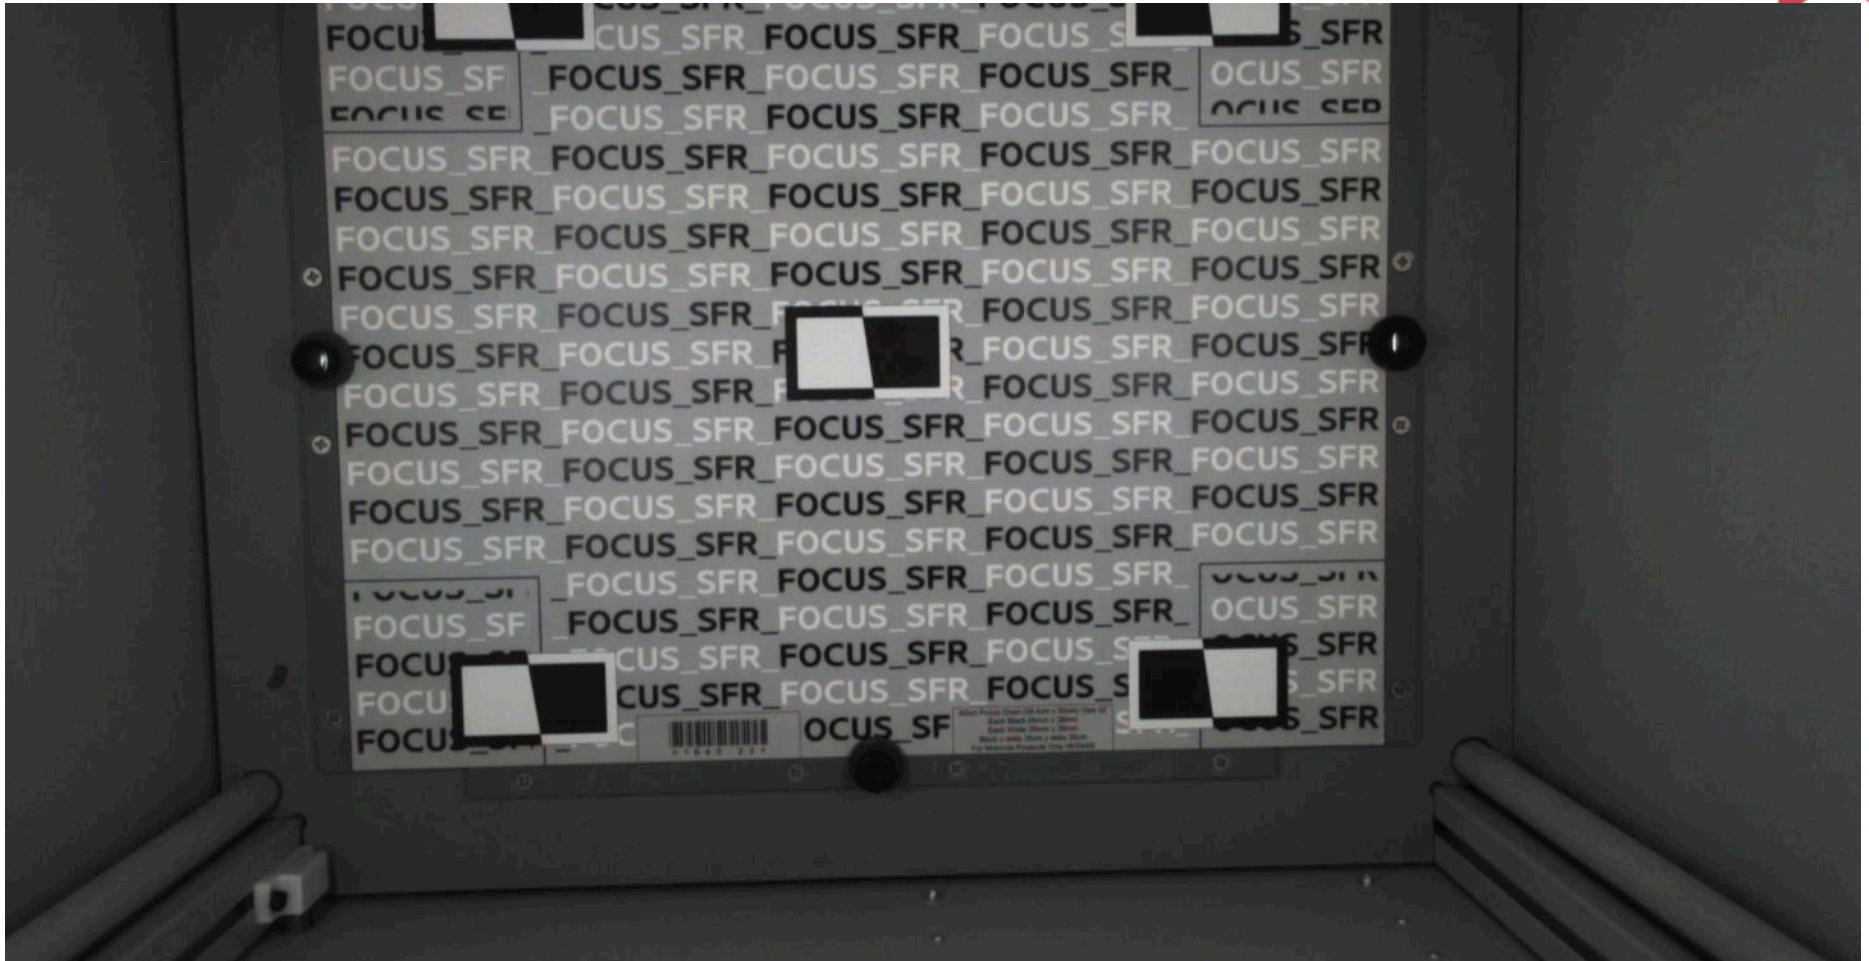
Placement Error Example

This picture shows a really severe case of the focus chart not being centered within the camera's view. This case is most likely caused by operator error when placing the phone into the test chamber.

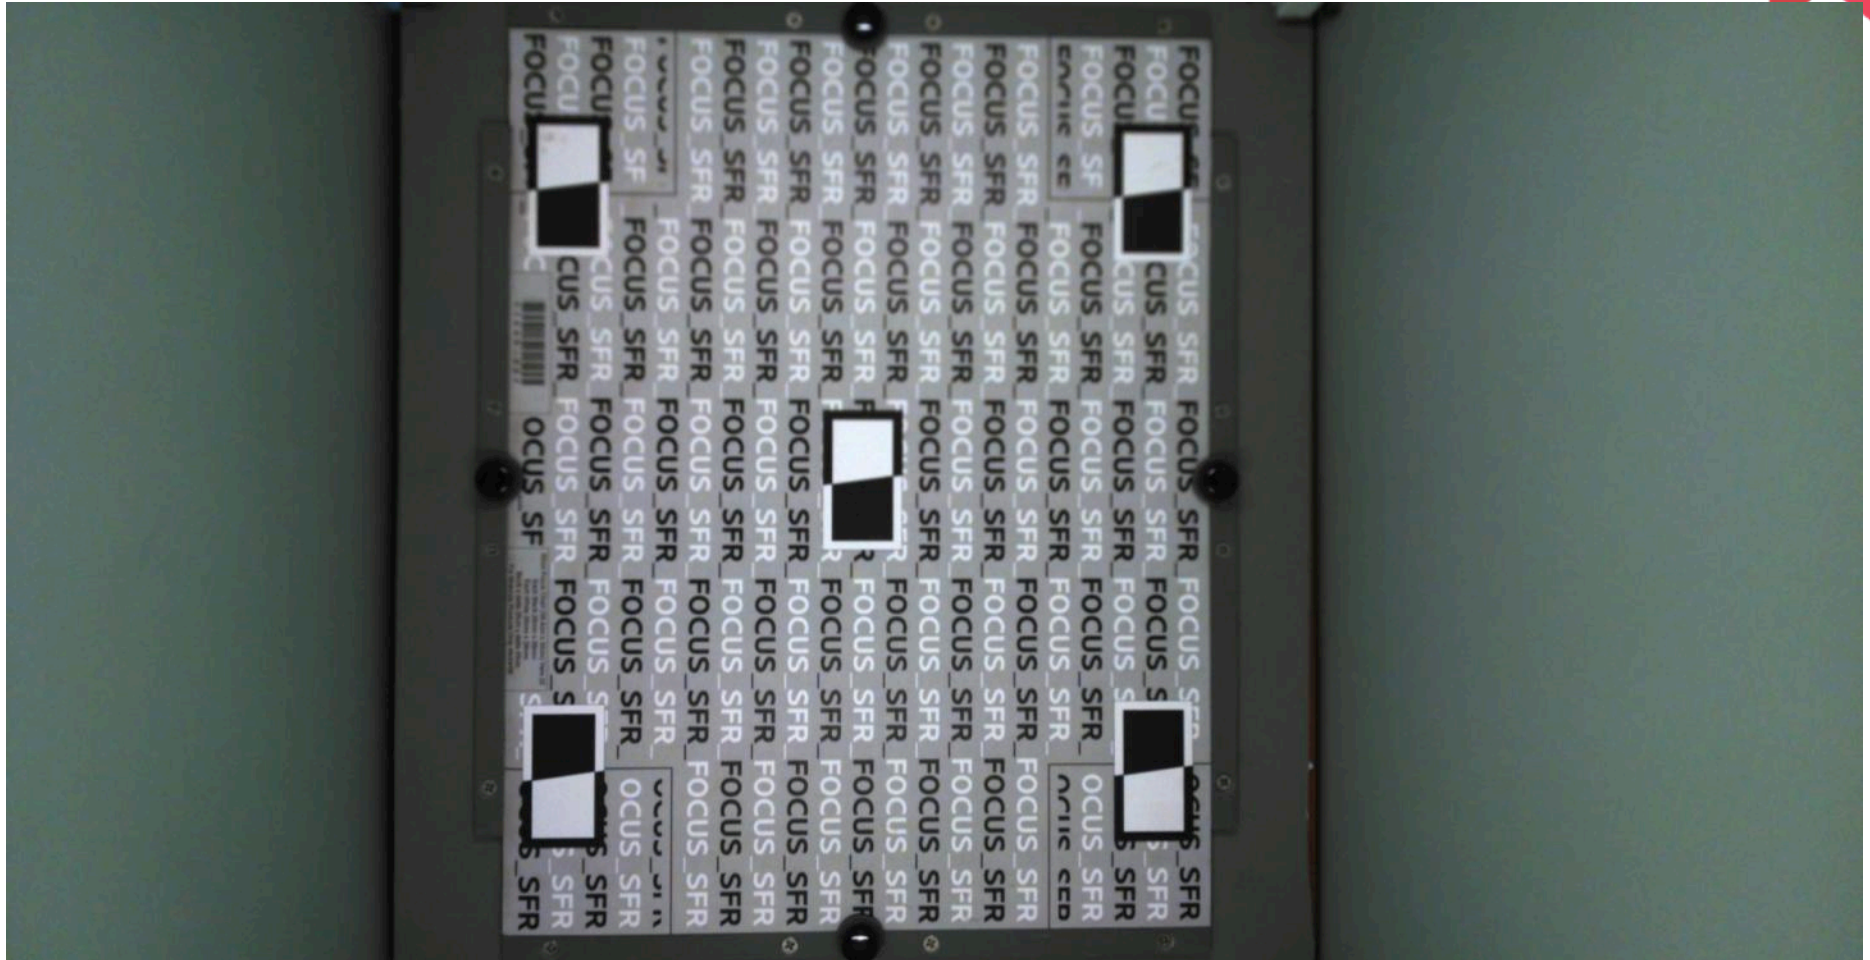
Focus Error Example

The top side of this image is blurry. This will most likely be a problem with the lens placement inside the module.
