Moto X Force/DROID Turbo 2 BASEBAND TROUBLESHOOTING GUIDE V1.0

TABLE OF CONTENTS

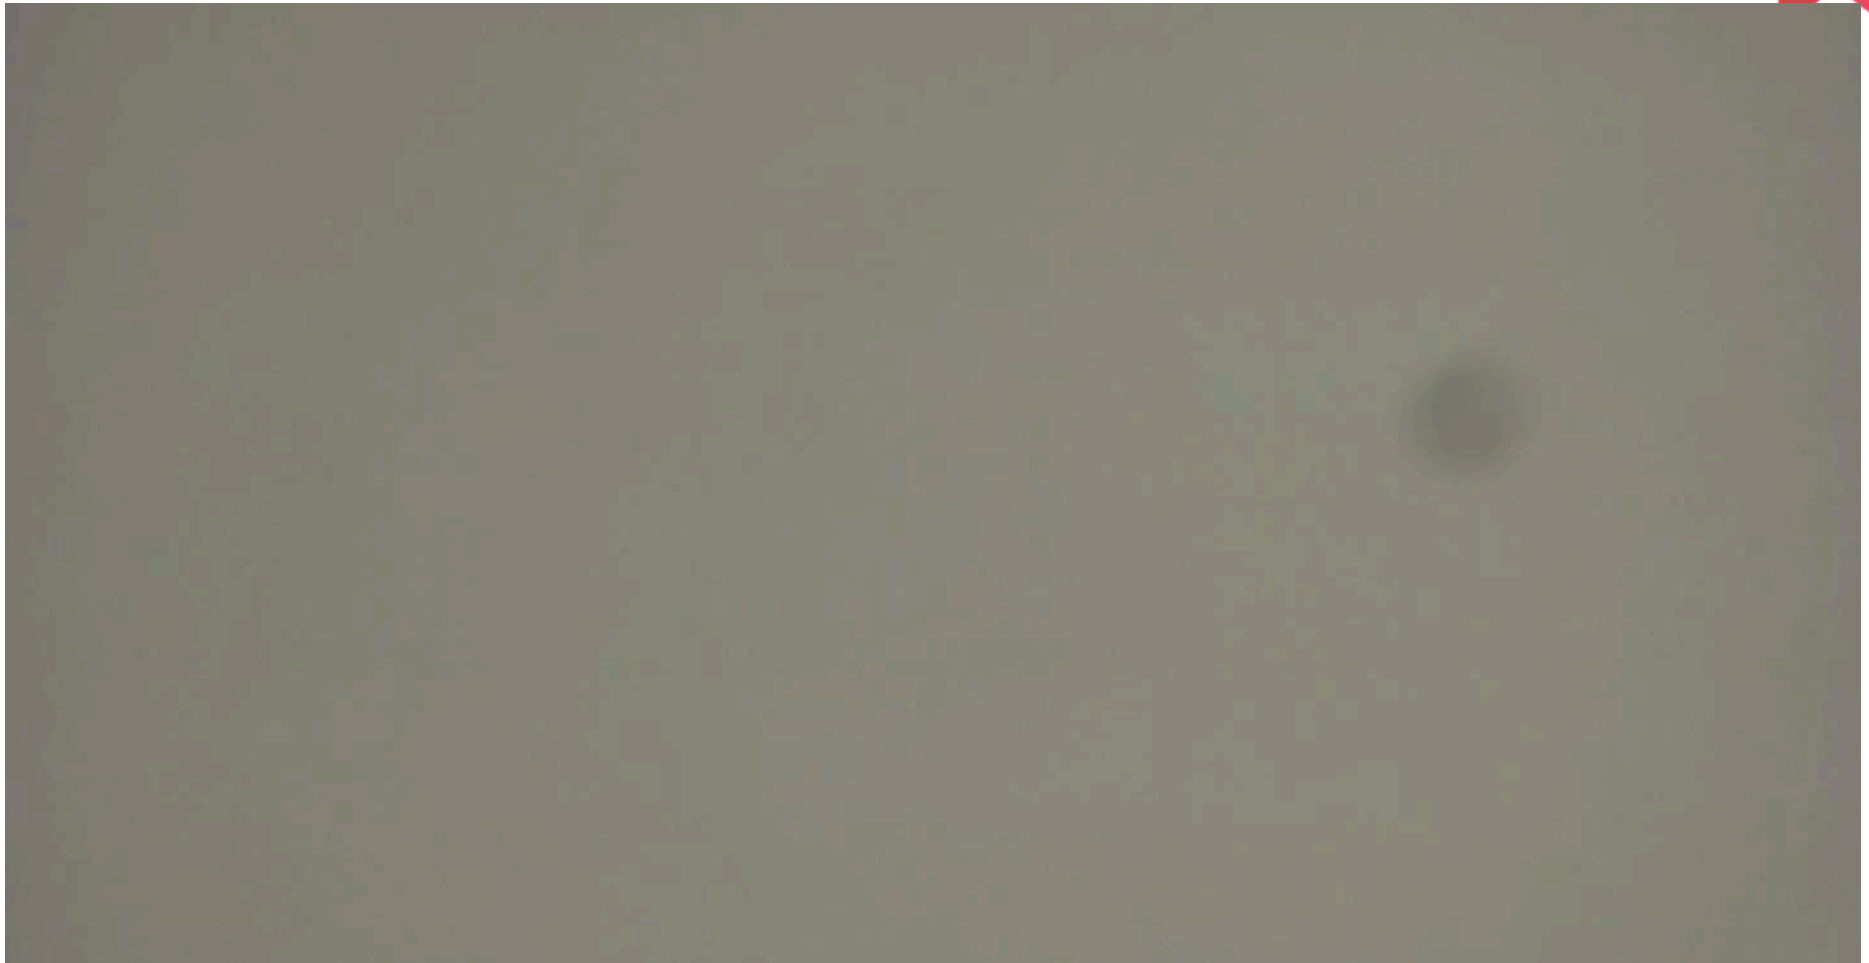
Blemish Example #1

Blemish failure due to FM. This FM is most likely beneath the lens.

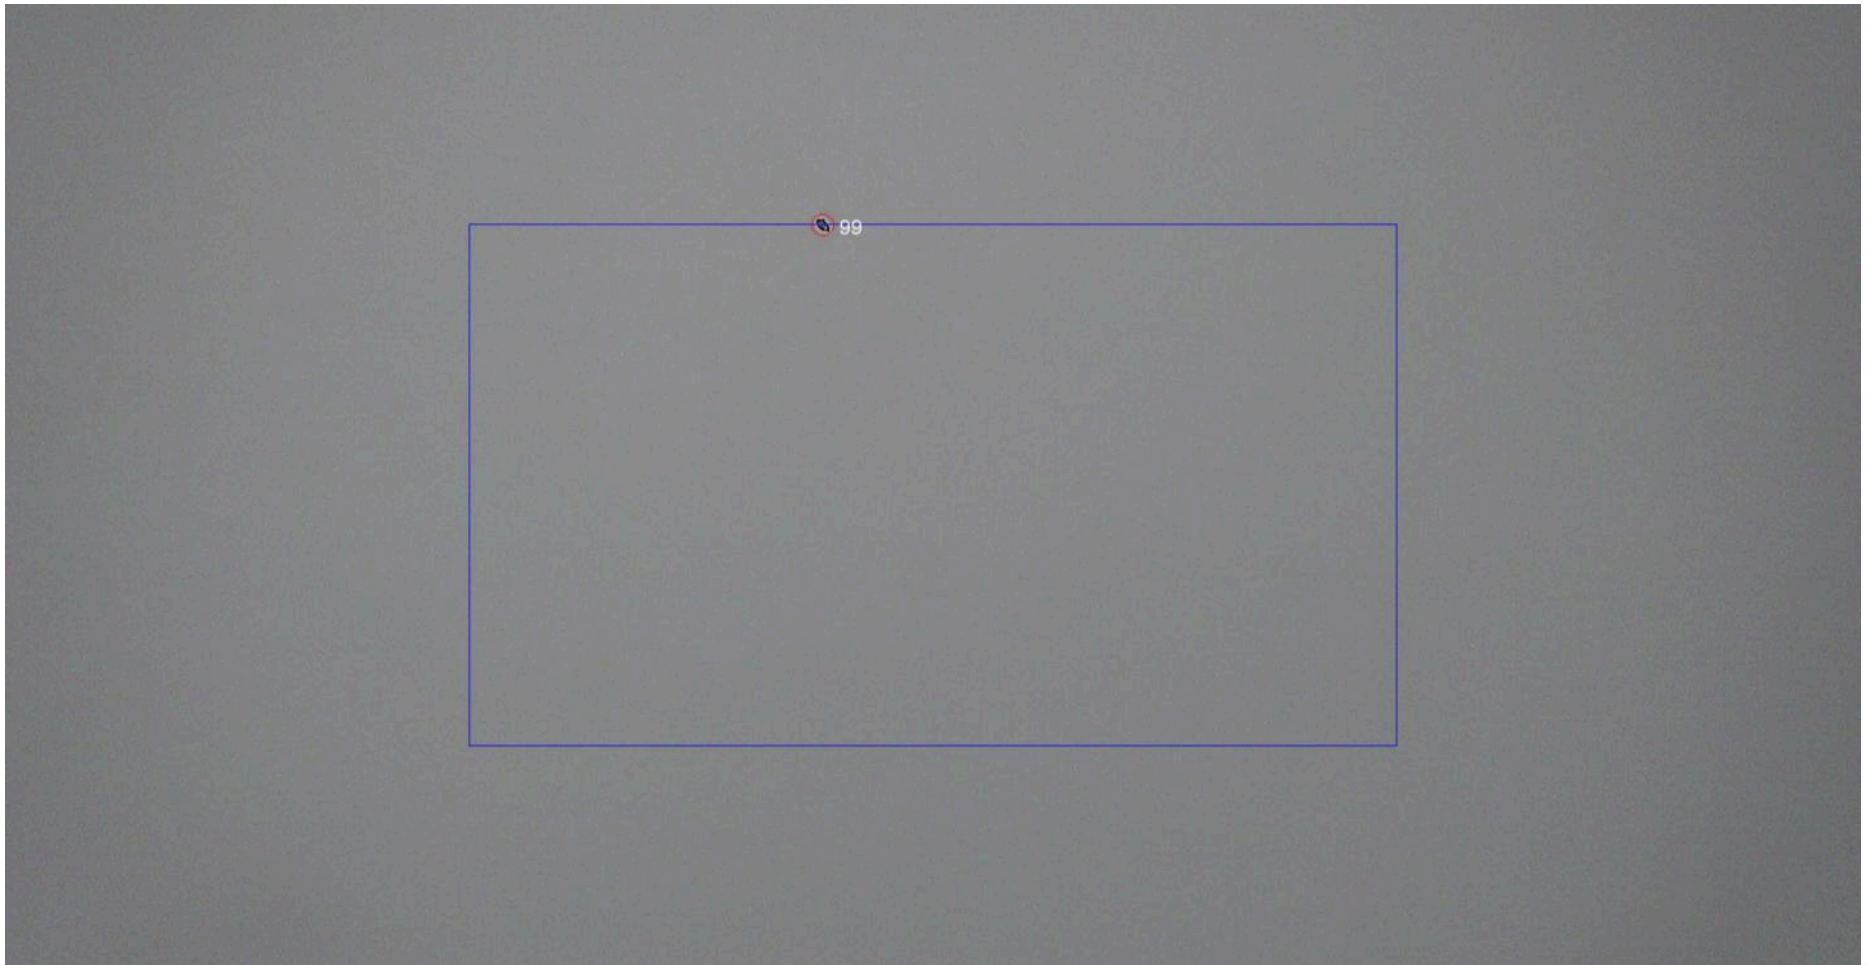
Blemish Example #2

Blemish failure due to FM. The blue box and red circle are part of the annotated

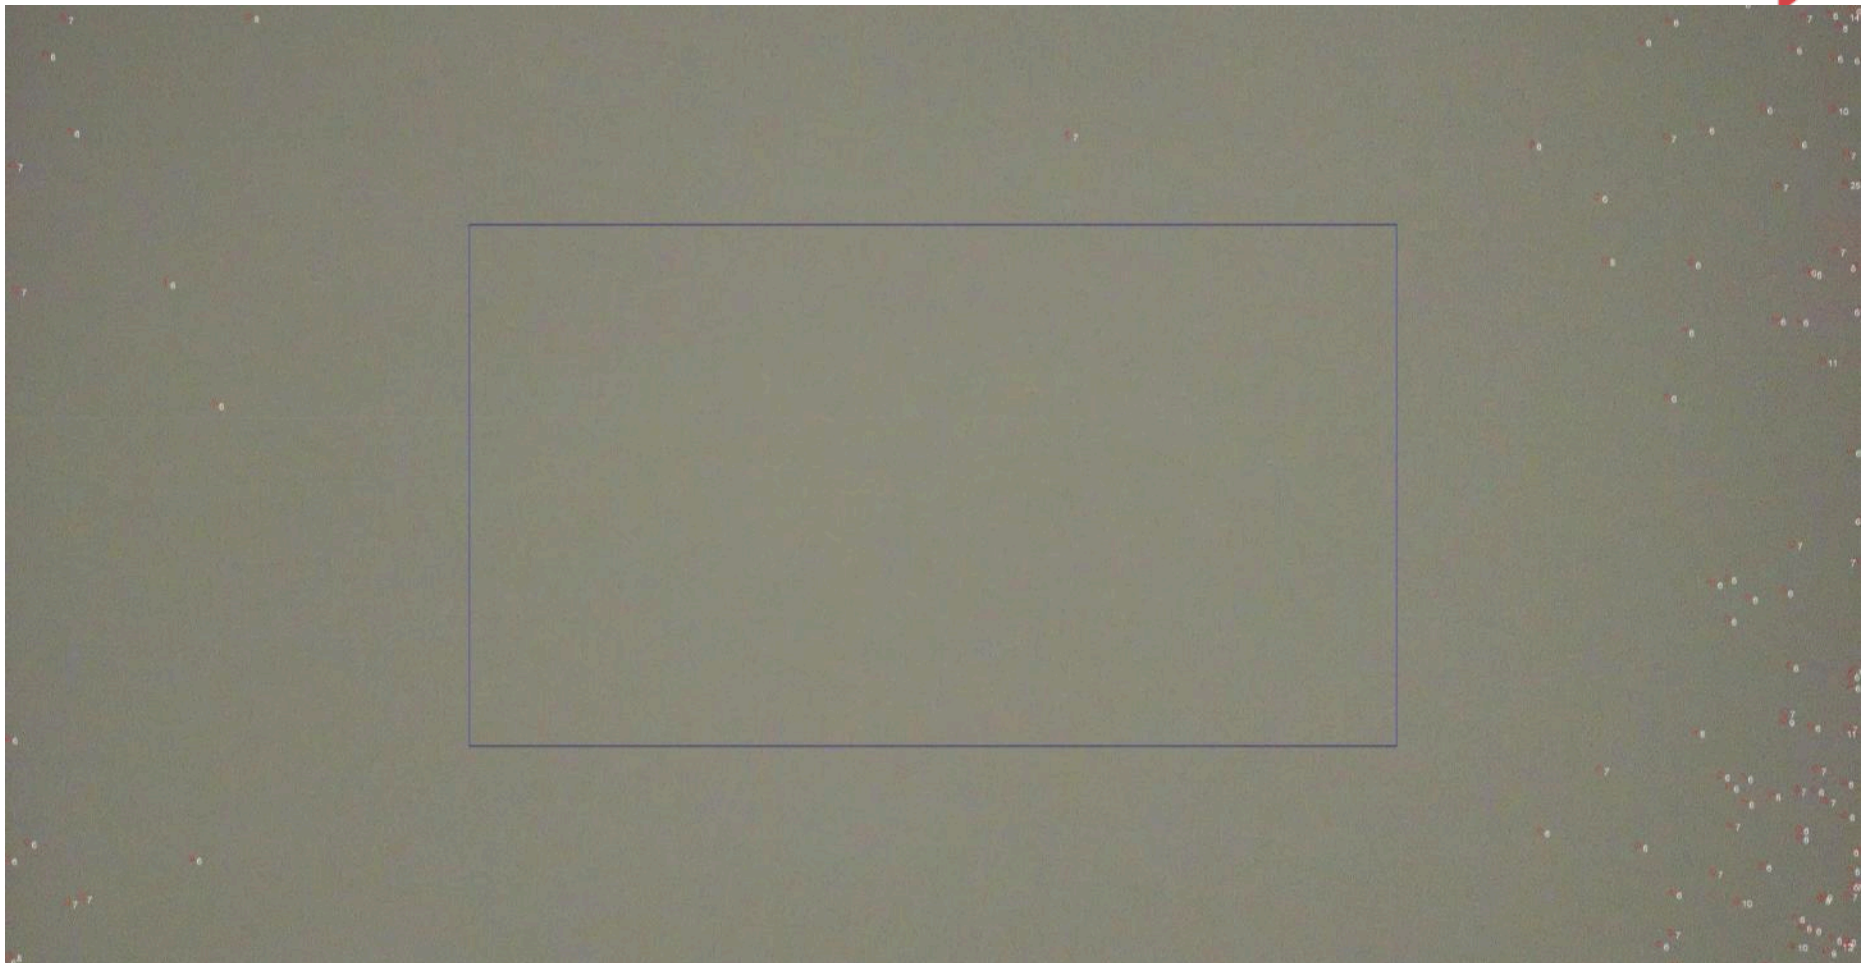
Blemish Example #3

Blemish failure due to noise. There are no particles or lens defects in this module, but the noise is so bad that it is getting mistaken for blemishes. This is most likely a problem with the sensor.

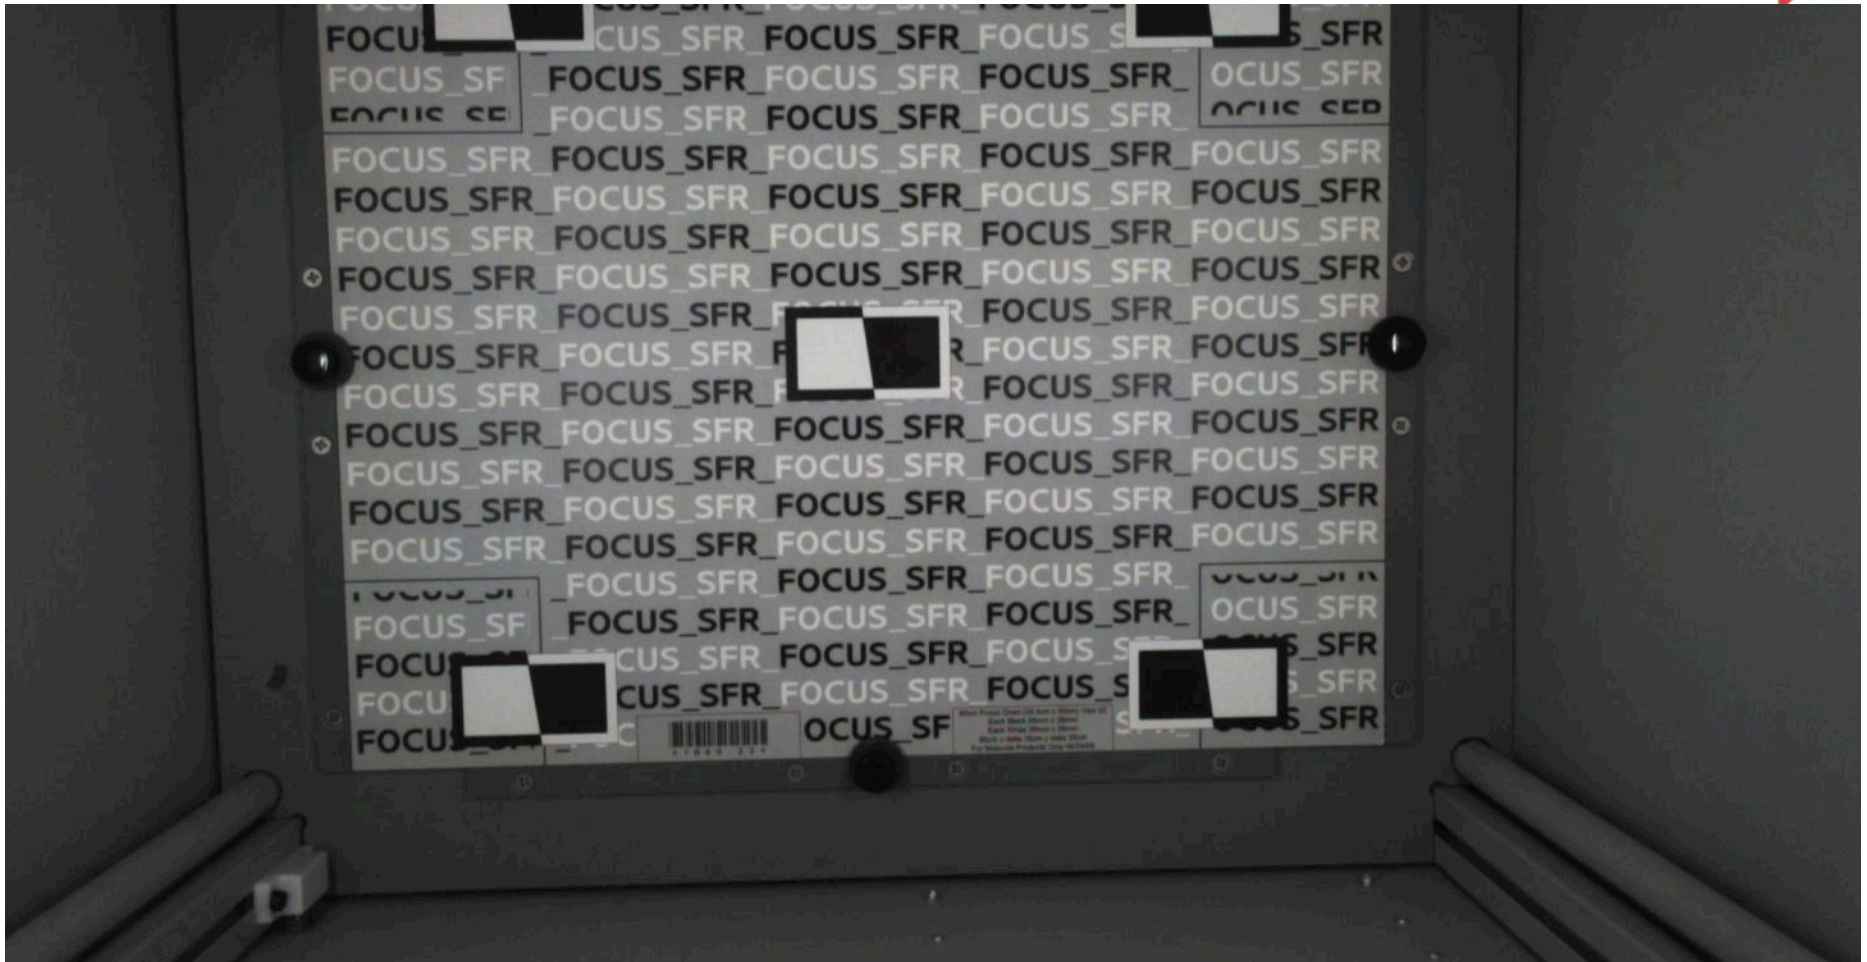
Placement Error Example

This picture shows a really severe case of the focus chart not being centered within the camera's view. This case is most likely caused by operator error when placing the phone into the test chamber.

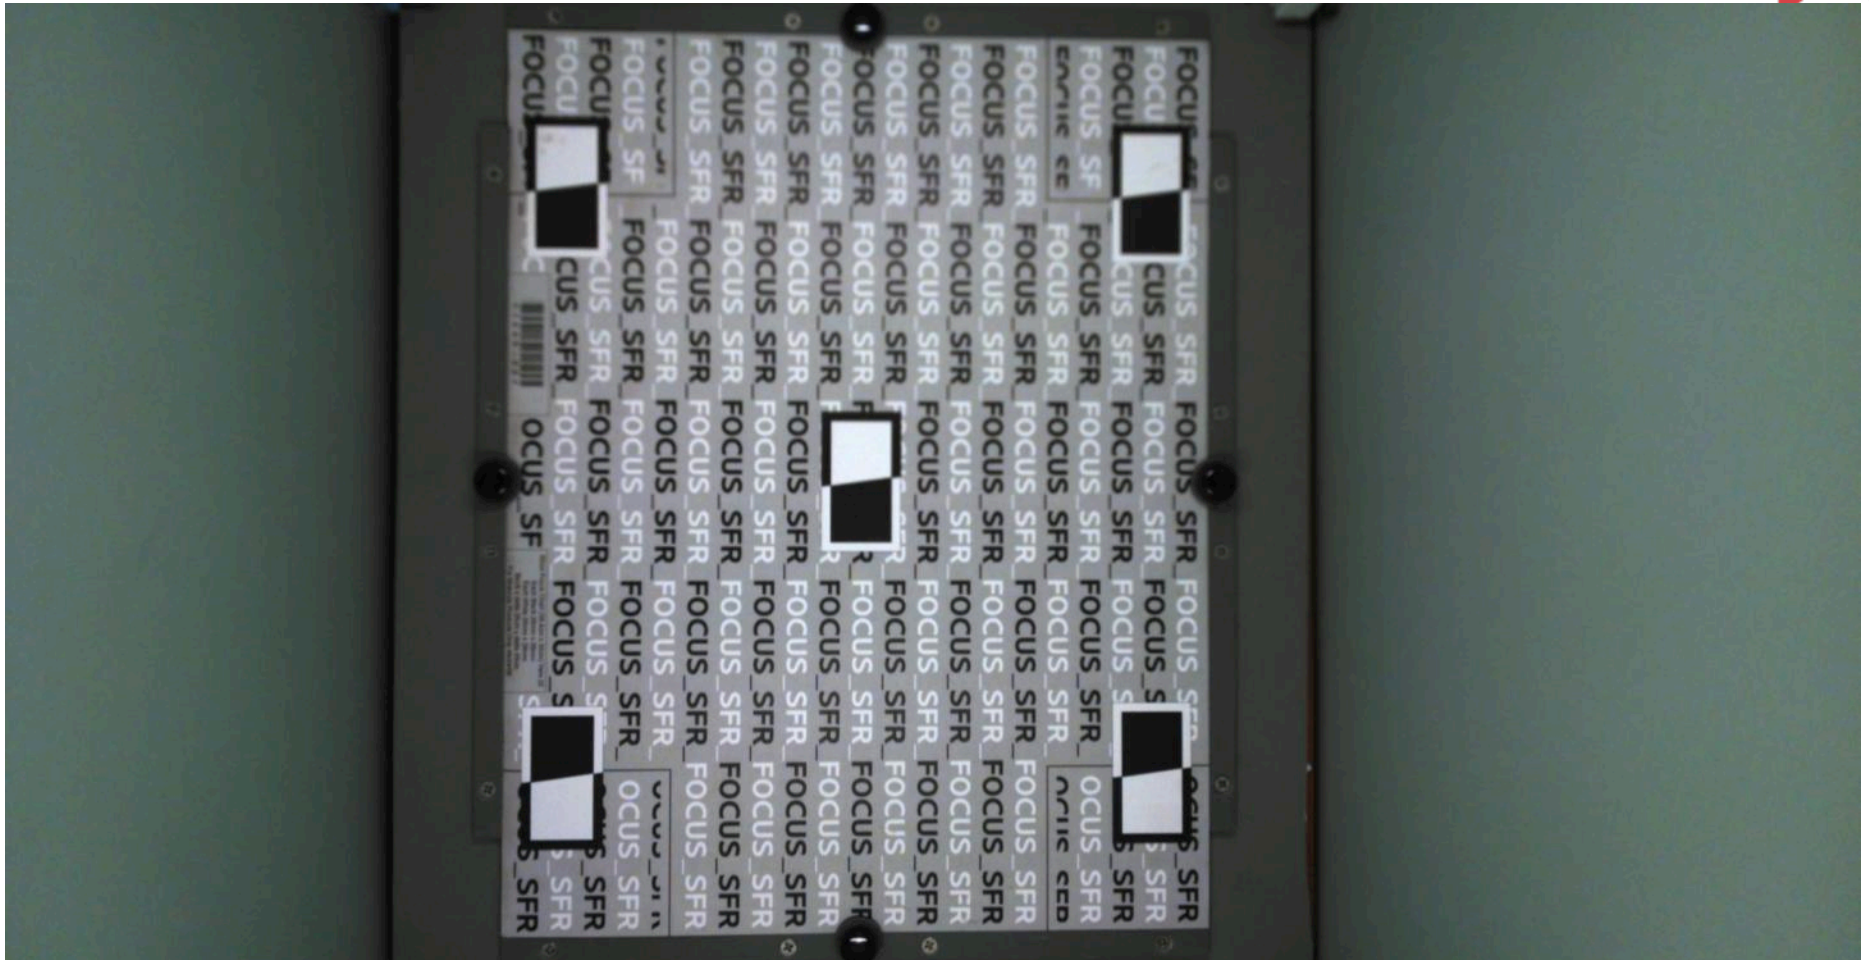
Focus Error Example

The top side of this image is blurry. This will most likely be a problem with the lens placement inside the module.
