Title: Troubleshooting-Guide MotoRAZR maxx V6

Doc. No: TSG\_3G\_V6  
Version: 1.0  
Date: 23.07.2007

## Troubleshooting Guide MotoRAZR maxx V6

### Level 3

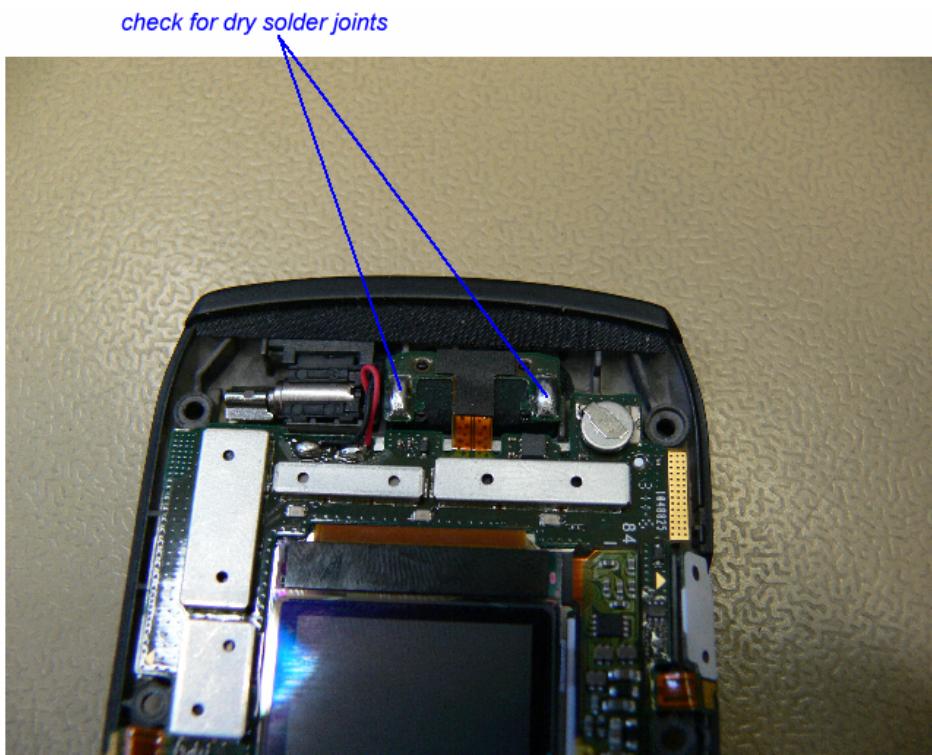
Figure 4

- b) *Speaker bad soldered/defective*

Remove flip cover and visually inspect soldered contacts at speaker. If not ok, resolder speaker. Otherwise replace speaker with a new one.

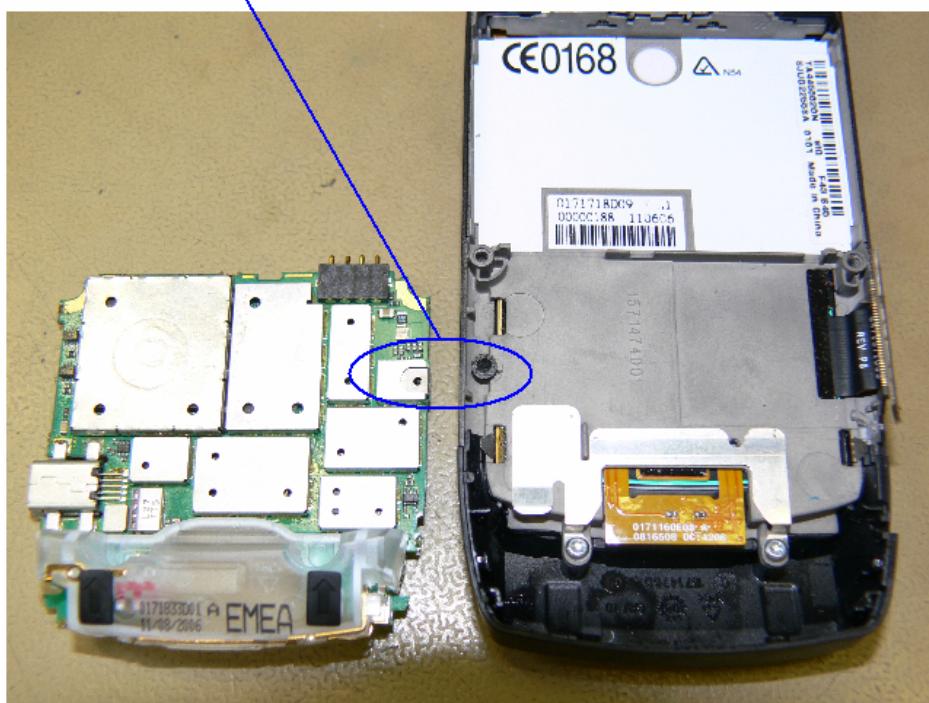
Figure 6

- a) *Dust/Foreign particles on microphone*

*check for dust/foreign particles on microphone/speaking hole*

Gain access to the transceiver board assembly and make sure that no dust/foreign particles are on microphone/speaking hole in flip assembly

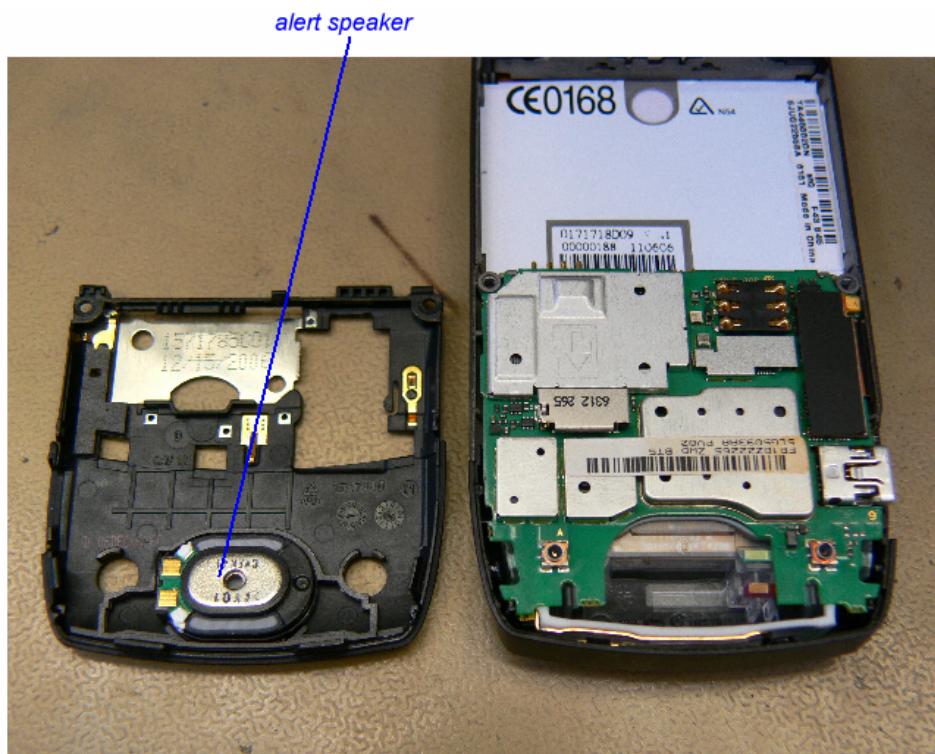
**Figure 7**

- a) *Faulty alert speaker (part of rear housing assy)*

Verification: Remove rear housing assy and temporarily replace the rear housing assy with a known good one. If the fault has been cleared, reassemble with new rear housing assy.

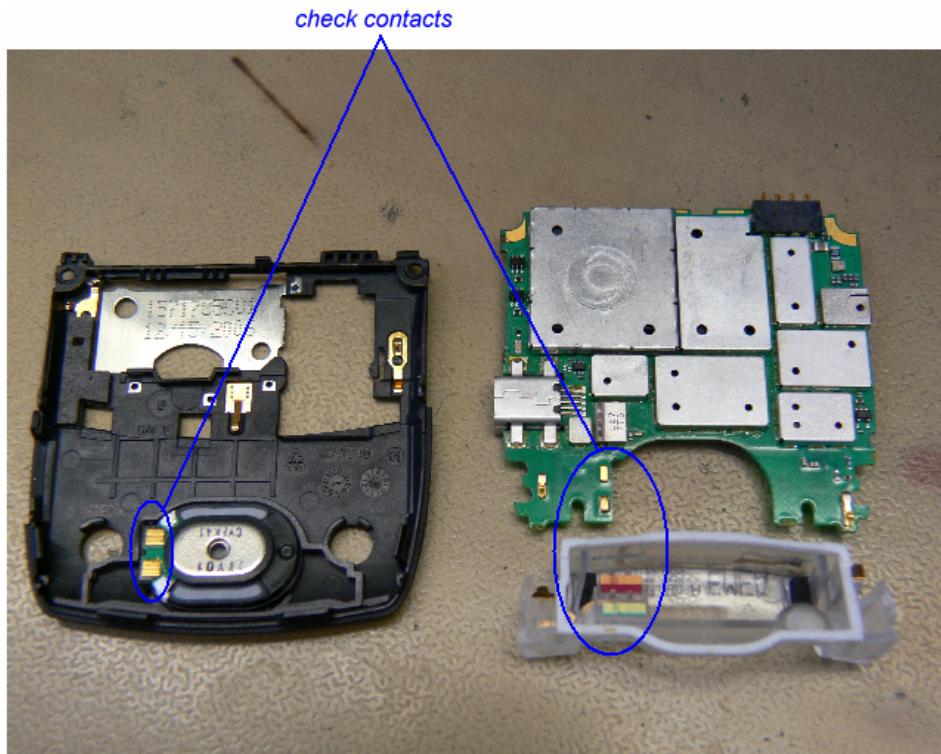
Figure 8

- b) *Faulty connection transceiver board assembly to alert speaker*

Remove antenna assembly and check contacts. Temporarily replace antenna assy with a known good one. If the fault has been cleared, reassemble with a new antenna assy.

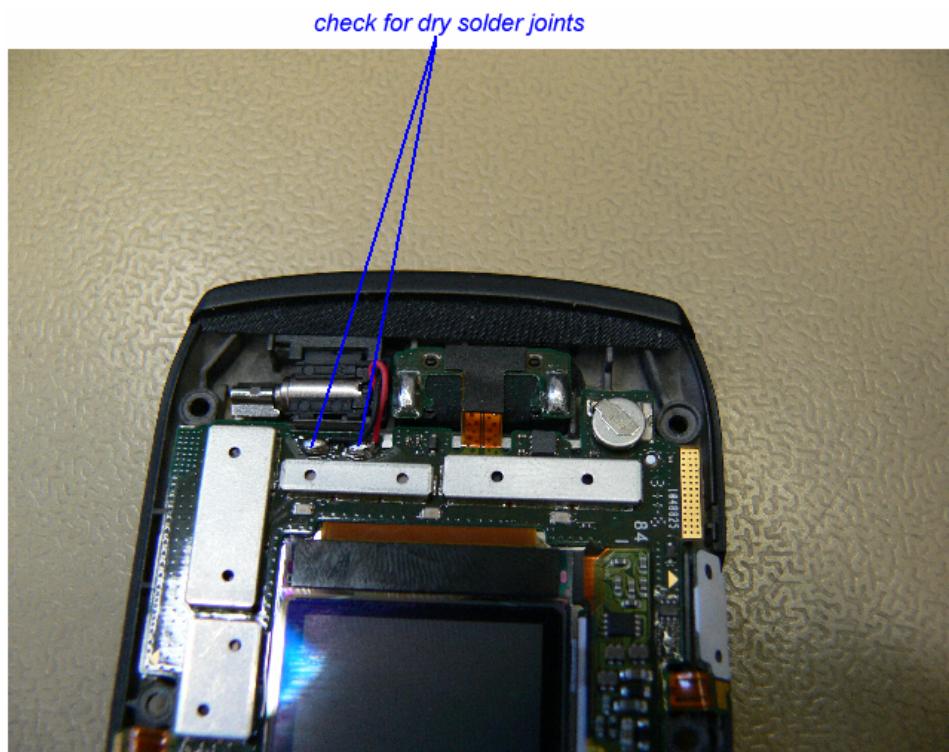
Figure 9

- b) *Vibrator bad soldered/defective*

Remove flip cover and visually inspect soldered contacts at vibrator. If not ok, resolder vibrator. Otherwise replace vibrator with a new one.

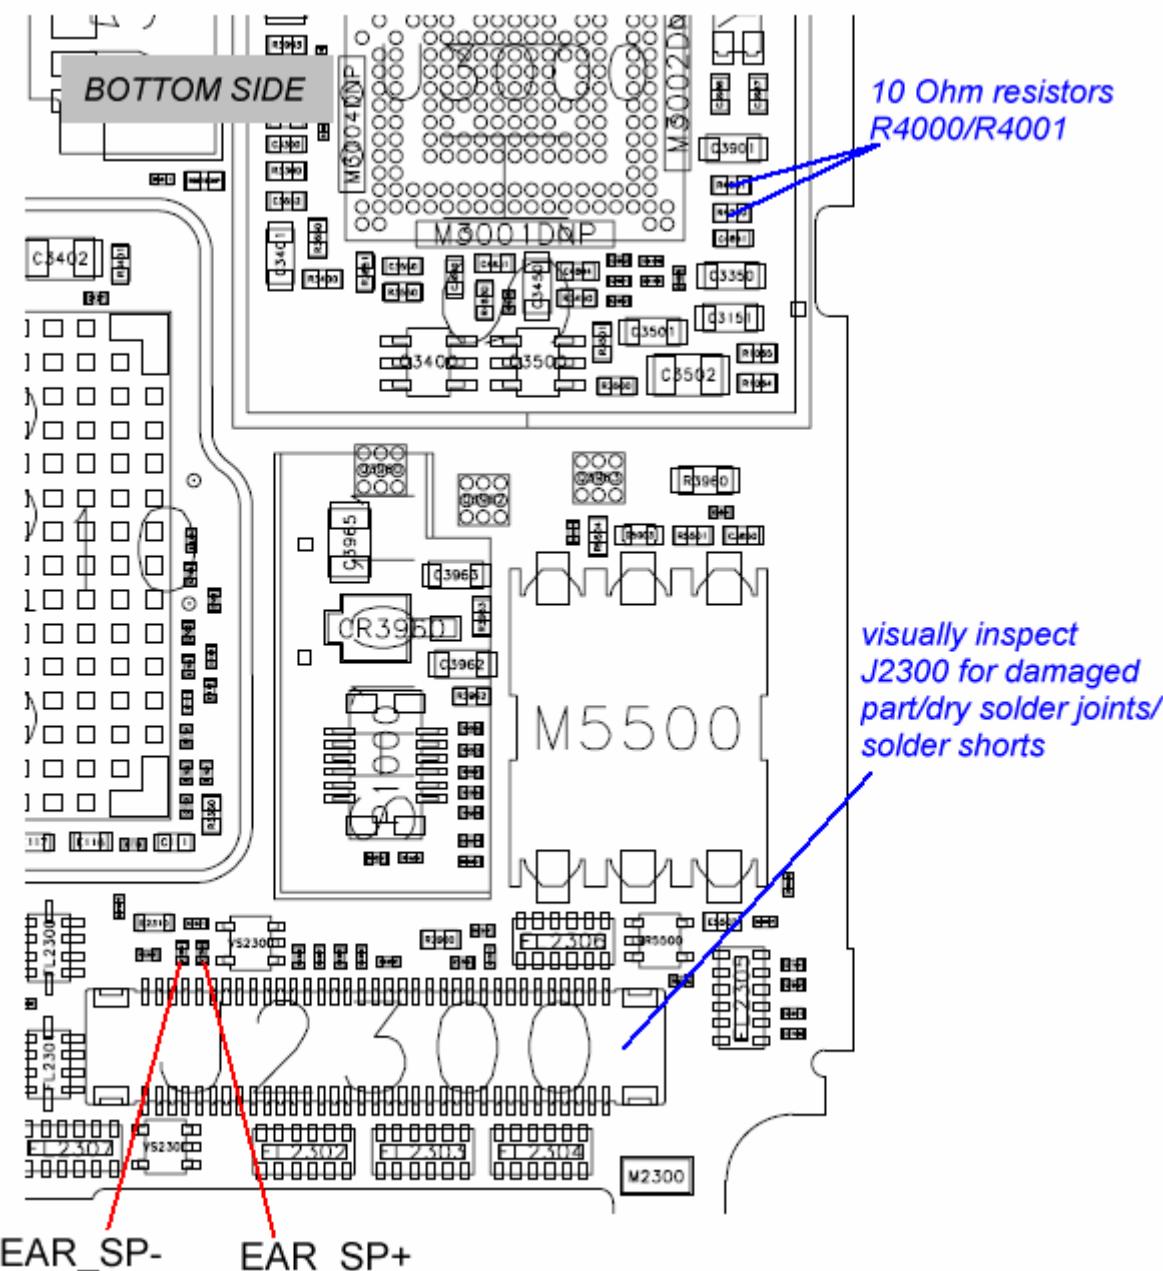
Figure 15

Check EAR\_SP+ at C2303-1 and EAR\_SP- at C2304-1, both should have around 1.5Vdc offset voltage, if audio loop is switched on, and additional up to 3Vpp at 1 kHz, if test tone is switched on via RepairStudio/Radiocomm.

- if not: check J2300/C2303/C2304 and Resistors R4000/R4001 (both 10 Ohm)
- if ok: change ATLAS IC U3000

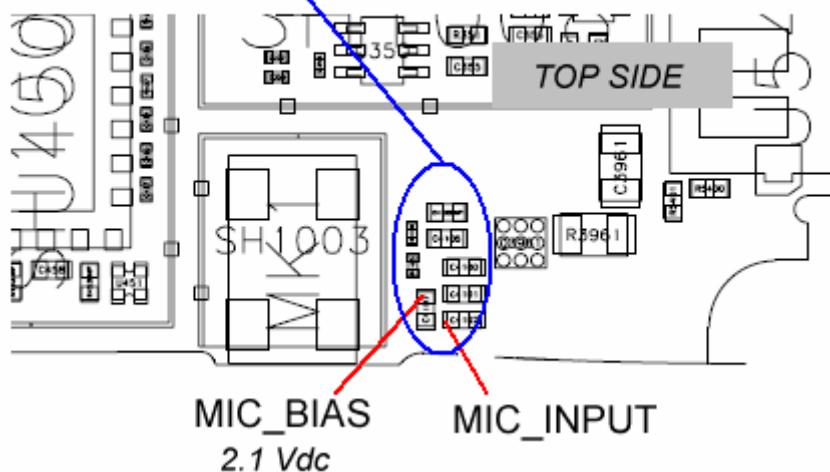
Figure 16

Check MIC\_BIAS at C4107-1 – should be around 2.1Vdc. If not, check R4105/C4106/C4107 for misplaced part/ low resistance to GND – if they are ok, replace ATLAS IC U3000.

*check these for misplaced part/ low resistance to GND*

If MIC\_BIAS is ok, check MIC\_INPUT at C4102-1 while blowing into the microphone to see the audio signal caused by the blowing. If there is no audio signal visible, replace microphone MK1. If there is an audio signal visible, replace ATLAS IC U3000.

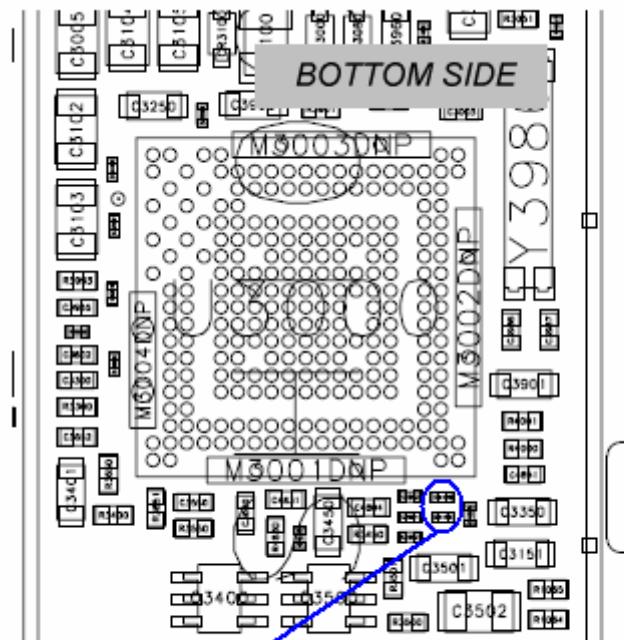
Figure 17

*C4103/C4109  
check these for misplaced part/ low resistance to GND*

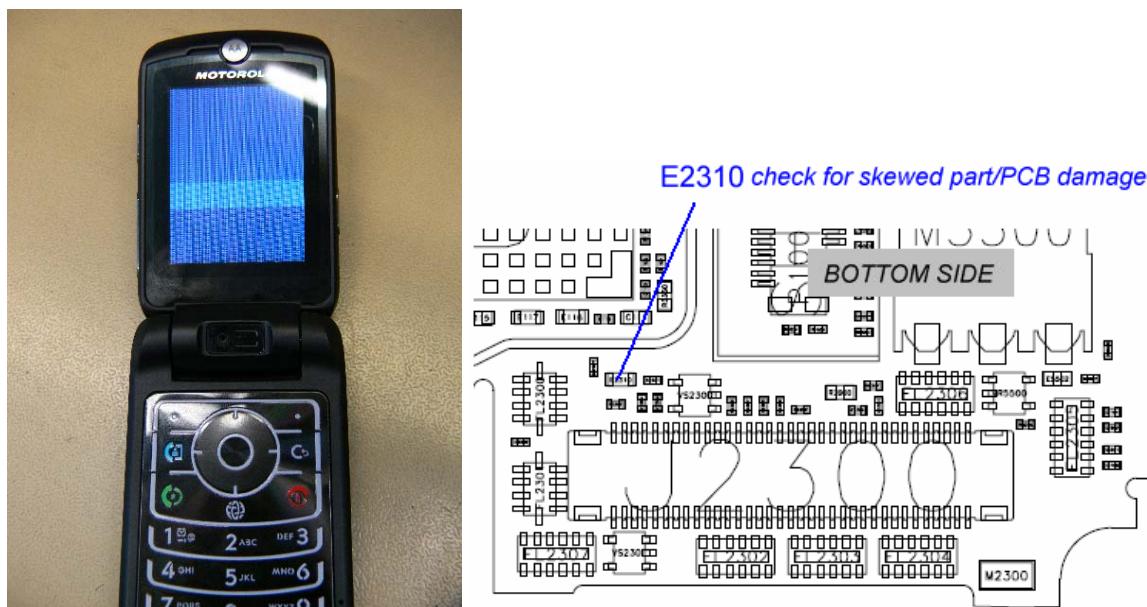
Figure 21

We have seen some phones with the symptom: After a few seconds after turn on the display seems to loose synchronization as shown on Figure 19. In most cases this issue was caused by a skewed [E2310](#). In some cases the PCB was damaged because of lifted pads. It seems to be damaged by a poor disassembly process.

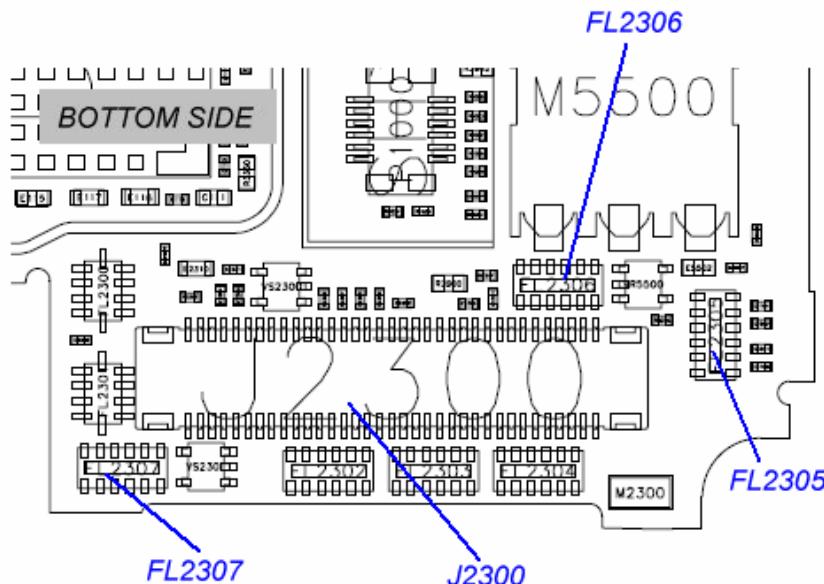
Figure 24

In practice the defective part can very often be found by doing a visual inspection. Check:

- [J2300](#)
- [FL2305](#)
- [FL2306](#)
- [FL2307](#) for solder shorts/dry solder joints/defective part.

If the keypad connector/filters are ok, it's most likely a problem with the ARGON – forward to an authorized level 4 service center.

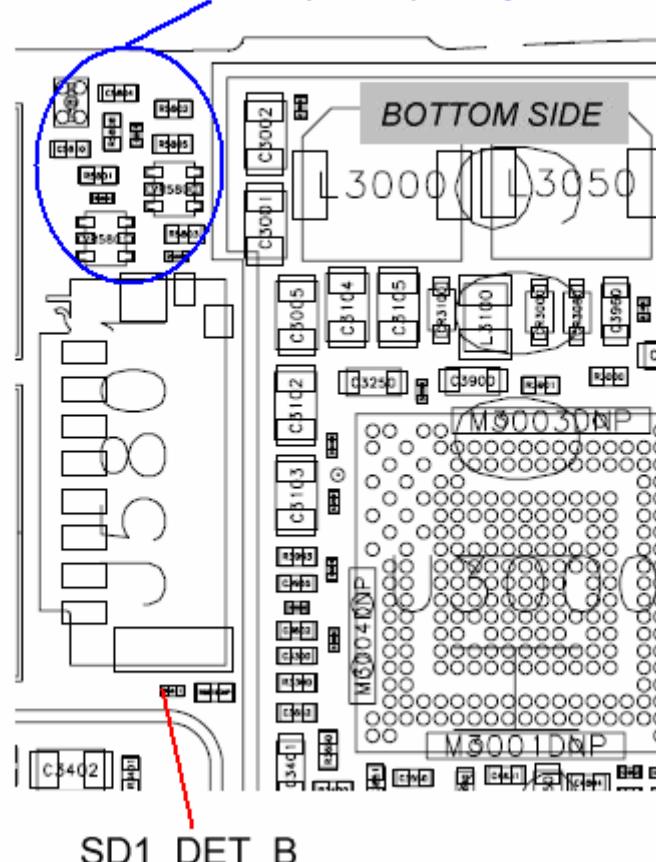
Figure 28

*check all of these for misplaced part/dry solder shorts*

If [SD1\\_DET\\_B](#) without TransFlash card inserted is ok (HIGH/1.9Vdc), but is not switching down to 0V with inserted TransFlash card, replace TransFlash connector [J5801](#).

Check [VMMC\\_2\\_9V](#) at [R5801-1](#) (2.9Vdc). If low, check [VR5801](#) for internal short to GND. If ok, it is probably a problem with the ARGON [U1000](#) – forward to an authorized level 4 service center.

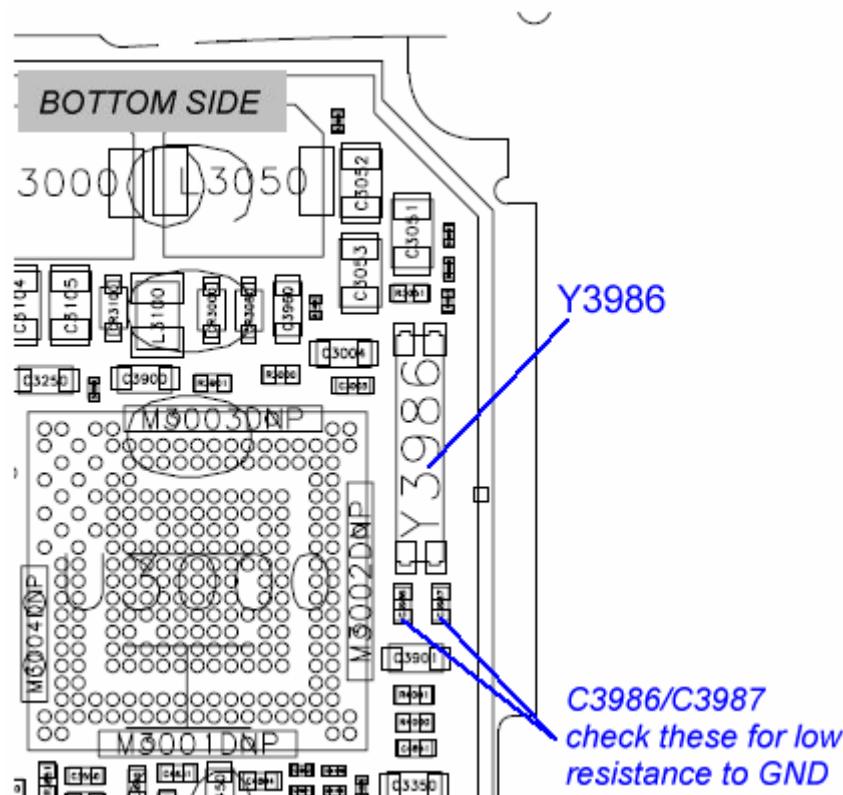
Figure 30

If radio draws no current it's most likely a problem with the 32.768 KHz clock generated by [Y3986](#).

- Change crystal [Y3986](#). (It might be difficult replacing Y3986 without damaging the underfilled ATLAS IC U3000. Wherever possible try using a solder iron instead of the heatgun)
- If unsuccessful change ATLAS IC [U3000](#).

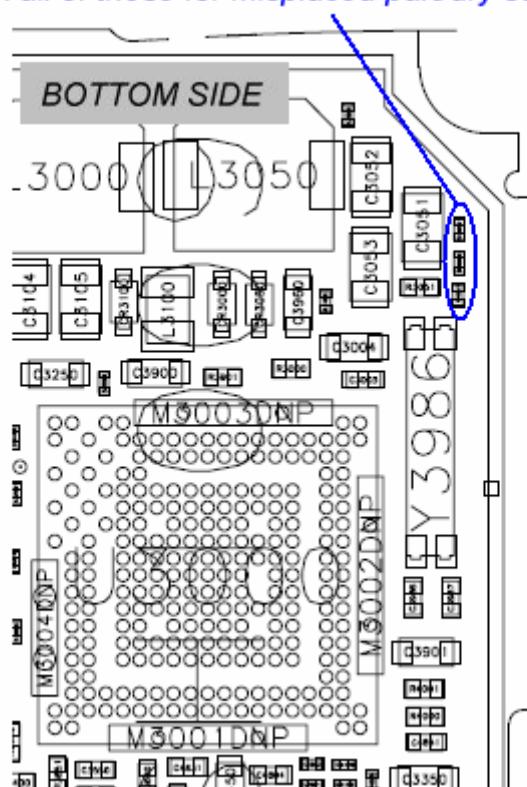
Figure 33

Because the signals which could be measured are not accessible without removing the ATLAS shield [SH1009](#) (which would damage the underfilled ATLAS IC [U3000](#)), it is probably the best way to start with replacing the battery connector [J5400](#). If the trouble remains replace additionally the ATLAS IC [U3000](#).

*check all of these for misplaced part/dry solder shorts*

**For replacement of the battery connector J5400 the air cooling device for protecting the ATLAS IC should be used.**

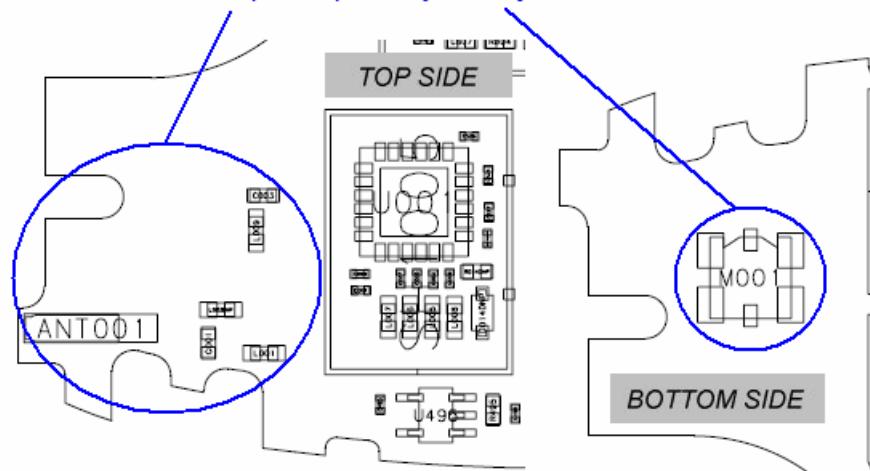
Figure 35

Check the connection to the antenna to ensure it is properly plugged. Prior to remove any shields for measurements, visually inspect the antenna circuit for skewed/misplaced parts.

*check all of these for misplaced parts/dry solder joints*

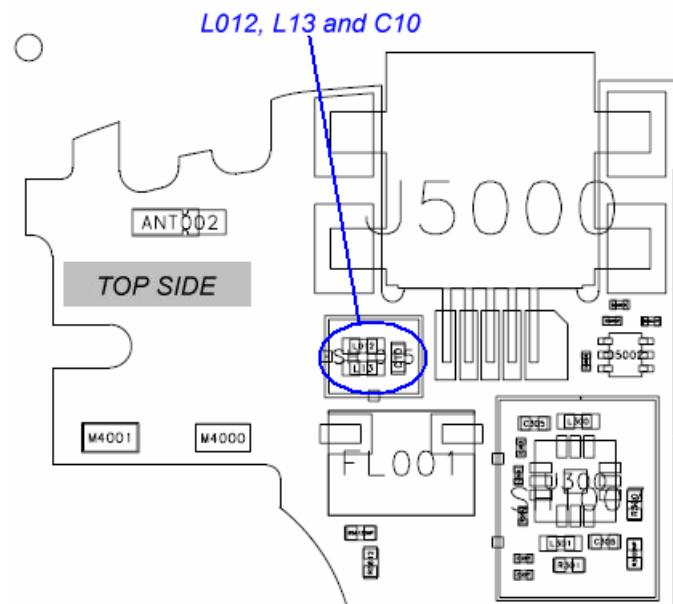
Figure 41

Visually inspect WCDMA diplexer components ([L012](#), [L13](#) and [C10](#))
