Title: Troubleshooting-Guide **C975 / C980**

Doc. No: TSG_C9xx

Date: 23.08.2005

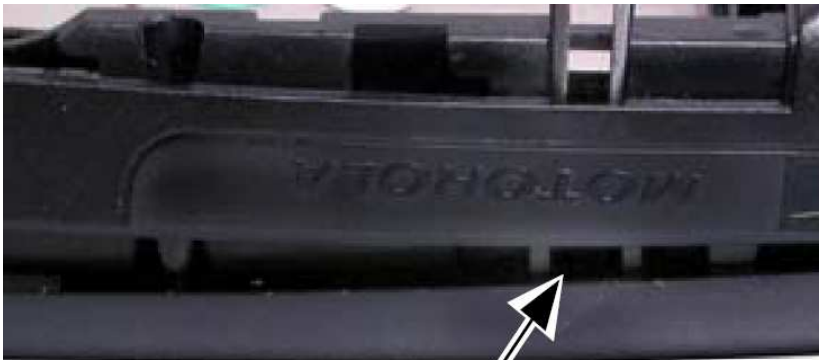
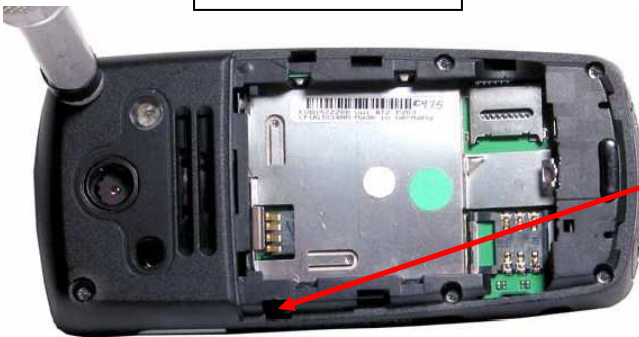
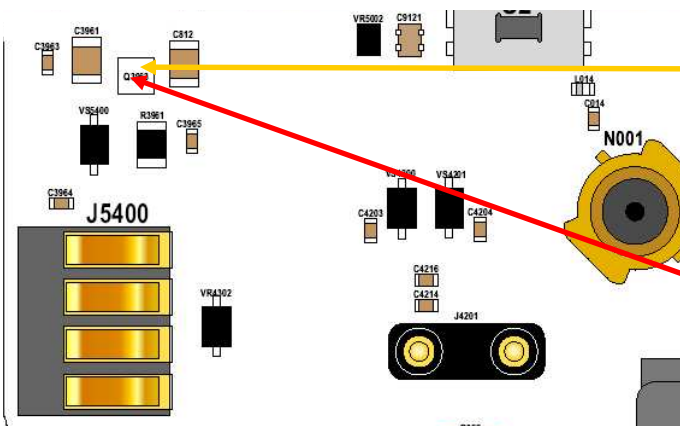
7.0 Defective Part: 1. Q3963

- Q3963 could be damaged during the disassembly process
- Q3963 is placed near the rear housing latches

Attention :
Place work be careful
in this area

**Part Q3963 could be
damaged during the
disassembly process**

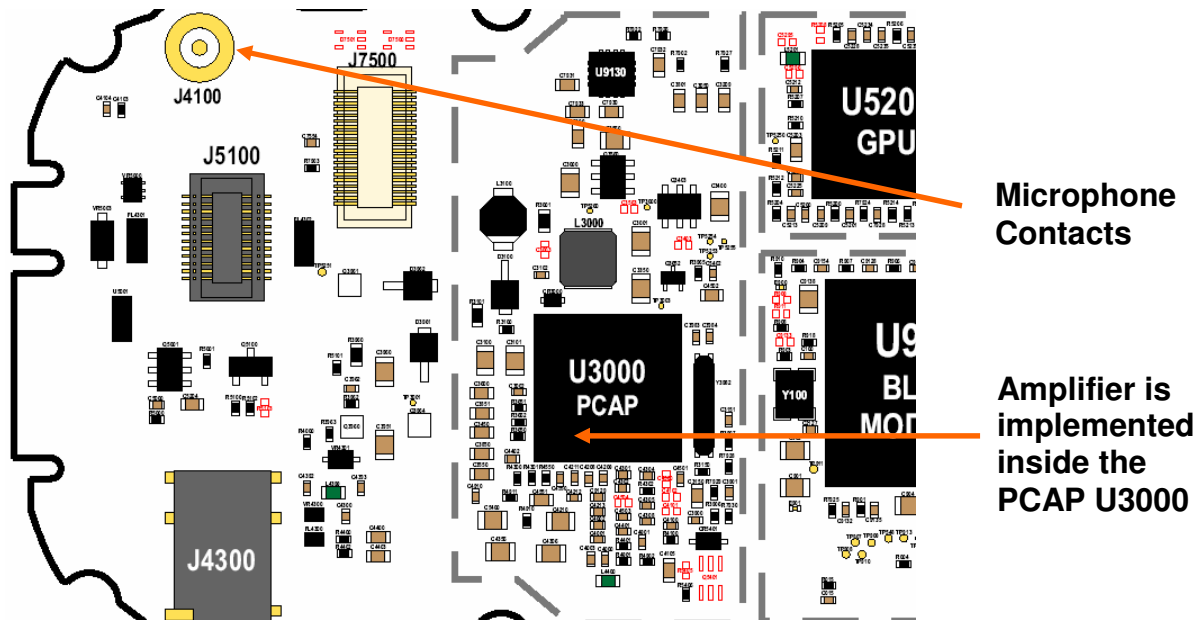
7.1 Defective Part: Microphone (Level 2)

**Fault code from customer: AUD07 (Audio-Mic, No)
AUD12 (Audio-Mic, Noisy at Unknown Cond)
AUD13 (Audio-Mic, Noisy at strong signal)**

Crackling mic audio, no microphone audio or intermittent microphone audio

1. Check audio loop (**AUD12/AUD13**)
 - crackling microphone audio or intermittent microphone audio
 - check if Mic contact are in good condition
 - clean microphone contacts
2. Check audio loop (**AUD07**)
 - no microphone audio or intermittent microphone audio
 - change microphone

**Distortion on alert audio, crackling audio or no audio.
Take new microphone, speaker and alert. Ensure good connection.
Please refer to "Defective Part U3000"**

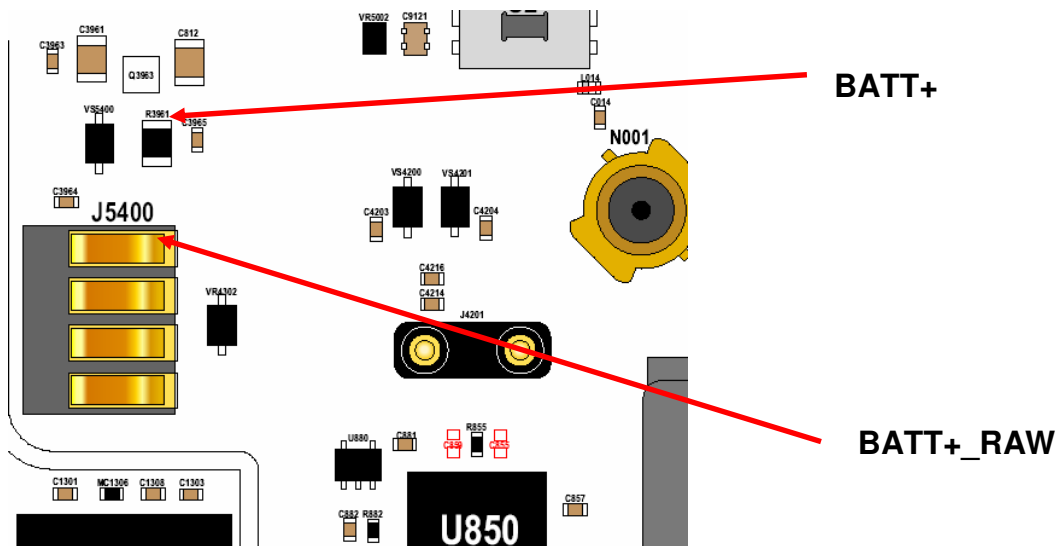
7.2 Defective Part: U850 (Level 3)

**Fault code from customer: TON01 (Turn on/off - No Turn On)
CHG01 (Charging - Does Not Charge)
BAT02 (Battery – Battery life short)**

1. Check BATT+ _RAW (PIN 4 from J5400 Battery Connector)
 - if you can measure a short to Ground disassembly the phone
 - phone draws high current (2 A) BATT+ to Ground
2. Check BATT+ on R3961
 - if you can measure a short to Ground...
 - remove SH1 (Shield from UMTS-PA U850)
 - remove U850
3. Check BATT+ on R3961
 - no short to Ground
 - replace U850

4. If you remove U850 and the short to Ground is present
 - change U800
5. Most of the defect PA`s get hot !!
 - change the PA under the warm / hot shield first

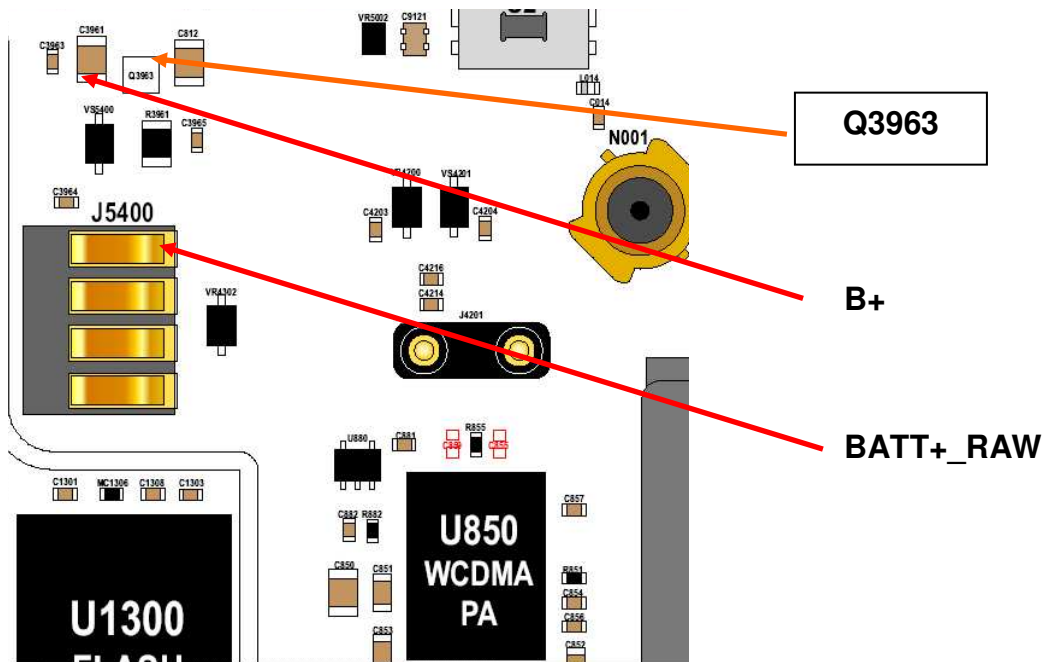
7.3 Defective Part: 2. Q3963 (Level 3)

Fault code from customer: TON01 (Turn on/off - No Turn On)

1. No power on with battery
 - phone turn on with USB-Cable
 - check Battery
 - check Battery Connector J5400 for twisted PIN
 - check BATT+ _RAW (PIN 4 from J5400 Battery Connector) !!
2. Check BATT+ and B+
 - connect Power (4,4 V) to PIN 4 from J5400
 - measure 4,4V on R3961 (BATT +)
 - measure 4,4V on C3961 (B +)
 - if the power(B+) is not present check Q3963
3. Check Q3963
 - visual inspection (broken, missing)
 - Q3963 was often damaged during the disassembly process

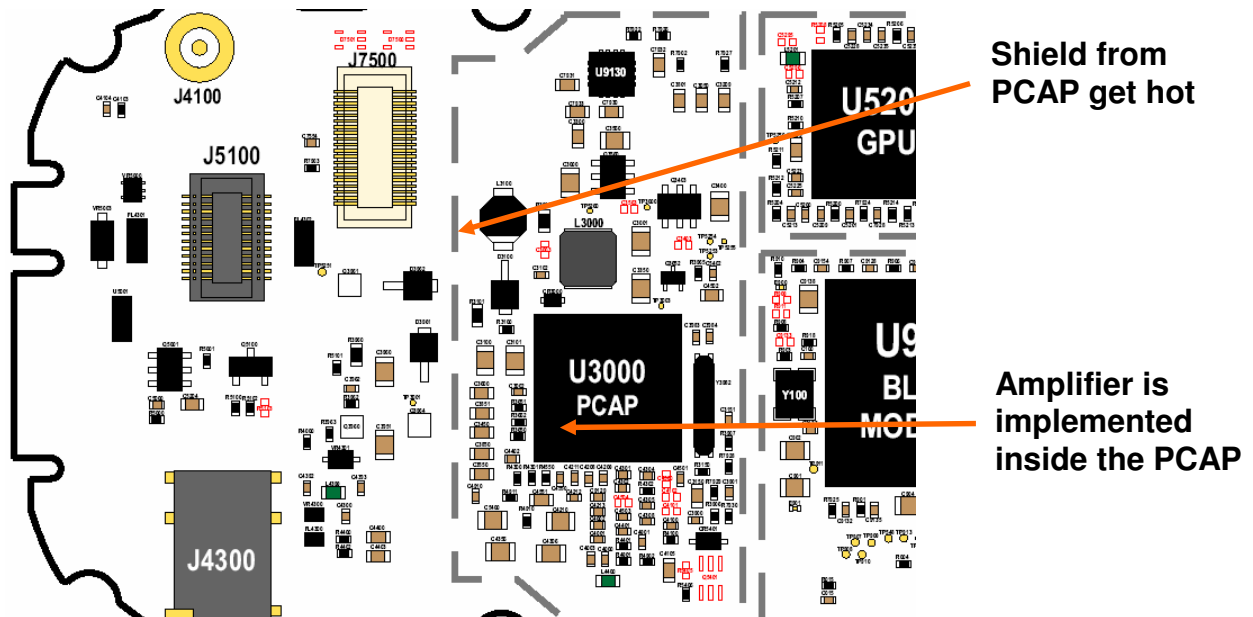
7.4 Defective Part: U3000 (Level 3)

Fault code from customer: **TON01 (Turn on/off - No Turn On)**
AUD00 (Audio- No Detail Provided)

1. Check turn on with USB-CABLE and with battery (**TON01**)
 - with battery PCB took 190 mA
 - with USB-CABLE PCB took first 700 mA and went then up to 900 mA
2. Check U3000 (**TON01**)
 - U3000 area (Shield get warm)
 - replace Shield SH 2
 - turn on with USB-Cable ..U3000 get hot
 - change U3000
3. Distortion on alert audio, crackling audio or no audio (**AUD00**)
 - try with new alert, microphone and speaker. Ensure good connection.
 - amplifier (audio) is implemented in the PCAP
 - change U3000

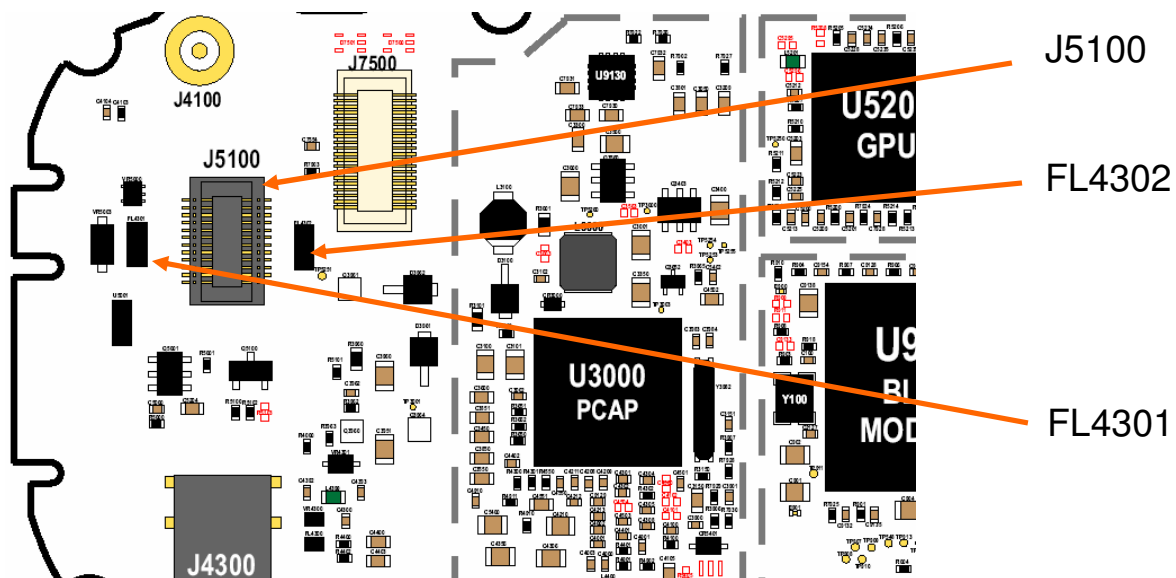
7.5 Defective Part: FL4301 / FL4302 (Level 3)

Fault code from customer: MKP1 (Main Keypad - No function/hangs)

Just some keys have no function, or no keypad function at all

Keys "2" and "7" have no function

- check resistance of keypad lines to Ground -> "KEY8" is open
- line is connected with FL4302
- change FL4302

Keys "2", "up" and "left" have no function

- check resistance of keypad lines to Ground -> "KEY5" is open
- line is connected with FL4301
- change FL4301

- check for short or open keypad lines to Ground
- tried Factory-Flex
- also take a look under "Defective Part" Page 16 and Page 18

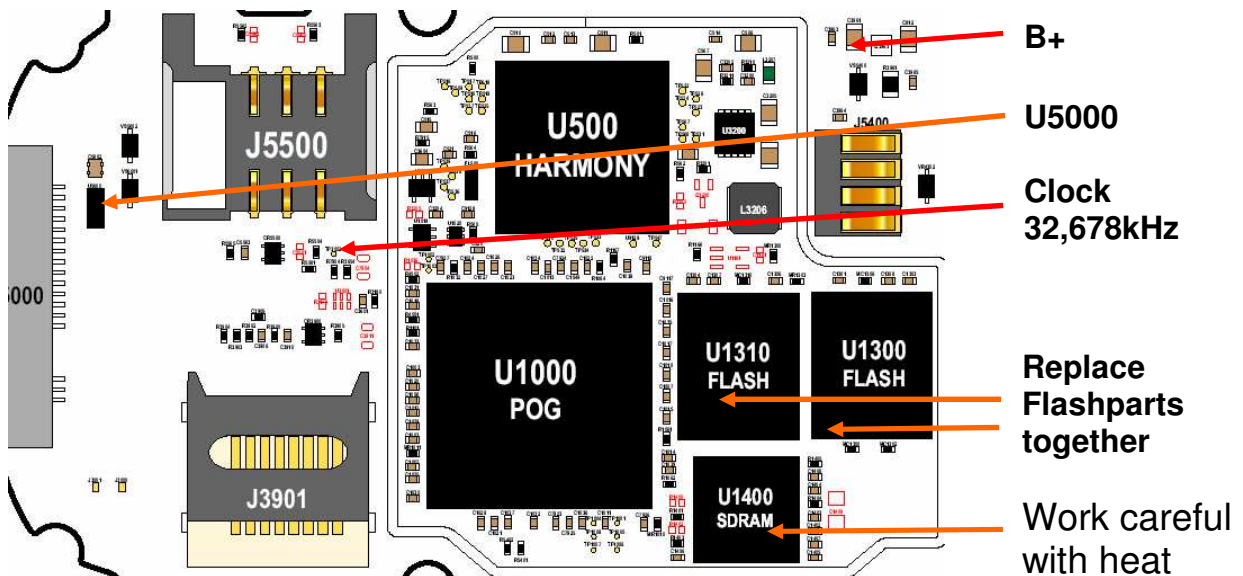
7.6 Defective Part: U1300/U1310 (Level 4)

Fault code from customer: **TON01 (Turn on/off - No Turn On)**
Phone went into FLASH-MODE or phone was not identified !!

3. Connect the Phone with **USB-Cable...Phone went into FLASH-MODE**

If the reflash process was unsuccessful (example: FLASH/RESET faulty)

- replace Shield SH3, U1300 and U1310

- work careful with heat at U1400 (RAM) area

- always change both Flashparts (U1300/U1310) !!

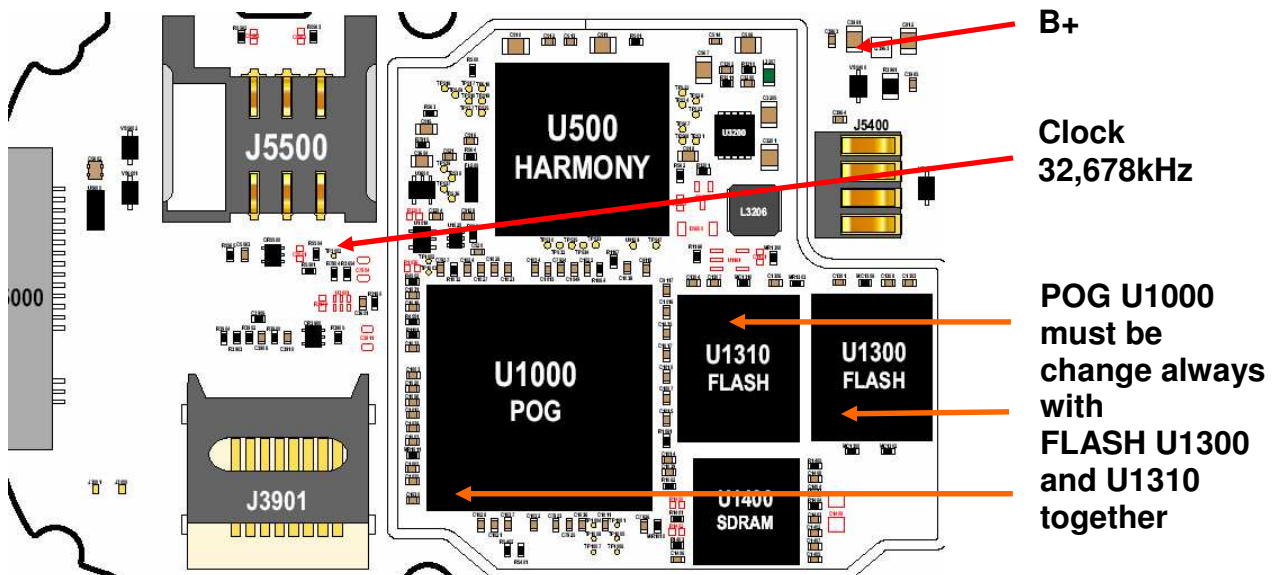
7.7 Defective Part: U1000 (Level 4)

Fault code from customer: **TON01 (Turn on/off - No Turn On)**
MKP1 (Main Keypad - No function/hangs)

Draws 140 mA for 10sec and powers down / No keys are working

Draws 140 mA for 10sec and powers down (TON01)

- connect the phone with FLASH-CABLE...Phone went into FLASH-MODE
- reflash 1FF file
- phone took software but no RESTART or FLASH / RESET failed
- changing U1300 and U1310 was unsuccessful
- change U1000

- visual inspection (FL4301 / FL4302 / J5100/ SW1 / SW2 / SW5 / VR5001 / VR5002)
- check for short or open keypad lines to Ground
- try factory-flex
- place check first "Defective Part" Page 14 and Page 18
- change U1000

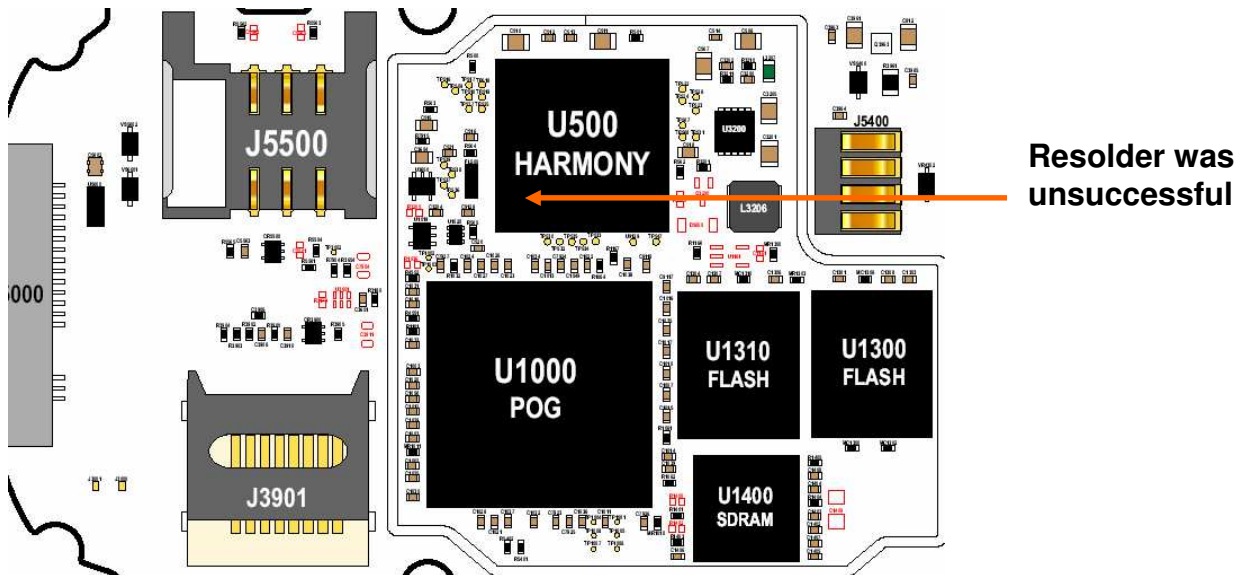
7.8 Defective Part: U500 (Level 3)

Fault code from customer: **CPR00 (Voice Call – No Detail Provided)**

Phone turns on but failed with SUSPEND MODE (Test: WINGATE)

TEST MODE not possible (RepairStudio / RadioComm)

- change U500

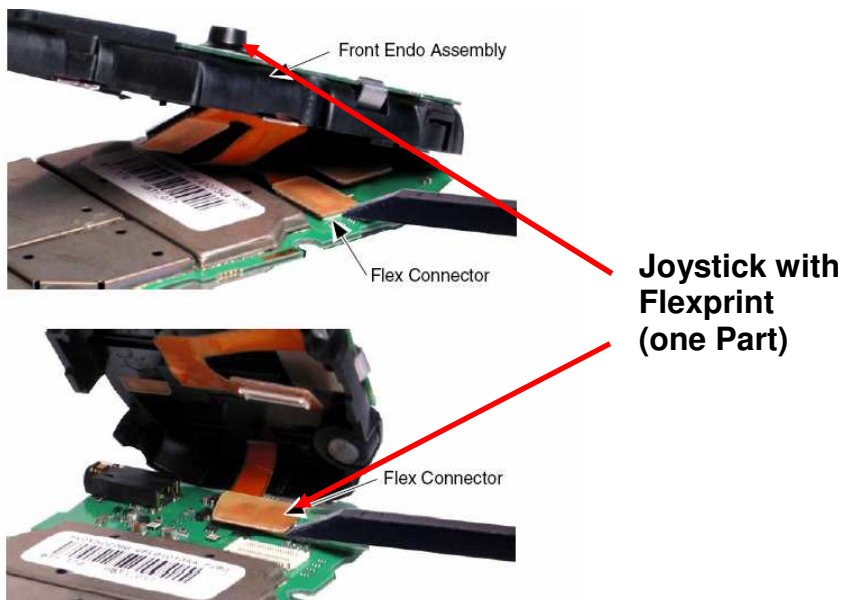
7.9 Defective Part: Joystick (Level 2)

Fault code from customer: MKP1 (Main Keypad - No function/hangs)

Joystick: Left, Right, Up or Down have no function or no Joystick function

- take a new Joystick (Joystick and Flexprint is one Part)

- Joystick faulty again
- look under "Defective Part FL4301 / FL4302" on Page 14
- look under "Defective Part U1000 " on Page 16
