FIELD SERVICE BULLETIN

LVCCFSB2005-121 Darwin Garcia May 5, 2005 2 **MPX220 PCBA Pad Contamination MPX220** 3

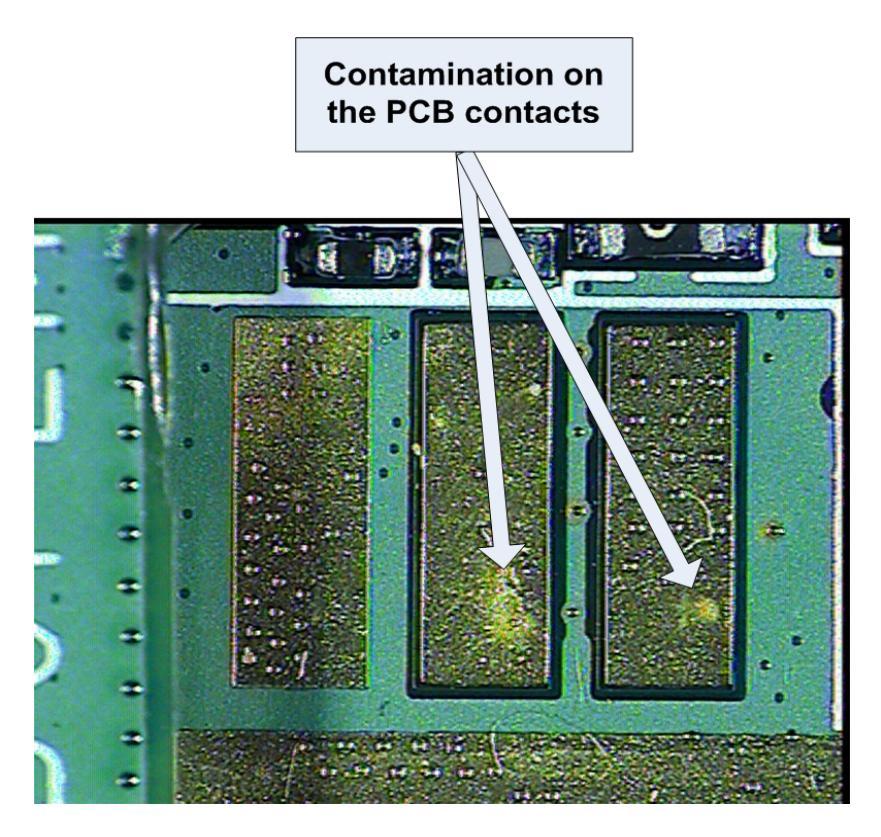
Service has detected a PCBA pad contamination issue during MPX220 NPI process for battery connector. Phones are being returned for "Auto Power Down" complaints. ODM's analysis determined that the battery connector's pad on PCBA have soil which could cause bad connection between battery connector and the pad, this contamination was induced during manual soldering of the Fleming module.

The bad connection would cause high resistance on the path which will then decrease the input VBAT voltage and possibility trigger a power down sequence in standby.

ODM factory to modify assembly SOP in April 2005 to indicate that after soldering of the Fleming, the battery connector's pad on PCBA must be cleaned before assembly.

When servicing any MPX220 customer phones with this issue, repair by cleaning the battery connector's pad on PCBA using standard cleaning procedure. It's recommended to perform this cleaning to all repairs that required disassembly of the rear housing.

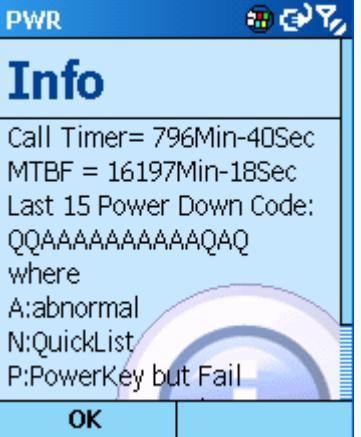
View the PWR history in all power down complaints by pressing *#**797#snd.

Many abnormal code are register in the history indicate possible power down issues.
