Title: Troubleshooting-Guide V3xx

Doc. No: TSG_3G_V3xx

Troubleshooting Guide MotoRAZR V3xx Level 3

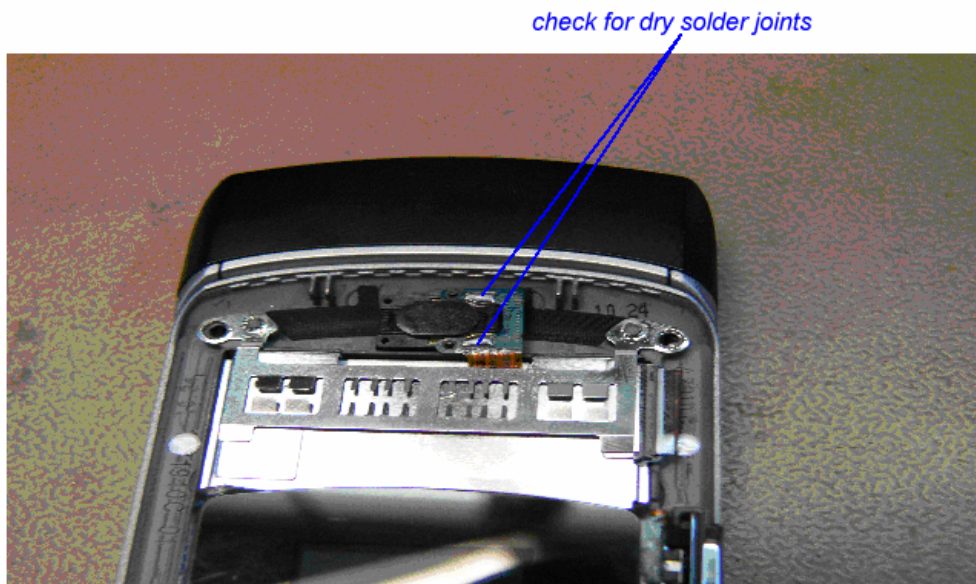
Figure 4

b) Speaker bad soldered/defective

Remove flip cover and visually inspect soldered contacts at speaker. If not ok, resolder speaker. Otherwise replace speaker with a new one.

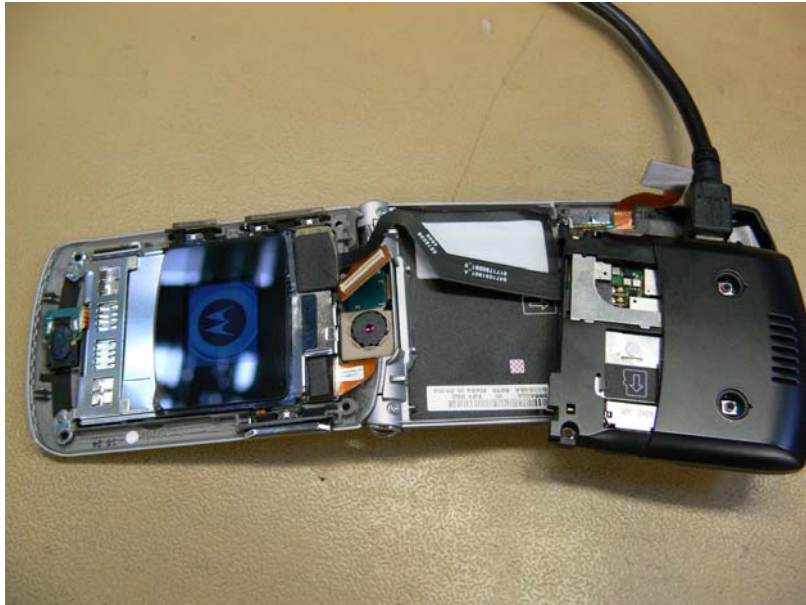
c) Flex assy defective

Remove flip cover. Unseat the display module assembly flex connector from its socket and temporarily connect the display module assembly and transceiver board assembly with a known good flex assy as shown on figure 5. Check speaker function by turning on a 1 kHz test tone via RepairStudio/Radiocomm. If the fault has been cleared, reassemble flip assy with new flex assy.

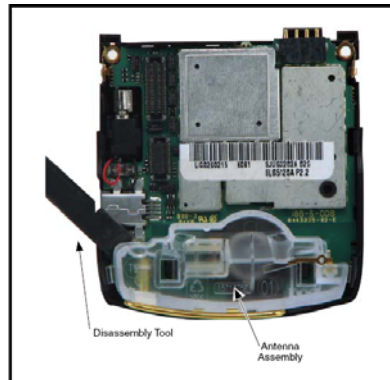
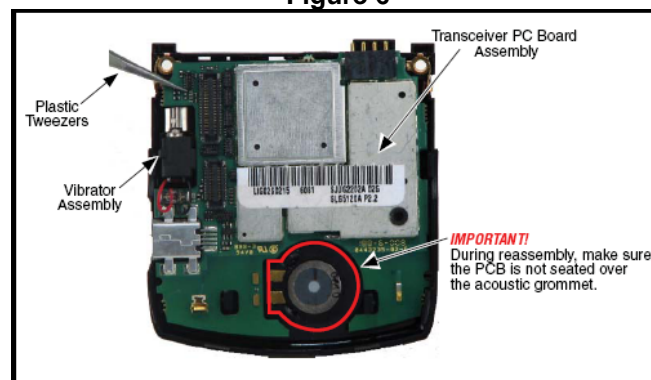
a) Faulty alert speaker

Verification: remove antenna assembly and temporarily replace the alert speaker with a known good one. If the fault has been cleared, reassemble with a new alert speaker.

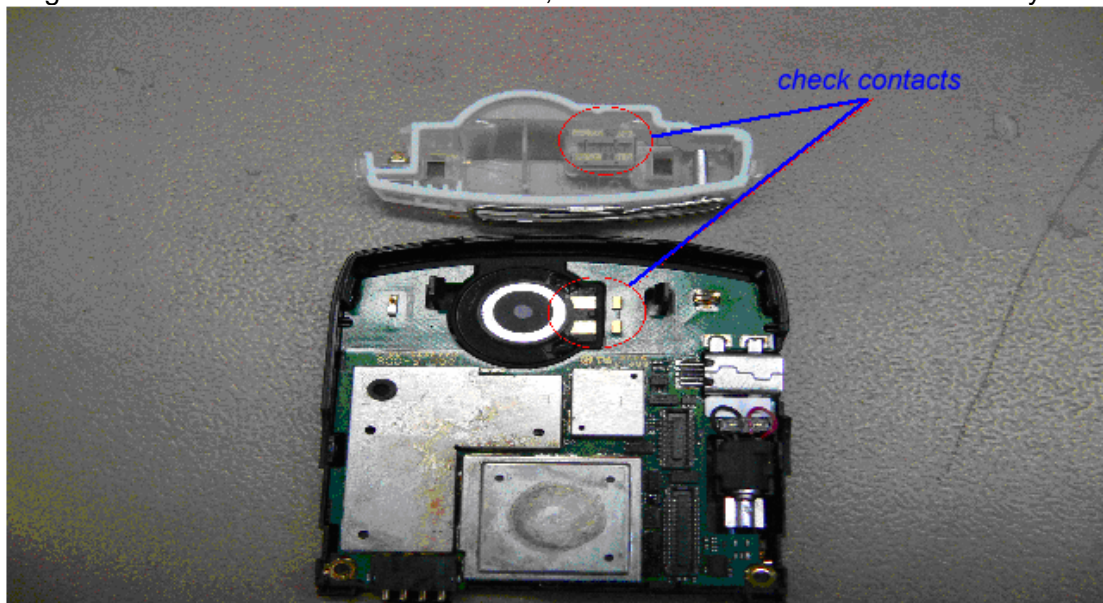
Figure 8

b) Faulty connection transceiver board assembly to alert speaker
Remove antenna assembly and check contacts. Temporarily replace antenna assy with a known good one. If the fault has been cleared, reassemble with a new antenna assy.

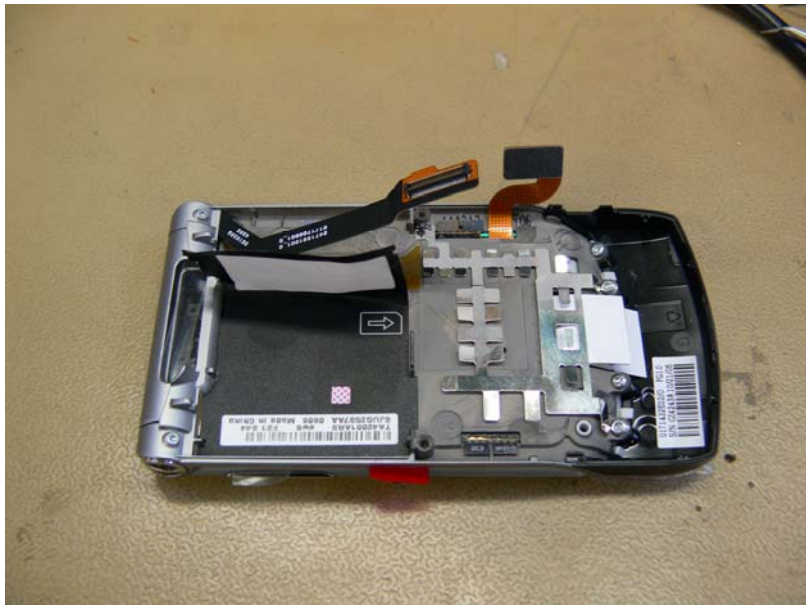
Figure 9

b) Transceiver board connections faulty

Remove rear chassis assembly from unit, check general condition of flexible printed cable (flex assy). If the flex is good, check that the flex connector is fully pressed down.

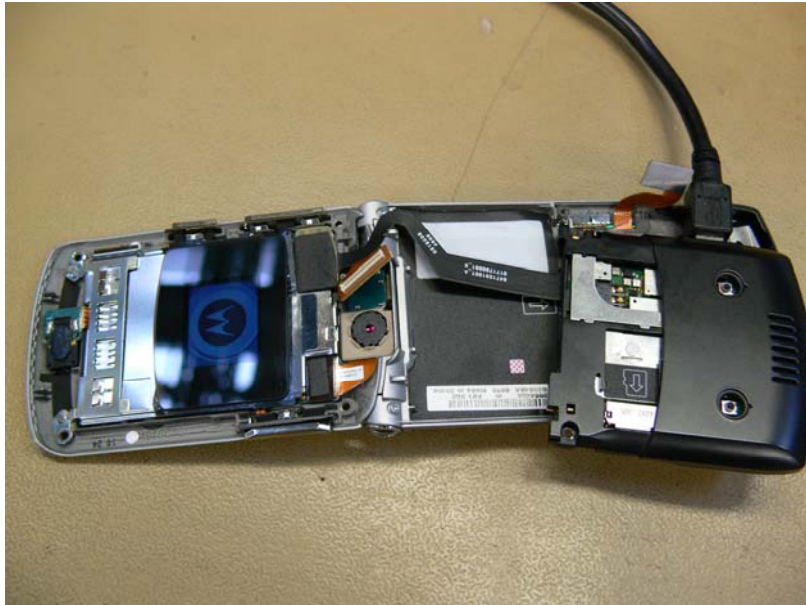
c) Flex assy faulty

Remove flip cover. Unseat the display module assembly flex connector from its socket and temporarily connect the display module assembly and transceiver board assembly with a known good flex assy (see figure 10). If the fault has been cleared, reassemble flip assy with new Flex Assy.

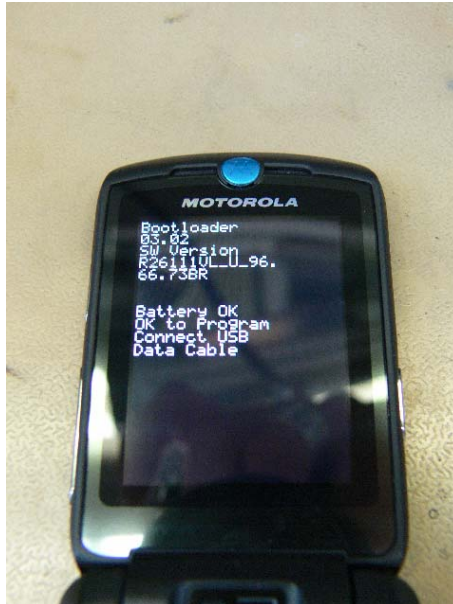
Figure 11

d) Software corrupt

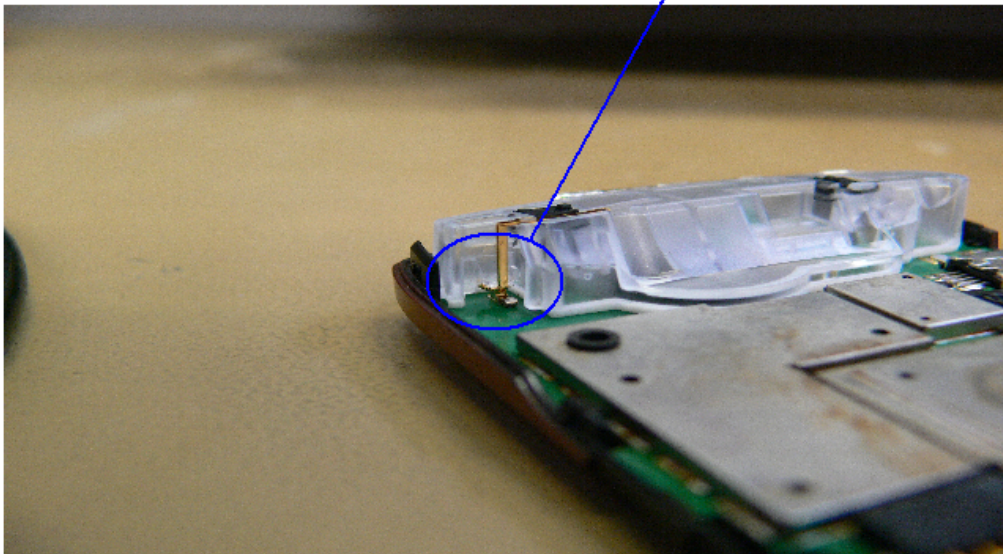
Figure 12

check if WCDMA/Bluetooth antenna is properly connected to antenna contact on pcb

Check to make sure that the antenna pin is properly connected to the transceiver board assembly. If connected properly, substitute a known good antenna. If the fault is still present, proceed to b).

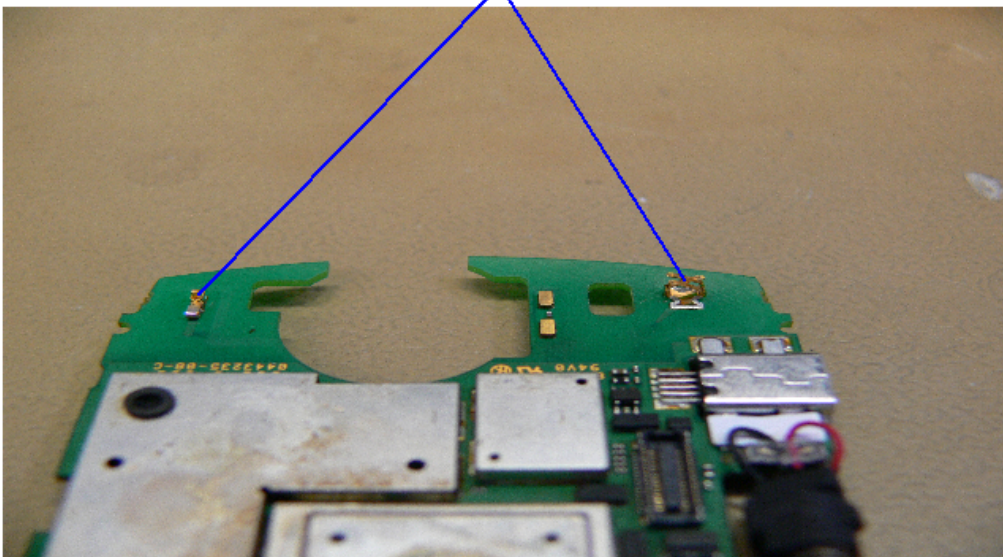
Figure 13

check antenna contacts for any damage

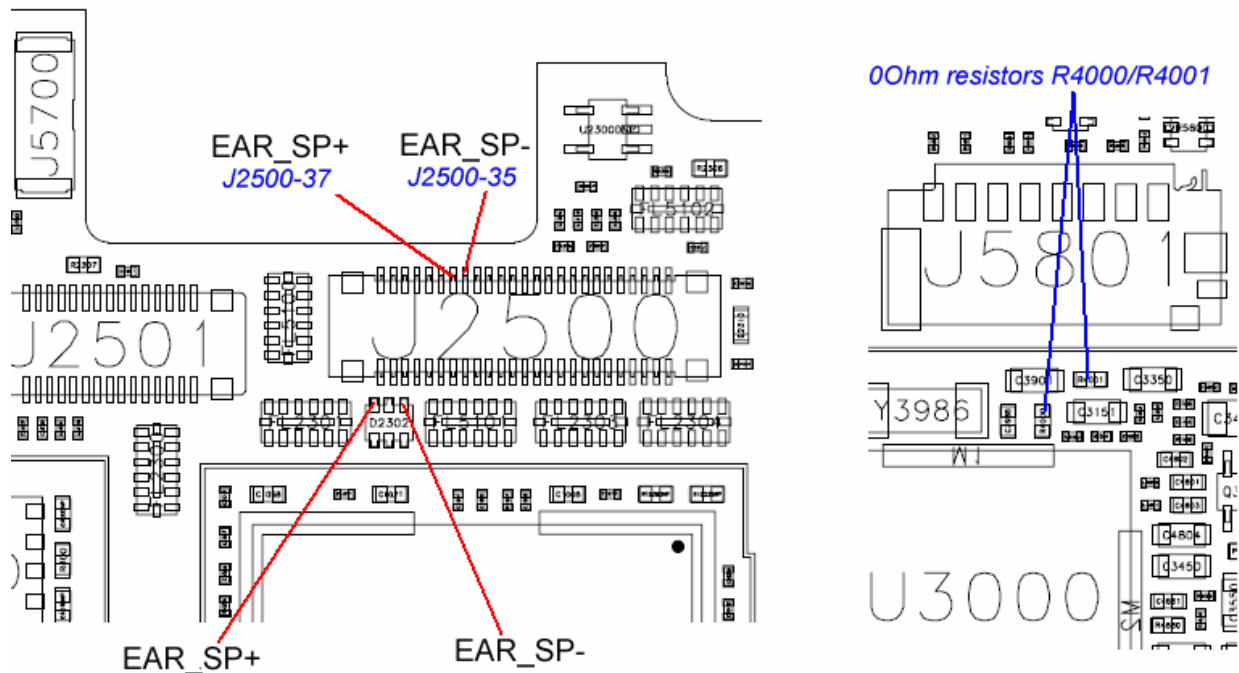
Figure 14

Check [EAR_SP+](#) and [EAR_SP-](#) at [D2302](#), both should have around 1.5Vdc offset voltage, if audio loop is switched on, and additional up to 3Vpp at 1kHz, if test tone is switched on via RepairStudio/Radiocomm.

- if not: check [J2500/D2302](#) and 0Ohm Resistors [R4000/R4001](#)
- if ok, change ATLAS IC [U3000](#)

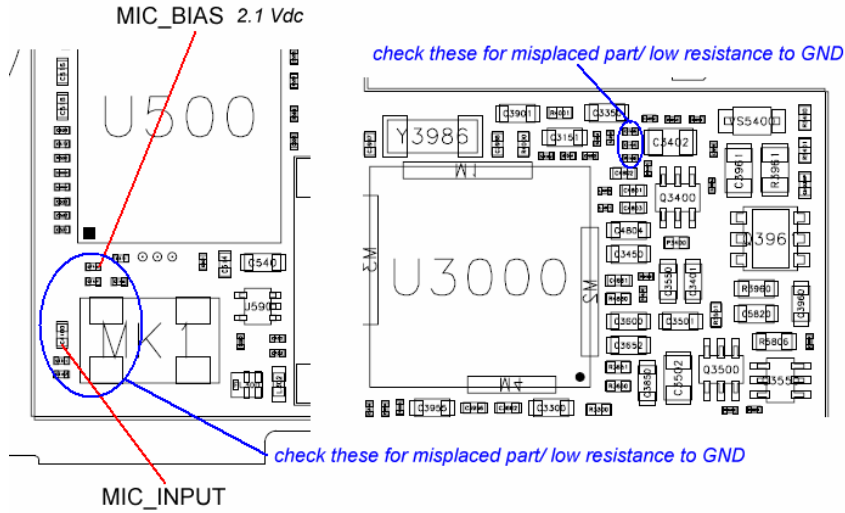
Figure 15

- check Mic BIAS at [C4110](#) – should be around 2.1Vdc
- if not check [C4110/C4106/C4107](#) for low resistance to GND, if they are ok, replace ATLAS IC [U3000](#)
- if ok check MIC_INPUT at [C4100](#) while blowing into the microphone to see the audio signal caused by the blowing
- if there is no audio signal, replace microphone
- If ok, replace ATLAS IC [U3000](#)

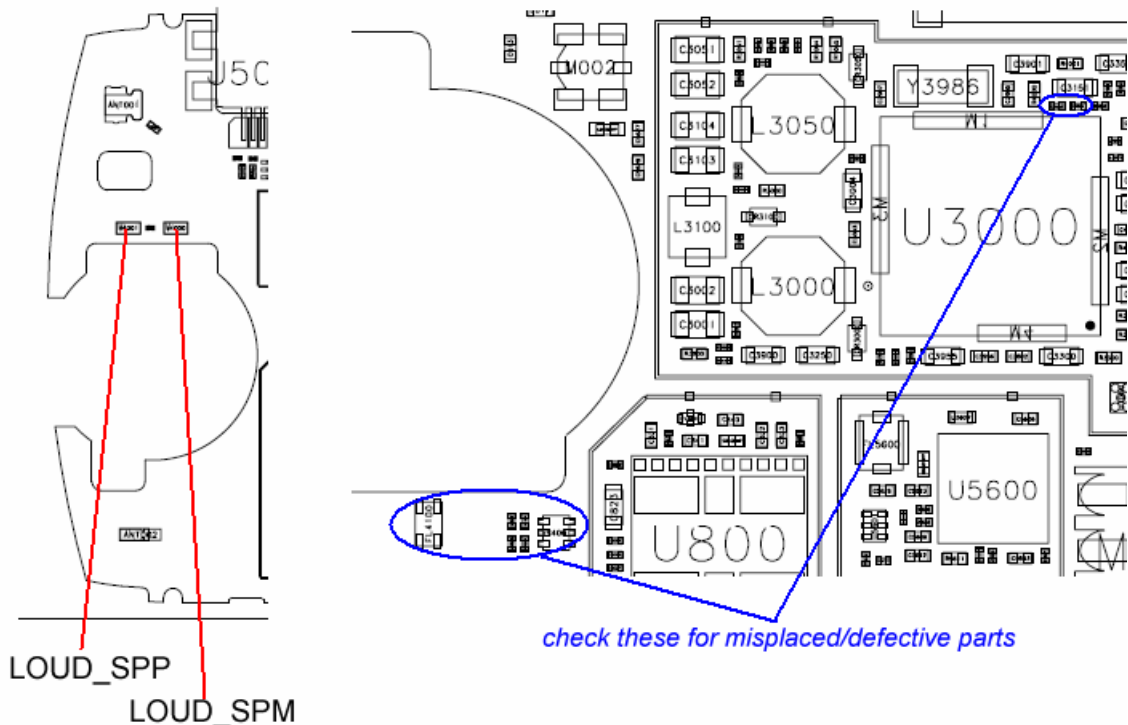
Figure 16

Check LOUD_SPM ([M4000](#)) and LOUD_SPP ([M4001](#)), both should have around 2.2Vdc.

The alert signal is amplified by the ATLAS IC and generated by the ARGON IC, so if the ATLAS alert audio path is ok, there could be a problem with the ARGON not generating the alert signals.

c) if not, check for misplaced/defective parts as shown in *Figure 15*.

d) If ok, change ATLAS IC [U3000](#)

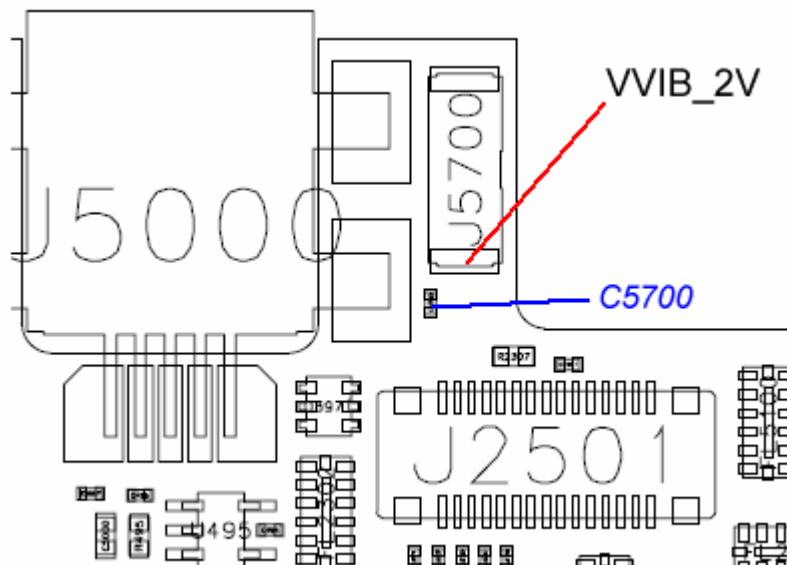
Turn on vibrator using RepairStudio/Radiocomm. Measure [VVIB_2V](#) at [J5700-1](#), should be 2Vdc.

- e) if not check [C5700](#) for low resistance to GND
- f) if ok, change ATLAS IC [U3000](#)

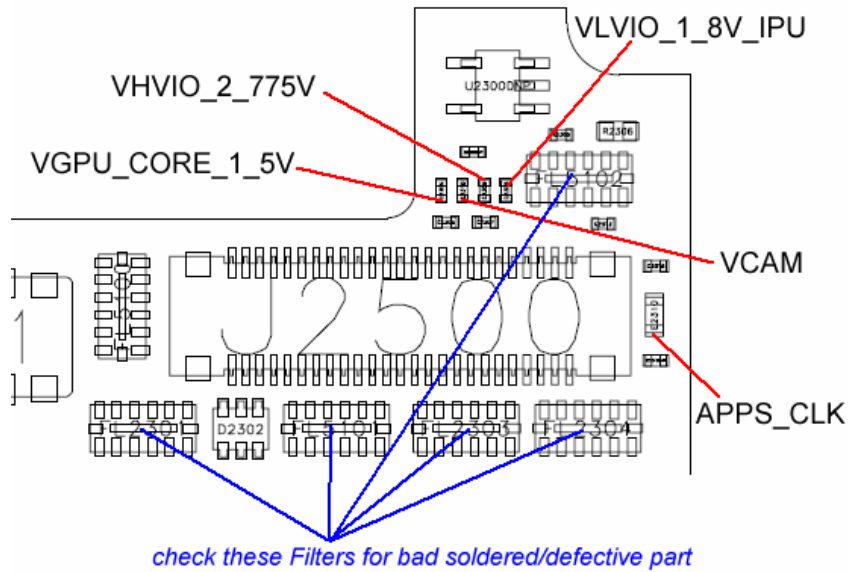
Figure 18

- Filters [FL2301](#), [FL2303](#), [FL2304](#), [FL5101](#), [FL5102](#)

You can check the function of these parts by using an Ohm Meter to check the resistance to GND for verification, which line is affected. By using the FLViewer it can be tracked which filters the signal passes until it reaches the ARGON.

If all of these are ok, it should most likely be a problem with the ARGON – forward to an authorized level 4 service center.

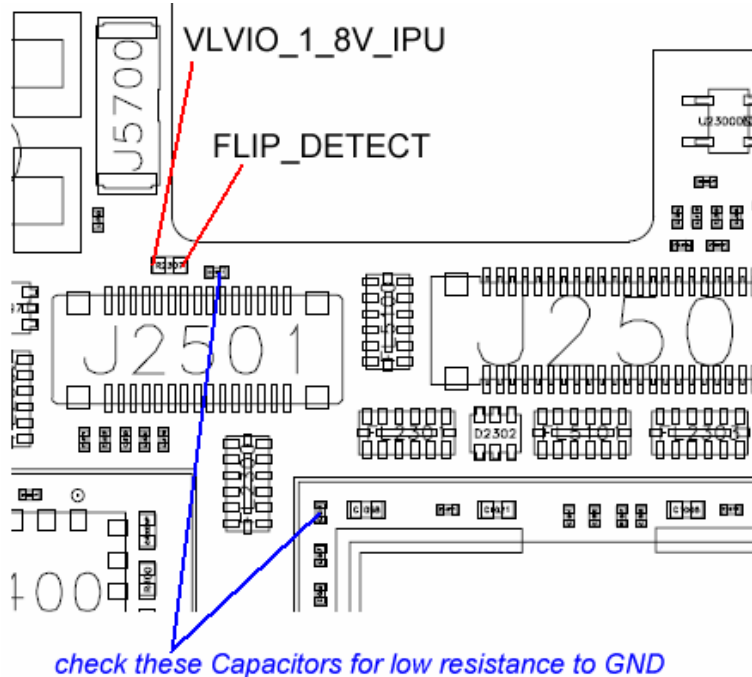
Figure 19

Check [FLIP_DETECT_C](#) at [R2307-2](#) – should be 1.8Vdc (High), if it is low check

- [VLvio_1_8V_IPU](#) at [R2307-1](#) , if 1.8Vdc are present check [C2311/C2314](#) for low resistance to GND, if ok it is most likely a problem with the Argon – forward to an authorized level 4 service center.

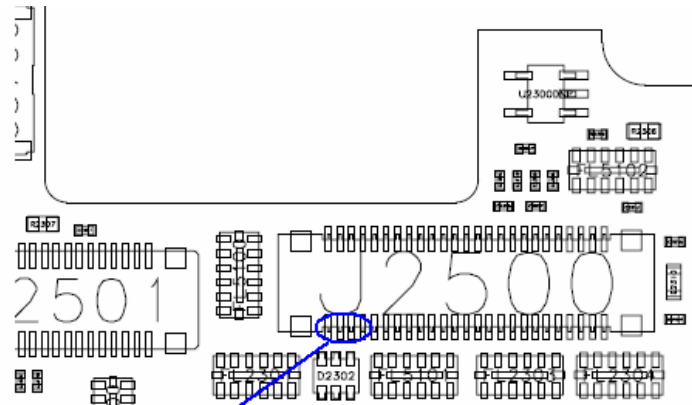
- make sure the fault is not in the flip assembly itself by testing pcb with a known good flip assembly
- check [J2500](#) for solder shorts/dry solder joints/damage
- if ok, change ATLAS IC

check J2500 for solder shorts/dry solder joints/damage

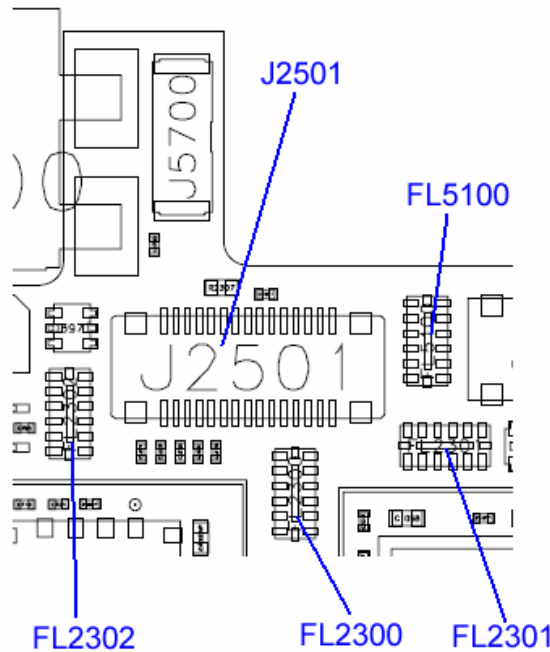
Figure 21

- [J2501](#)
- [FL2300](#)
- [FL2301](#)
- [FL2302](#)
- [FL5100](#) for solder shorts/bad soldered/defective part

check all of these for solder shorts/ bad soldered/defective part

If the keypad connector/filters are ok it's probably a problem with the ARGON – forward to an authorized level 4 service center.

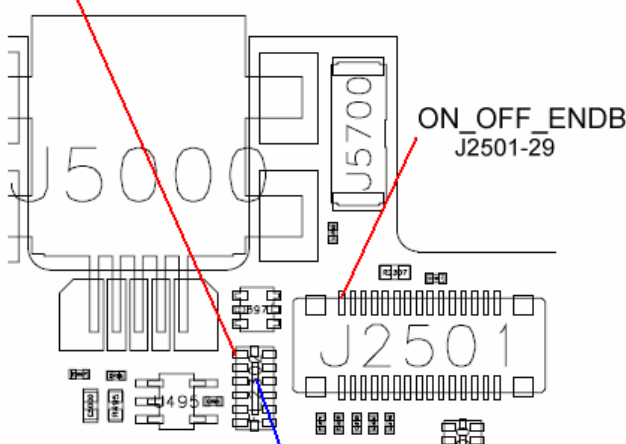
- If signal is at High Level and not switching down when On/Off Button is pressed check J2501 and FL2302
- If signal is always at Low Level or Down (below 2.8Vdc) check C3990/R3993. If they are ok it is most likely a problem with the ATLAS IC, change U3000.

check for bad soldered/defective part

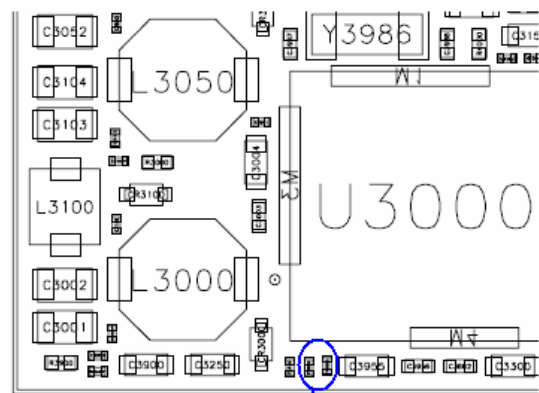
Figure 22

check these for tombstoned/misplaced parts

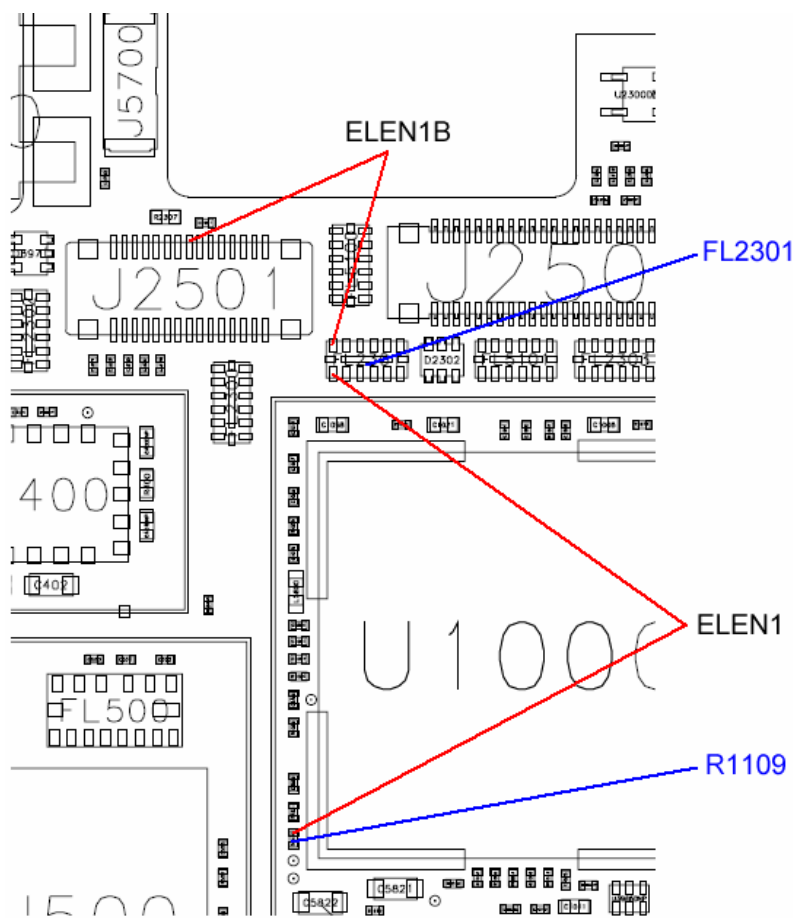
**Figure 23**

Turn on keypad backlight via RepairStudio/Radiocomm. Check [ELEN1B](#)

- If High check [J2501](#)
- If Low check [ELEN1](#).
- If ELEN1 is High (2.8Vdc) change [FL2301](#)
- If ELEN1 is Low it is most likely a problem with the ARGON – forward to an authorized level 4 service center.

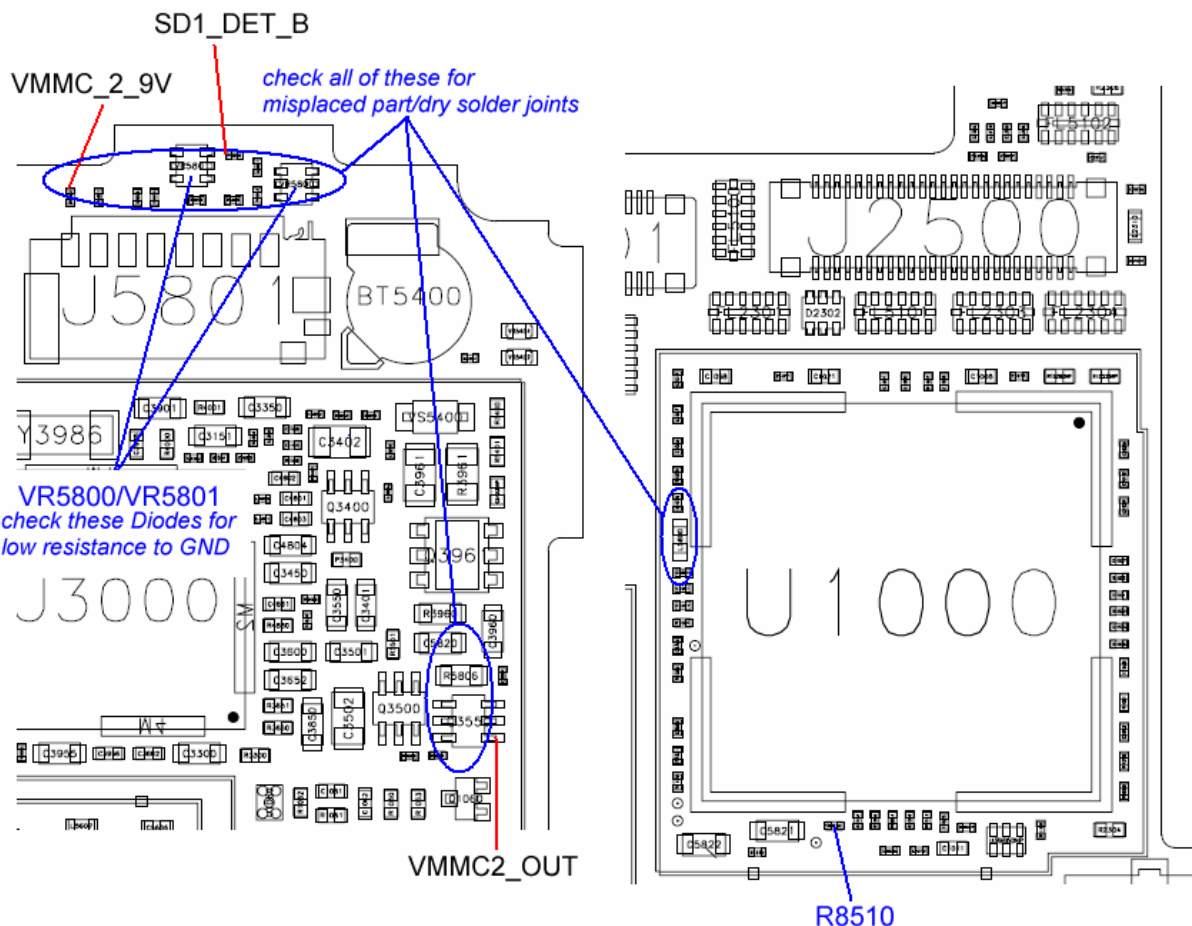
Figure 25

If [SD1_DET_B](#) without TransFlash card inserted is ok (High/1.9Vdc), but is not switching down to 0V with inserted TransFlash card, change TransFlash Connector [J5801](#).

Check [VMMC_2_9V](#) at [R5802](#) (2.9Vdc). If low, check [Q3550/VR5800/VR5801](#) for internal shorts to GND. If ok, change ATLAS IC [U3000](#).

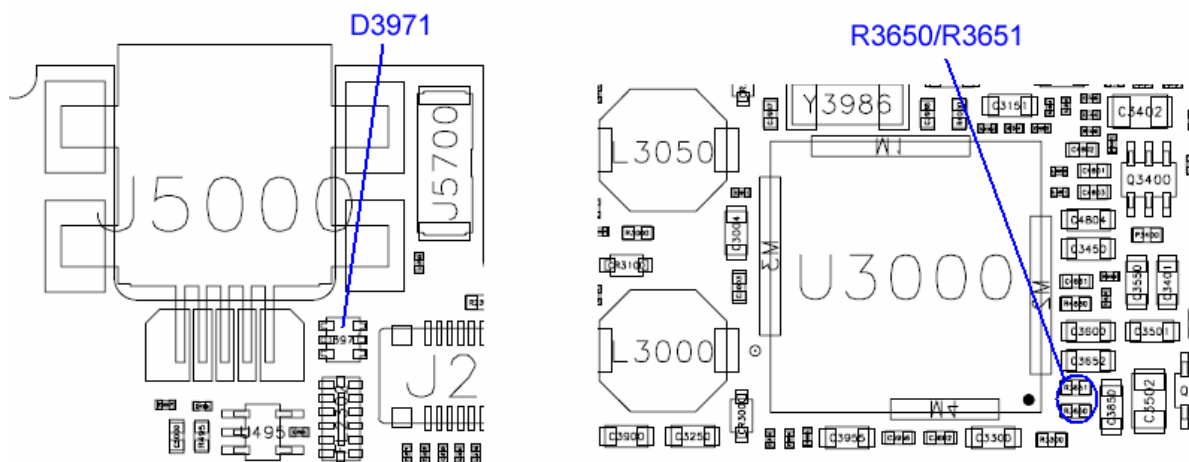
**Figure 26**

- If not, visually check EMU Connector [J5000](#) for mechanical defects or contamination on contacts, bad soldered pins or solder shorts
- Check [D3971](#), [R3650/R3651](#) (22 Ohm)
- If ok, change ATLAS IC ([U3000](#))

If the problem remains, it could be a problem with the ARGON IC – forward to an authorized level 4 service center.

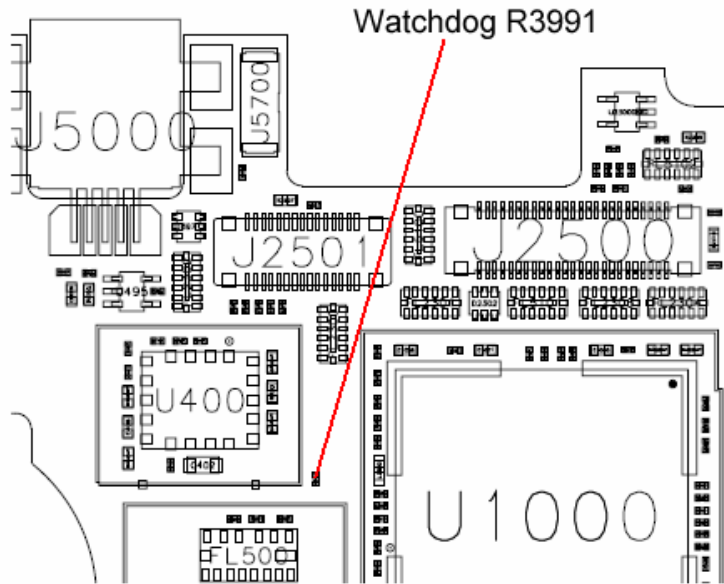
Figure 27

In case the phone draws current but switches off after a few seconds, you can force the phone not to switch off, by setting the [Watchdog R3991DNP](#). By placing a short resistor as R3991, or by just solder across the pads of R3991 the WATCHDOG signal will be pulled to HIGH level (VIOL0_REG_1_8V) and the ATLAS IC will not switch off its power regulators. Thereby you will be able to measure or to do a thermal troubleshooting using a coolant spray as described in the [Battery life short/charging problems/no turn on due to excessive current drain](#) section of this document.

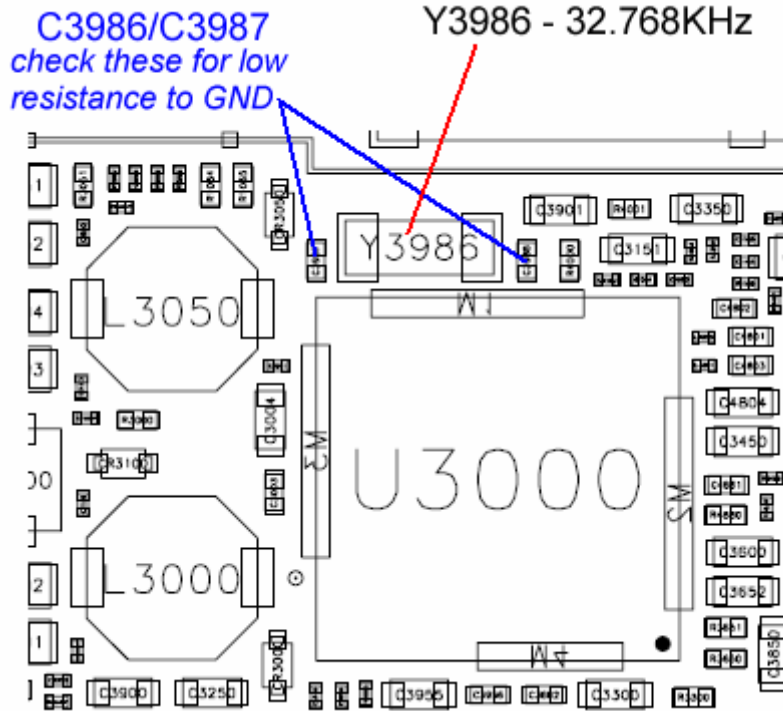
Figure 28

If radio draws no current it's most likely a problem with the 32.768 KHz clock generated by [Y3986](#).

- change Crystal [Y3986](#)
- if unsuccessful change ATLAS IC ([U3000](#))

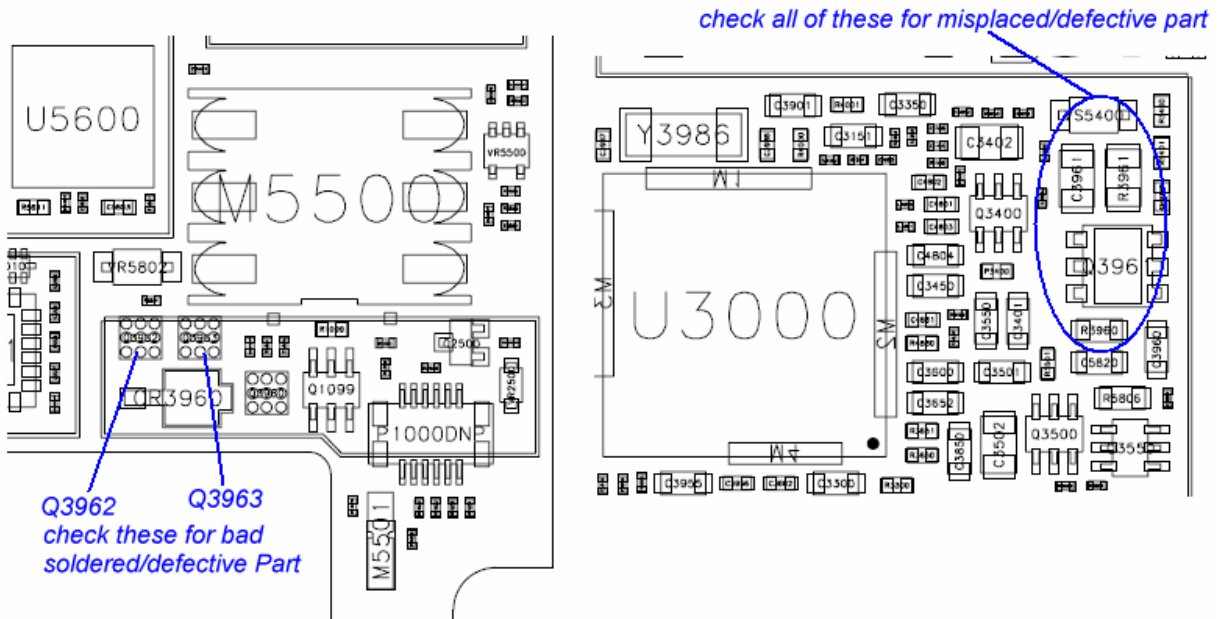
Figure 31

If there is no off current, check the whole path for the charging current. Make a battery/charger phasing to see, if only the charger current or also the battery-phasing is affected. For a charger current problem only:

- Check the whole charger path for misplaced parts/solder shorts/defective parts
- **If ok** replace ATLAS IC [U3000](#)

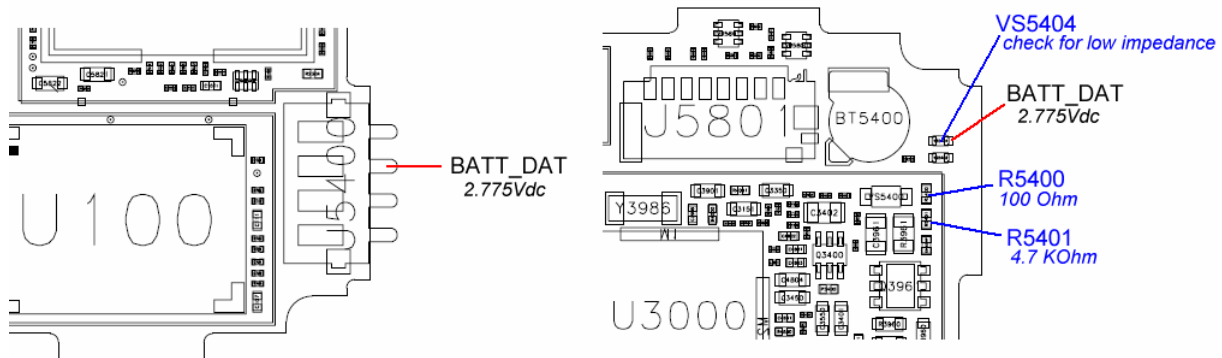
Figure 32

Verify [BATT_DAT \(J5400-2\)](#) while PCB is connected to EMU-USB cable. It should be 2.775V.

- If it is low, check [BATT_DAT](#) at Diode [VS5404-1](#). If 2.775Vdc are present here, it is most likely a problem with broken solder connection/bad soldering at [J5400](#)
- check [VS5404](#), [R5400](#) (100 Ohm) and [R5401](#) (4k7 Ohm). If they are ok it should be a problem with the ARGON [U1000](#) – forward to an authorized level 4 service center.

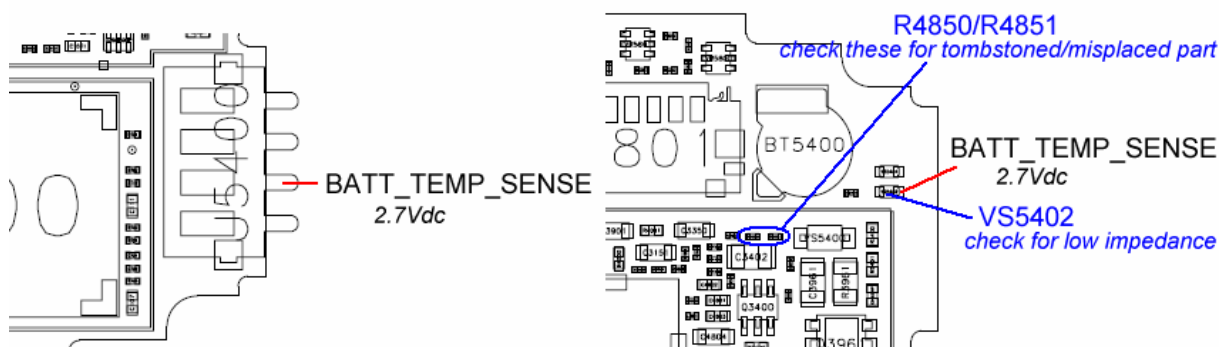
Figure 33

Check [BATT_TEMP_SENSE](#) at [J5400-3](#), it should be 2.7Vdc.

- If it is not check [BATT_TEMP_SENSE](#) at [VS5402](#). If 2.7Vdc are present here, it is most likely a problem with broken solder connection/bad soldering at [J5400](#)
- Check [R4850/R4851](#) for tombstoned/misplaced part. If they are ok it should be a problem with the ATLAS IC.

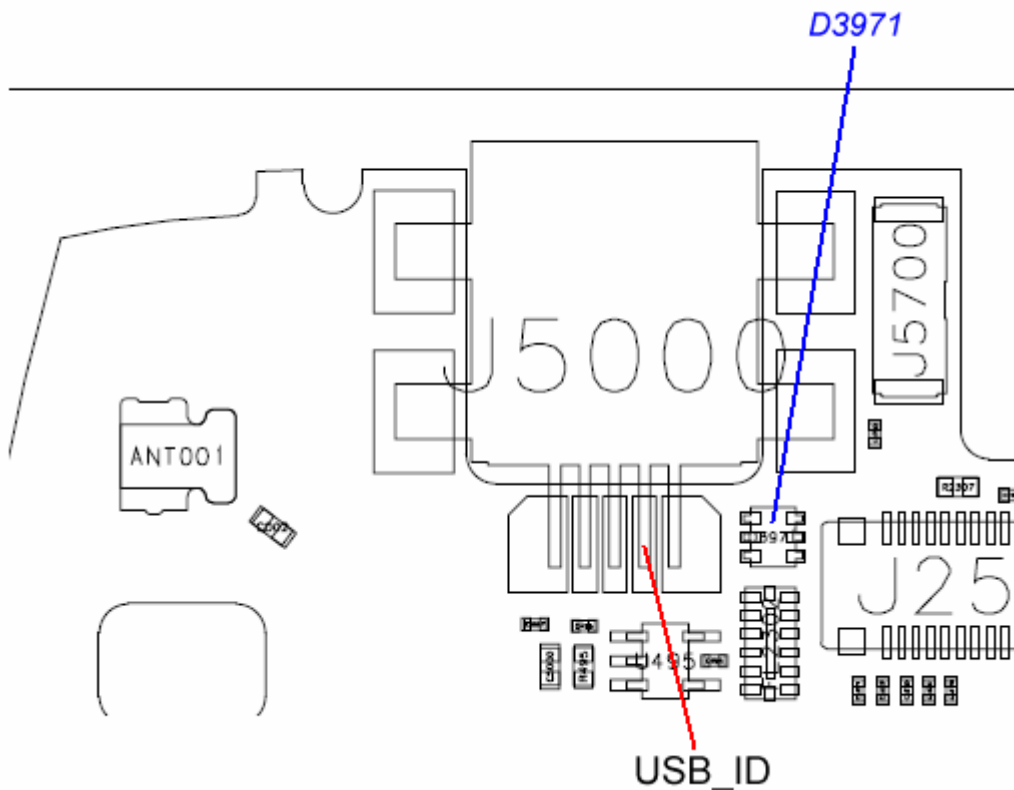
Some phones do not detect connected accessories (Charger/Headset). Those phones will turn on if connected to a charger (instead of entering charging mode). If so

- check [USB_ID \(J5000-4\)](#) to GND with an ohmmeter
 - if less than 1M Ω [D3971](#) should be removed
 - if still less than 1M Ω it should be because of a defective ATLAS IC, change [U3000](#)
- A new Diode Array [D3971](#) has to be placed after successful repair.

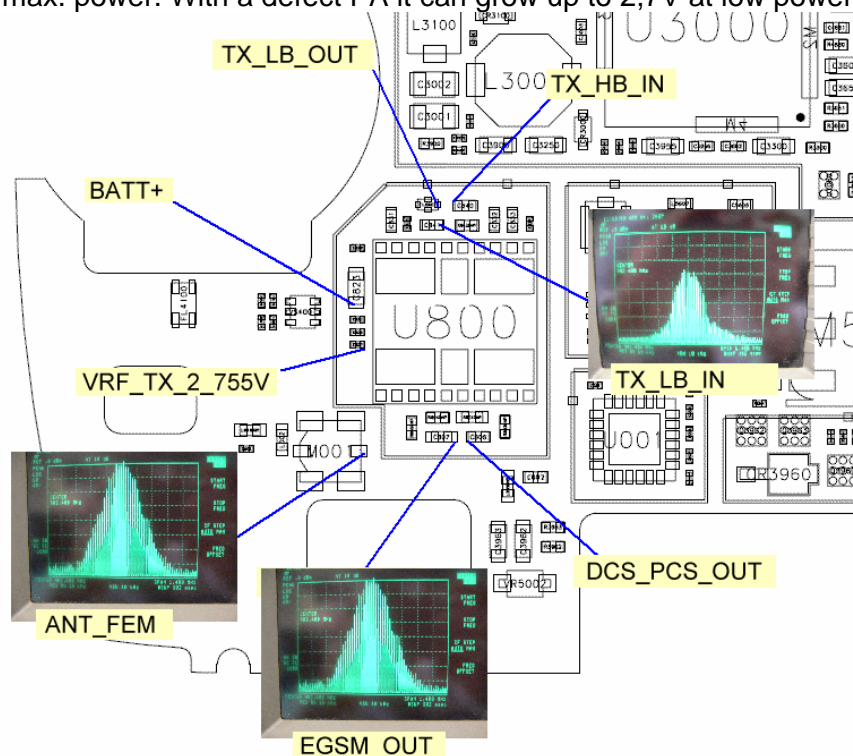
**Figure 35**

- If ok in size and form (if unsure compare to good radio) change FEM [U001](#)
- Check [TX_LB_IN](#) – if missing check additionally [TX_LB_OUT](#), if TX_LB_OUT is present replace/resolder [FL5601](#), if TX_LB_OUT is missing check [TransAAM](#) /[ARGON](#)

- [VRAMP](#) at [C534](#) (pulsed at 217 Hz from SYMPHONY [U100](#)) is proportional to the expected amplification of the PA. Normal values are about 750mV at low power and 2,1V at max. power. With a defect PA it can grow up to 2,7V at low power!

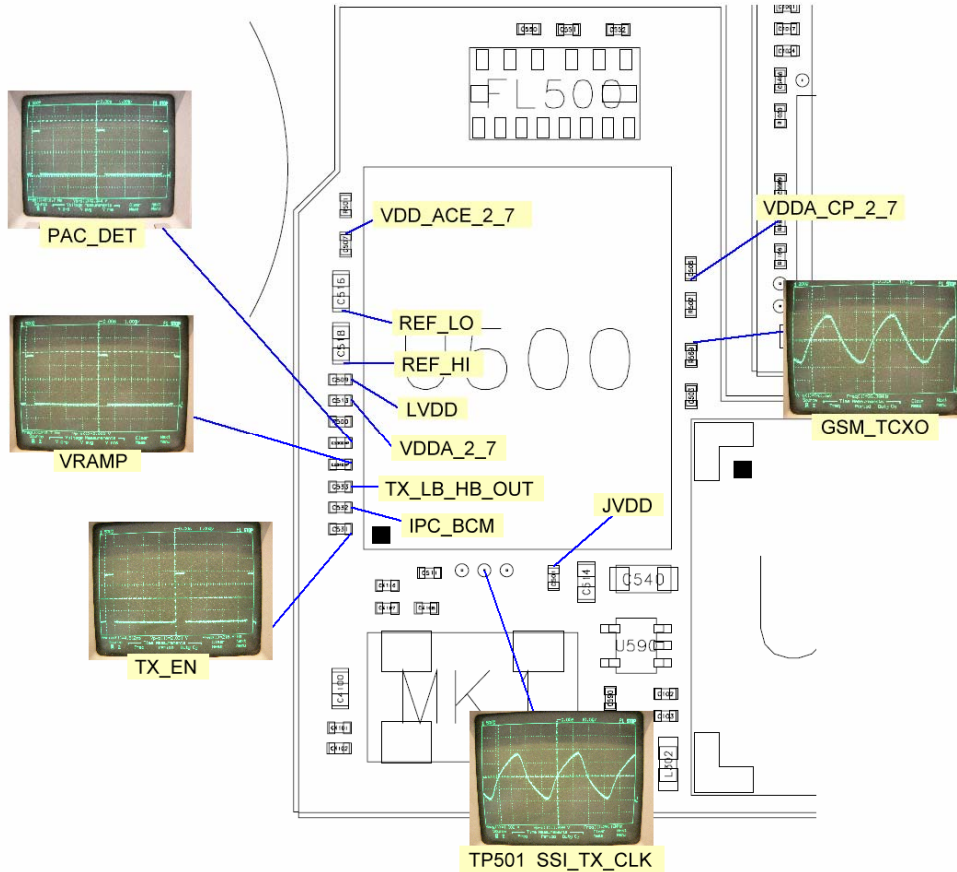
Figure 36

- [PAC_DET](#) at [C530](#)
- [IPC_BCM](#) at [C532](#)
- [TX_LB_HB_OUT](#) at [C533](#)

If [VRF_TX_2.775V](#) is missing or low, it's probably not correctly generated by the ATLAS IC or is being pulled down by a defective part which most probably will get warm – and can easily be found by a thermal troubleshooting as described in the [Battery life short/charging problems/no turn on due to excessive current drain](#) section of this document.

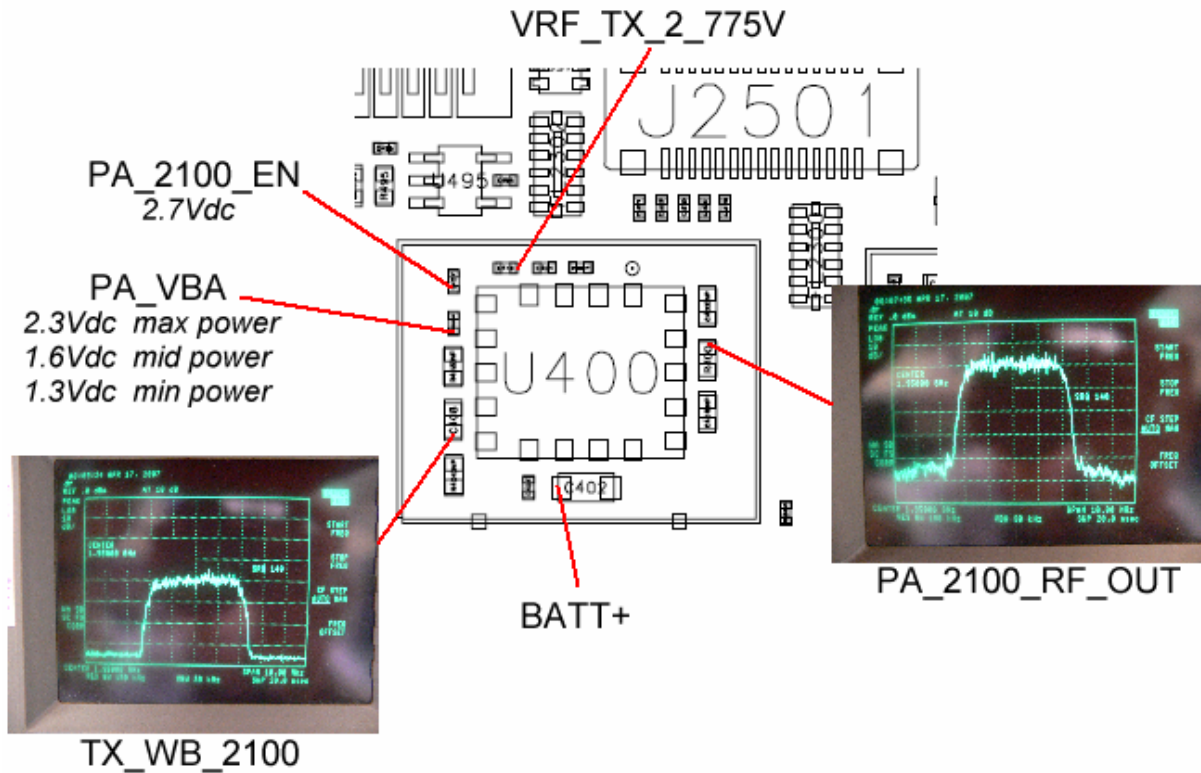
**Figure 37**

- Check PA output [PA2100_RF_OUT](#) at [R400](#) – if ok in size and form (if unsure compare to good radio) check replace FEM [U001](#)

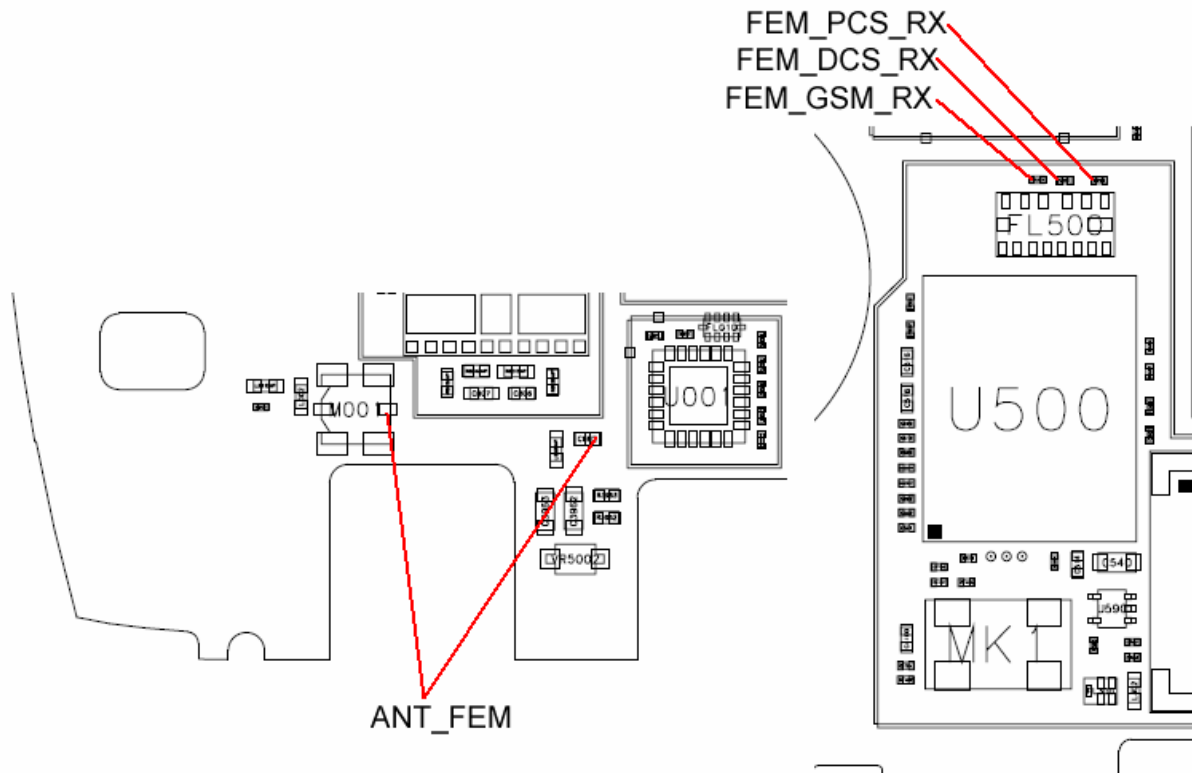
- If not ok check PA input [TX_WB_2100](#) at [C408](#)
- If PA input is good, check supply voltages [VRF_TX_2_775V](#) at [C410](#) and BATT+ at [C402](#), [PA_2100_EN](#) at [C407](#) about 2.7Vdc (WCDMA TX Enable signal from SYMPHONY [U100](#)). If all of these signals are present, WCDMA PA [U400](#) is most properly defective.
- If [PA input](#) is bad, it is most likely a problem with the SYMPHONY [U100](#) or the ARGON IC

- **If not ok** replace FEM [U001](#)
- **If ok** there is most likely a problem with the SAW Filter [FL500](#), the TransAAM [U500](#) or the ARGON IC [U1000](#) – forward to an authorized level 4 service center.

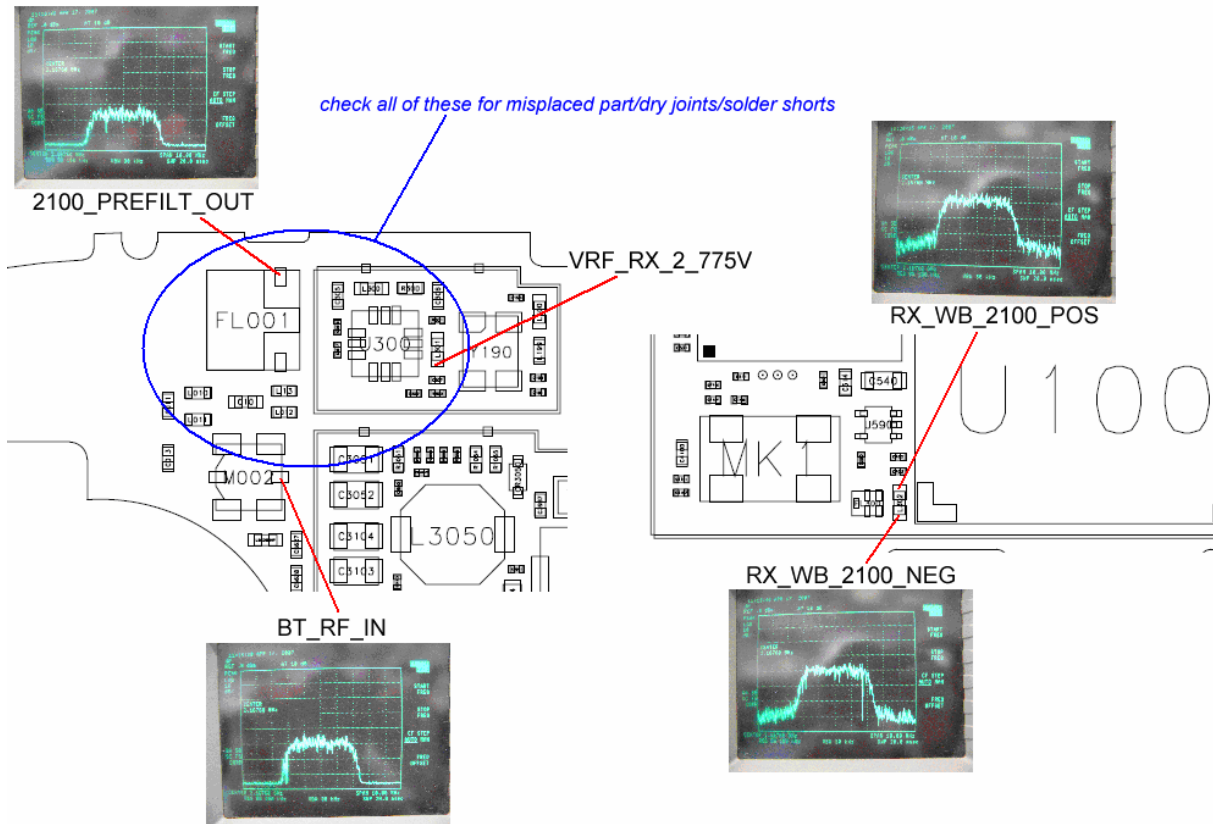
Figure 39

- Check [BT_RF_IN](#) at antenna switch [M002-1](#). If bad, replace [M002](#).
- Check for presence of [2100_PREFILT_OUT](#) at [FL001](#), if bad replace [FL001](#).
- Check RX_WB_2100_NEG/RX_WB_2100_POS at [L302](#), if ok in size and form (if unsure compare with a known good pcb) the SYMPHONY [U100](#) or the ARGON [U1000](#) will be most likely the issue.
- If RX_WB_2100_NEG/RX_WB_2100_POS are not ok, check [VRF_RX_2_775](#) at [L301](#), if ok check/replace [U300/FL300](#)
