# FIELD SERVICE BULLETIN

LVCCFSB2004-5 Tony Bryan January 9th, 2004 3

**GSM Triplets - SEC Display Module** V300, V400, V500, V525, V600 3

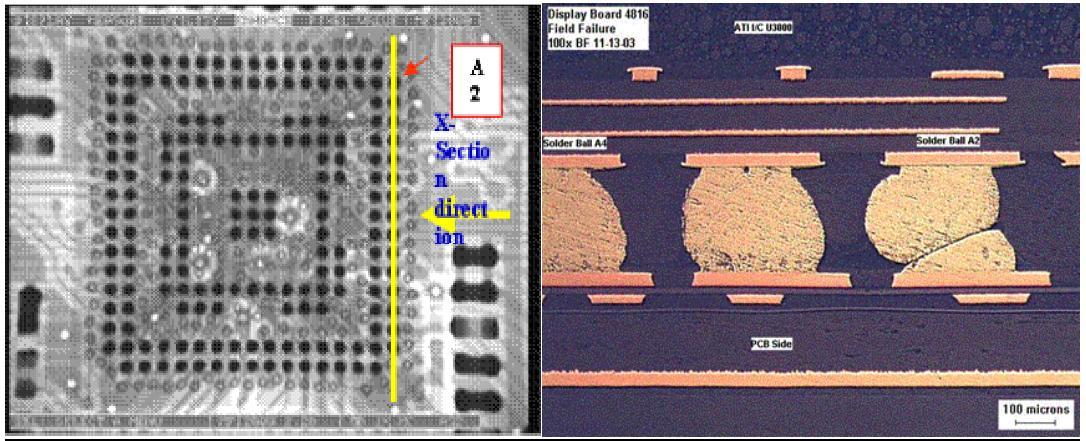
Service is aware of an issue identified during the 1<sup>st</sup> 200 NPI Analysis on V300 and V500/525. Some units, returned with a customer complaint of "No Main Display", were found to have a blank/white Main Display and no CLI Display upon power up. Analysis revealed an open solder joint on the ATI Chip (U3000), internal to the Display Module, on the ATI\_CLK Line to be the cause. The open occurs as a result of a cold solder connection on the BGA traced back to solder mask process control issue at IDS, one of Samsung's Display PCB suppliers. See Figure 1.0 below.

Figure 1.0 - U3000 (ATI) – Open Solder Connection at Pin A2

Root Cause: Display PCB - Open connection U3000 at A2 - Cold Solder - Paste solder did not metallurgically bond with bump solder. The cause of solder failures were due to a clogged SMT mask hole which has to be cleaned by cleaningpaper after every spreading process of solder paste. The cleaning paper did not roll up at that time because the sensor was tilted in the wrong position. The following corrective actions have been implemented by Samsung at IDS to eliminate this defect. Repair of the sensor position on Solder Screen machine and improvement of the Solder Stencil Cleaning Process to eliminate the possibility of a reoccurrence of this defect. IDS will perform a minimum crosssection analysis of 5 completed Display PCB panels a day (1 per line) as a preemptive screen for possible solder defects. IDS will closely monitor internal process reports for any increase in solder related defects.

4. Finally, replace the defective display module, reassemble the unit, and retest to confirm the repair.

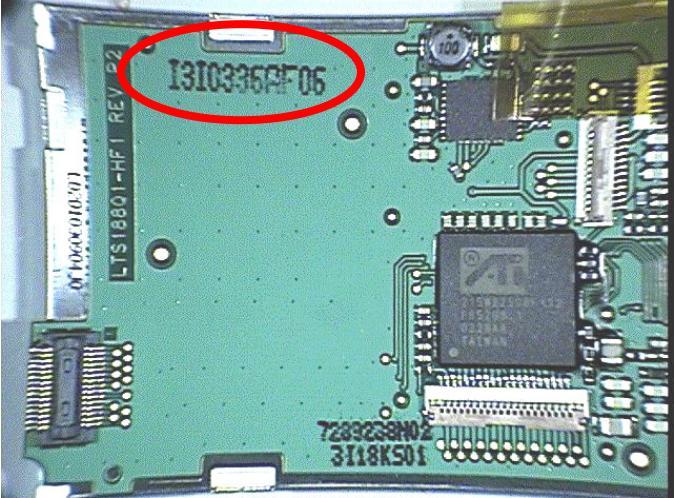
All Samsung Display Modules, built with IDS Display PCB's with date codes in the first three weeks in September, are affected by this issue. See Figure 2.0 below.

Figure 2.0 – Vendor/Date Code Markings

## \*Affected Date Code Range: I3I01 thru I3I19
