Moto G Turbo Edition Troubleshooting Guide V1.0

(Note: This document only documents the differences between Moto G Turbo Edition and Moto G (3rd Generation))

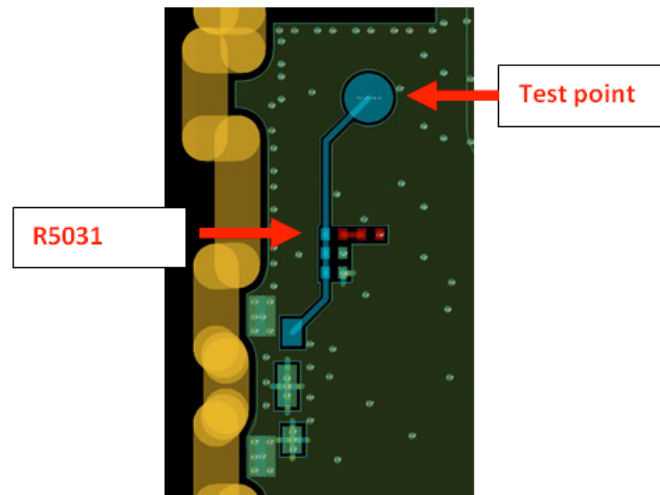
1. Before any action, the PMIC need to see a valid BATT+ (2.5V to 4.3V), and B+ should be the same as VBATT. PMIC is alive, ready to work. BATT+ being 2.5V will power up PMIC but to start a full power up sequence for the phone, SW need to see BATT+ at 3.6V.
2. Power button is pressed. This is a mechanical button. If pressed, the PMIC should receive a low voltage at pin K10. You can verify it at a resistor **R5031** or a **test point below**. If this signal does not get lower, likely the button is failing.

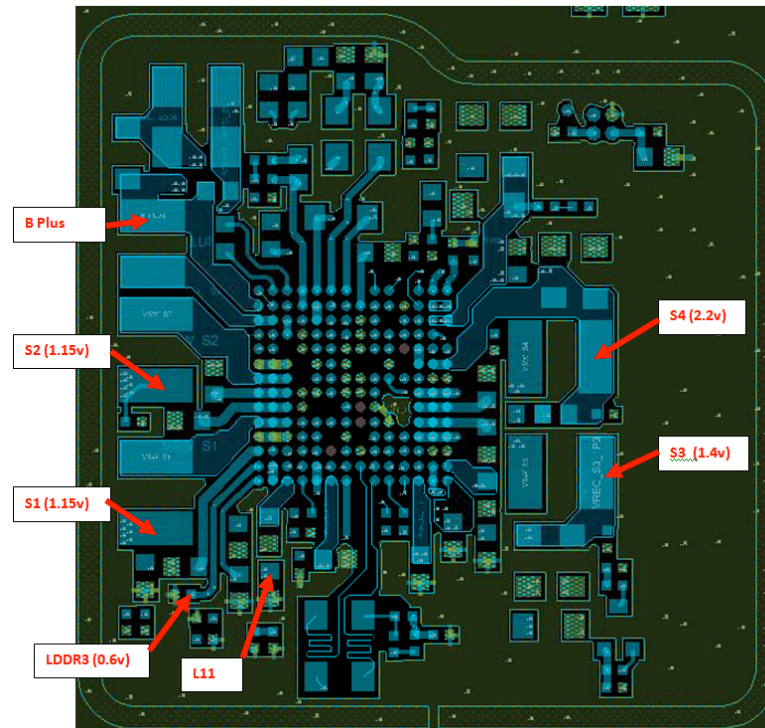
3. At this moment, the PMIC will check the battery voltage. It needs to be higher than 2.7V (default UVLO) to move forward. If the voltage is lower, or the PMIC is locked, (internal logic is messed up), you would see only a tiny current 2mA rises and falls, when you press the power button. Min turn-on Voltage is 3.6V at battery (and phone will shut down at $V_{batt} < 3.0V$).
4. A power up sequence is started. From regulator Vreg_S4, to Vreg_L5, one by one, the regulator comes up. And then the PMIC clock comes up and feeds to MSM. Check the picture for reference.

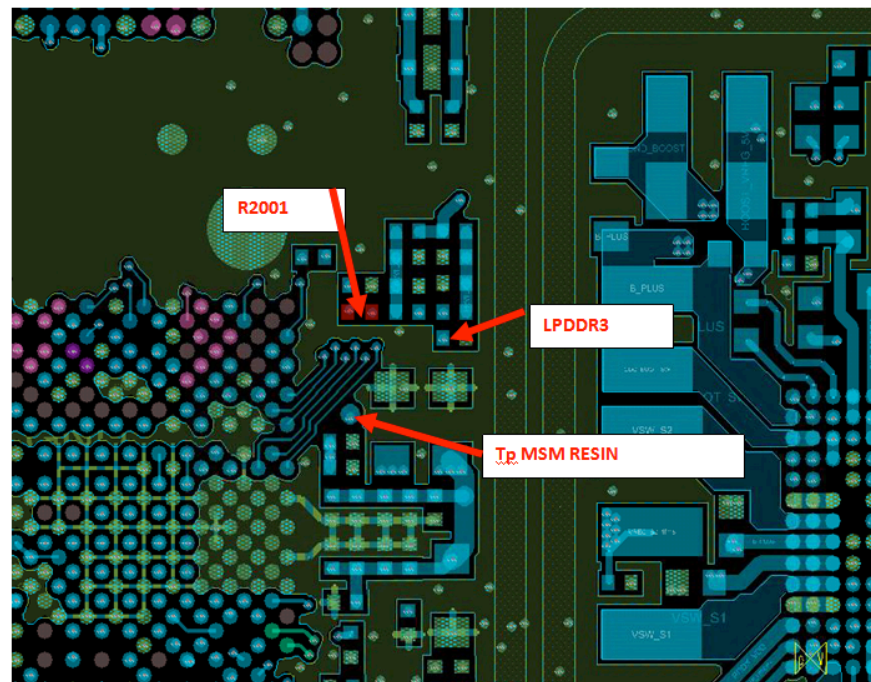
5. After the clock is ready, PMIC continues booting up sequence, until VREG_L11 is available.
6. PMIC will **pull up** the PON_RESET_N to inform MSM to start to work. A test point **TP_MSM_RESIN_N** can be used to verify the signal PON_RESET_N. MSM will run the primary boot load SW.
7. MSM responds back by **pulling up** PS_HOLD, telling PMIC to keep power up. **R2001** can be measured to verify this signal.
