Service Repair Documentation

Level 2.5 – CFX 65

1	
Service Repair Documentation Level 2.5 - CFX65	V1.0

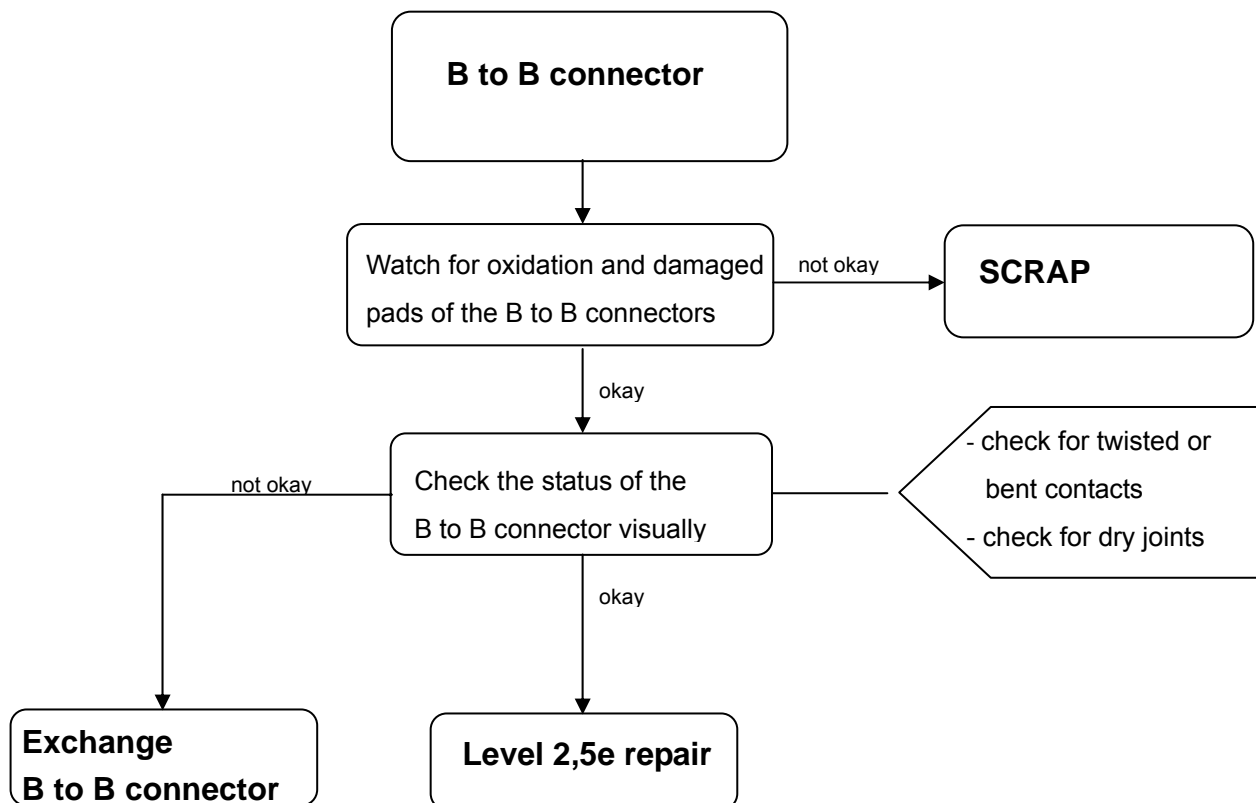
1. B to B connector (J305)

Fault symptoms	
Customer	GRT
No display but main board works	n/a
Camera and/ or earpiece does not work

Use soldering iron to remove defective component. Avoid excessive heat! Watch surrounding components! Resolder new component afterwards.

E-commerce order number: L50634-Z97-C377
 Soldering temperature: 240 - 255°C
 IRIS diagnosis code: BA000 Accessories/ Camera
 21000 Display/ Performance
 22000 Display/ Background illumination

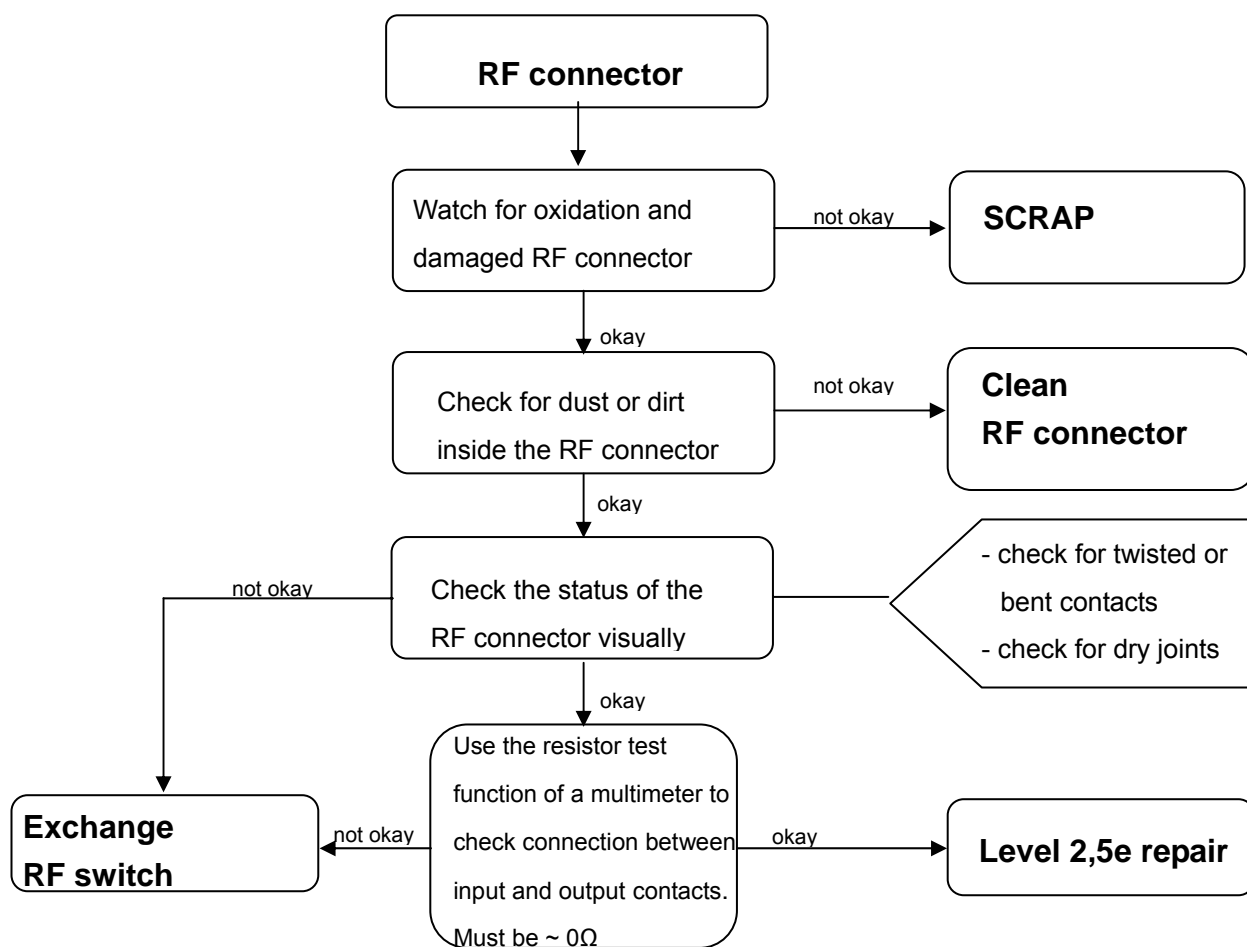
2. RF switch (ANT300)

Fault symptoms	
Customer	GRT
Network search	Failure in TX/ RX measurements
No location update	No location update possible

Use hot air blower to remove defective component. Avoid excessive heat! Watch surrounding components! Resolder new component afterwards.

Soldering temperature: 240 - 255°C

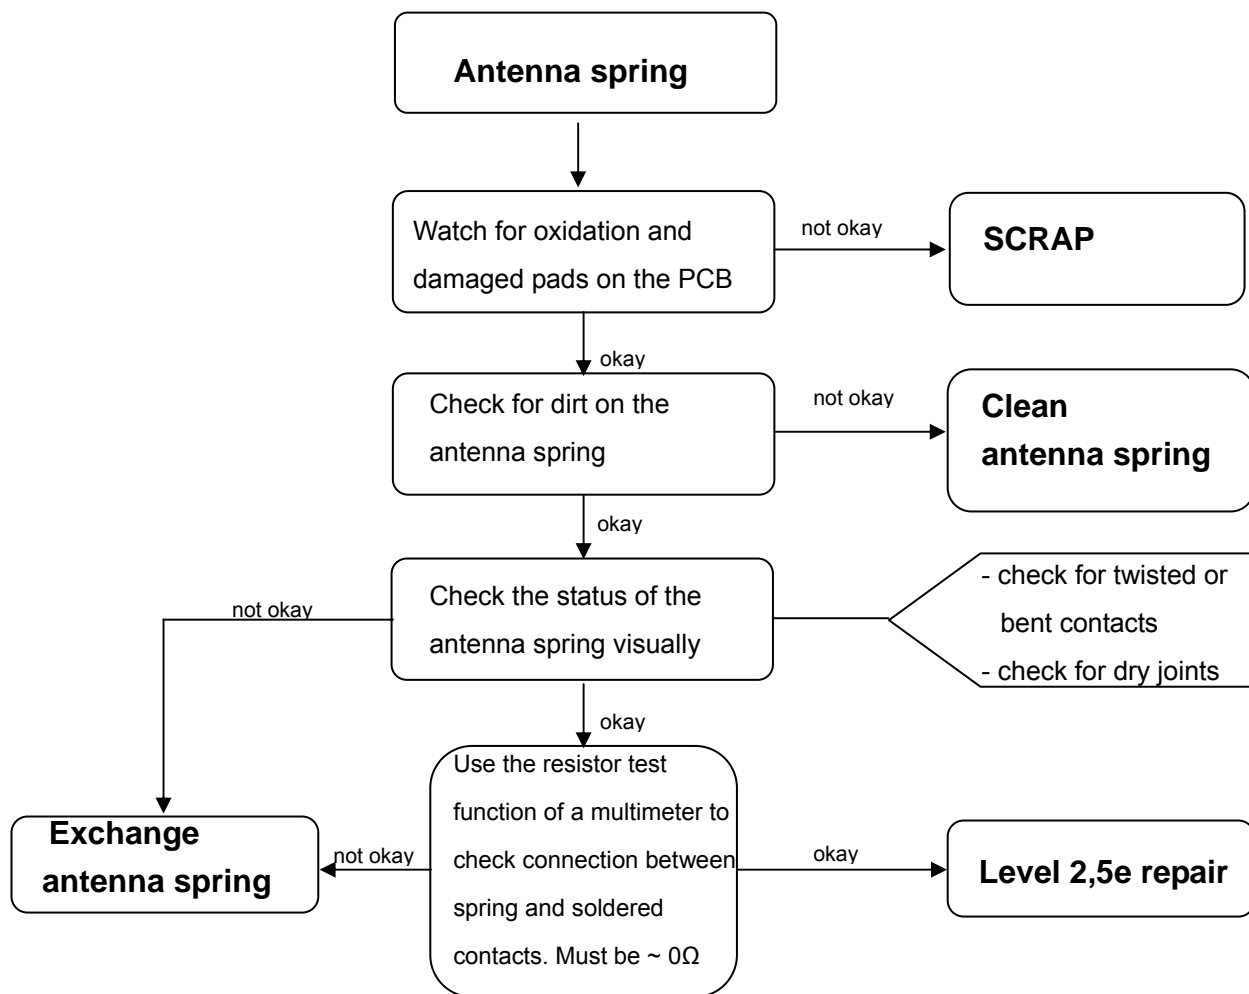
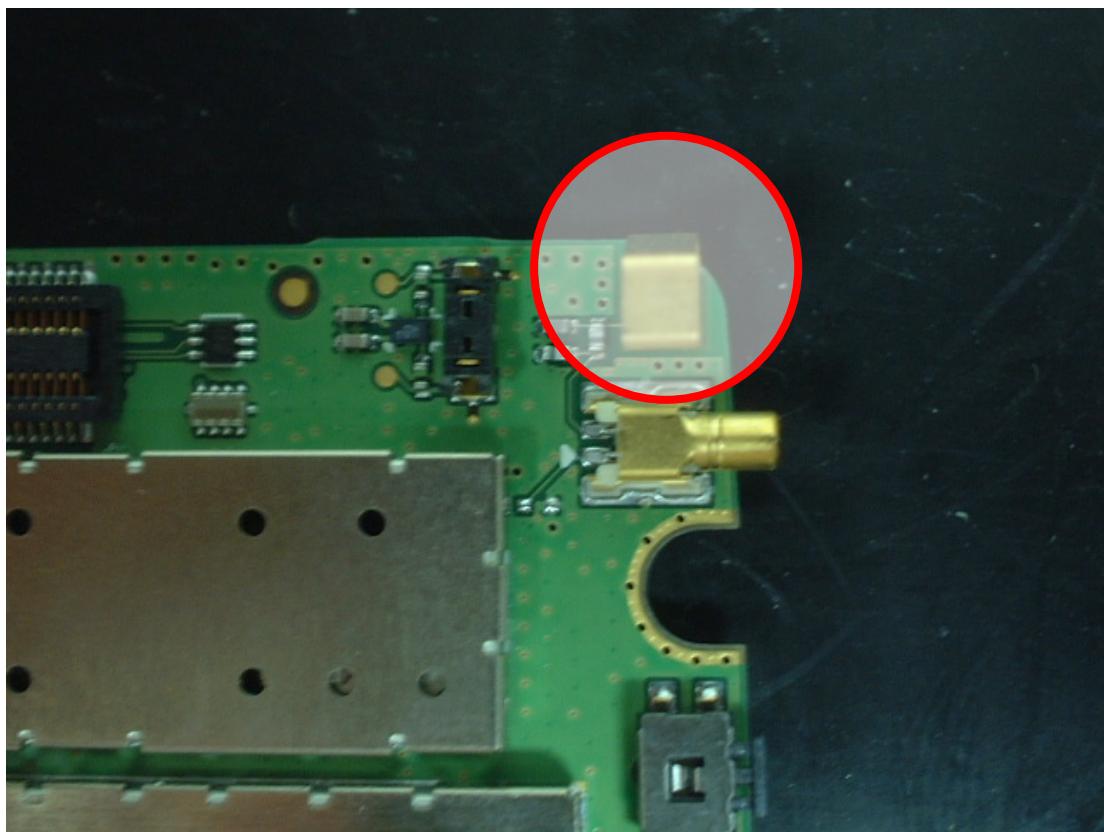
3. Antenna spring (J301)

Fault symptoms	
Customer	GRT
Poor network	Failure in RX/ TX measurements
No network	No location update possible

Use soldering iron to remove defective component. Avoid excessive heat! Watch surrounding components! Resolder new component afterwards.

E-commerce order number: L50658-A136-B16
Soldering temperature: 240 - 255°C
IRIS diagnosis code: 83140 TX power fault internal antenna

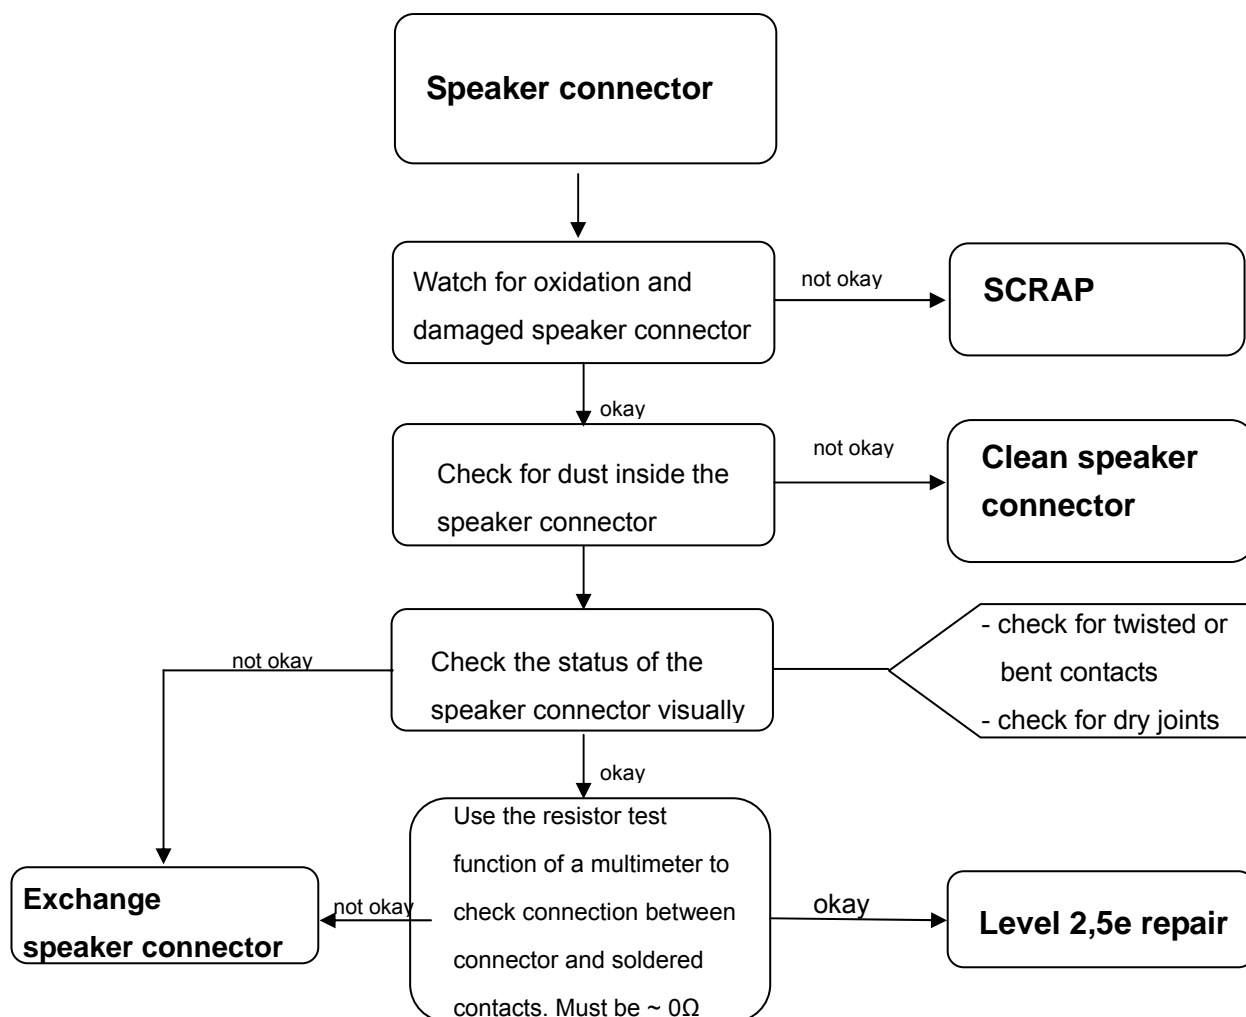
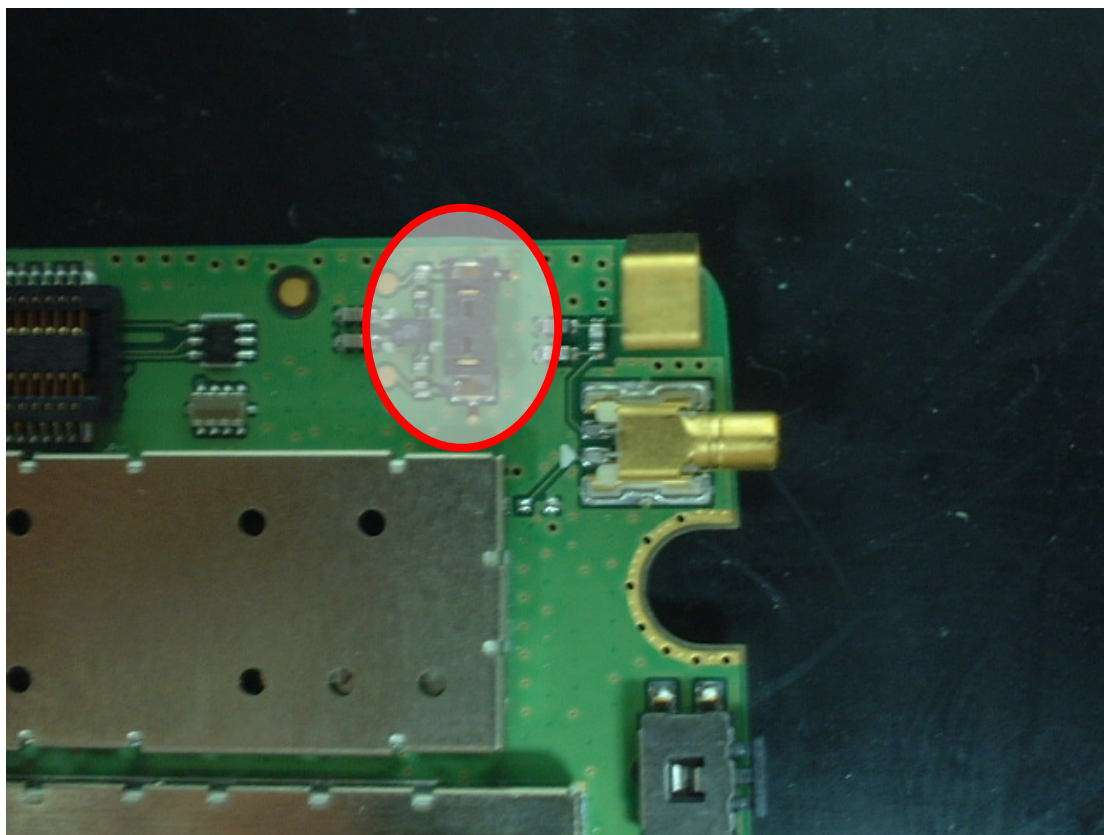
4. Speaker connector (J200)

Fault symptoms	
Customer	GRT
No sound from speaker The speaker is barely to hear	Audio loop test fails

Use soldering iron to remove defective component. Avoid excessive heat! Watch surrounding components! Resolder new component afterwards.

Soldering temperature: 240 - 255°C

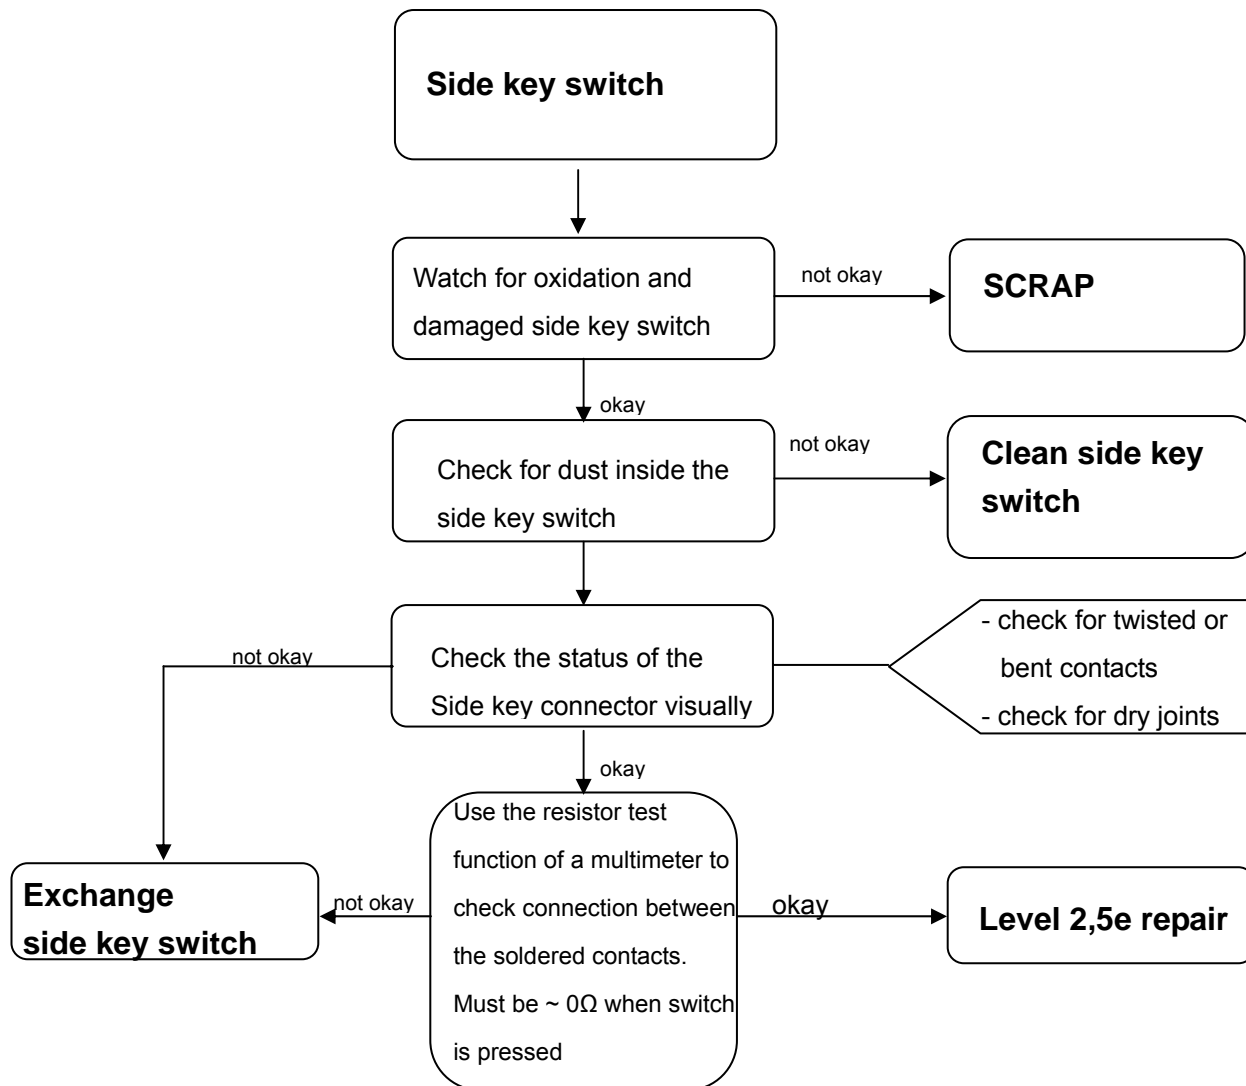
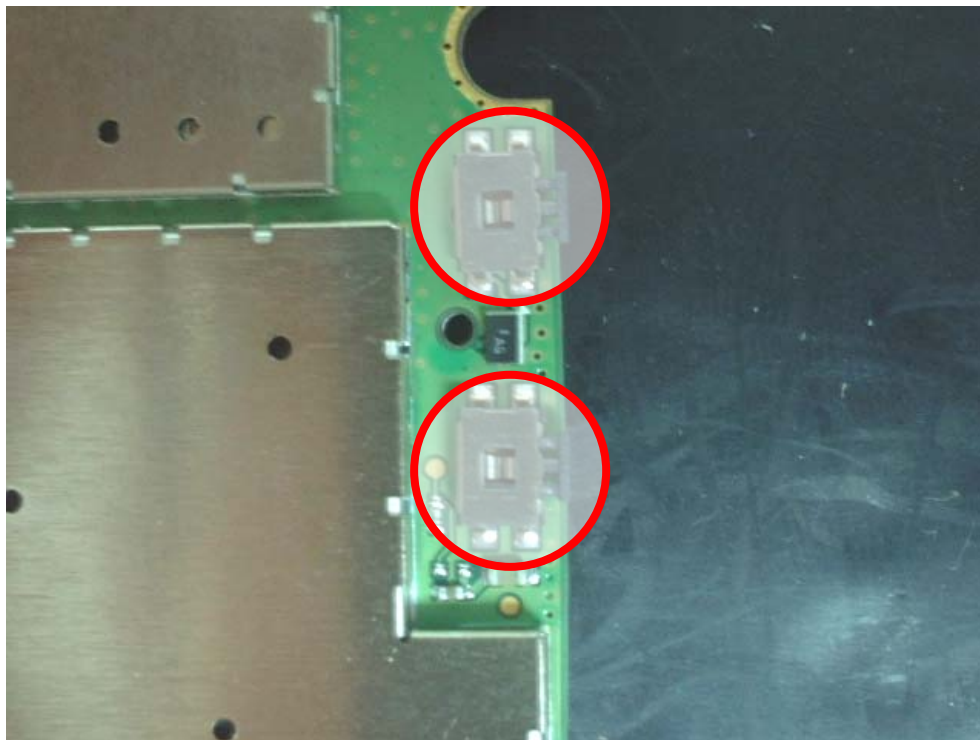
5. Side key switch (S400,S401)

Fault symptoms	
Customer	GRT
No function while pressing	n/a
Pressing feeling is bad

Use soldering iron to remove defective component. Avoid excessive heat! Watch surrounding components! Resolder new component afterwards.

Soldering temperature: 240 - 255°C

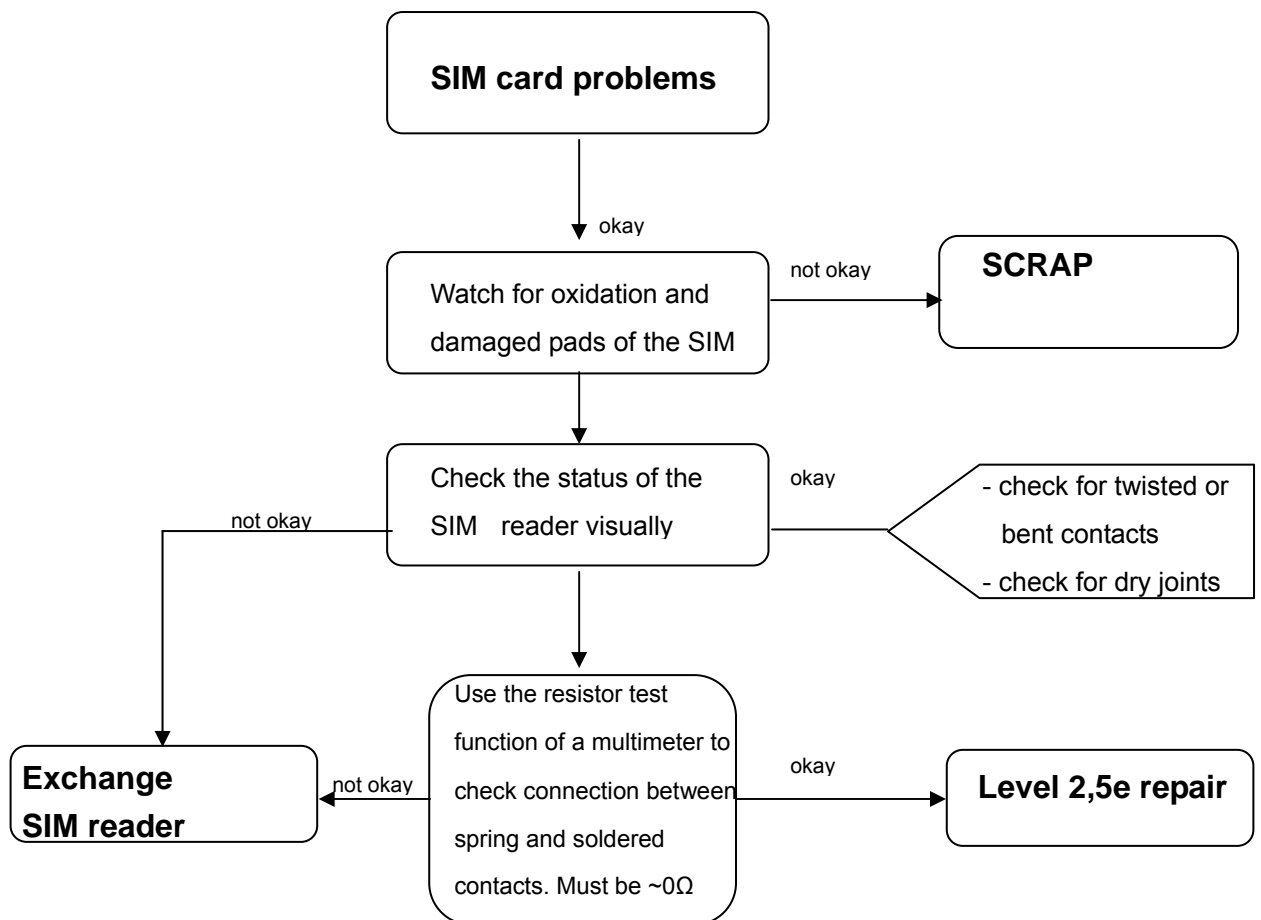
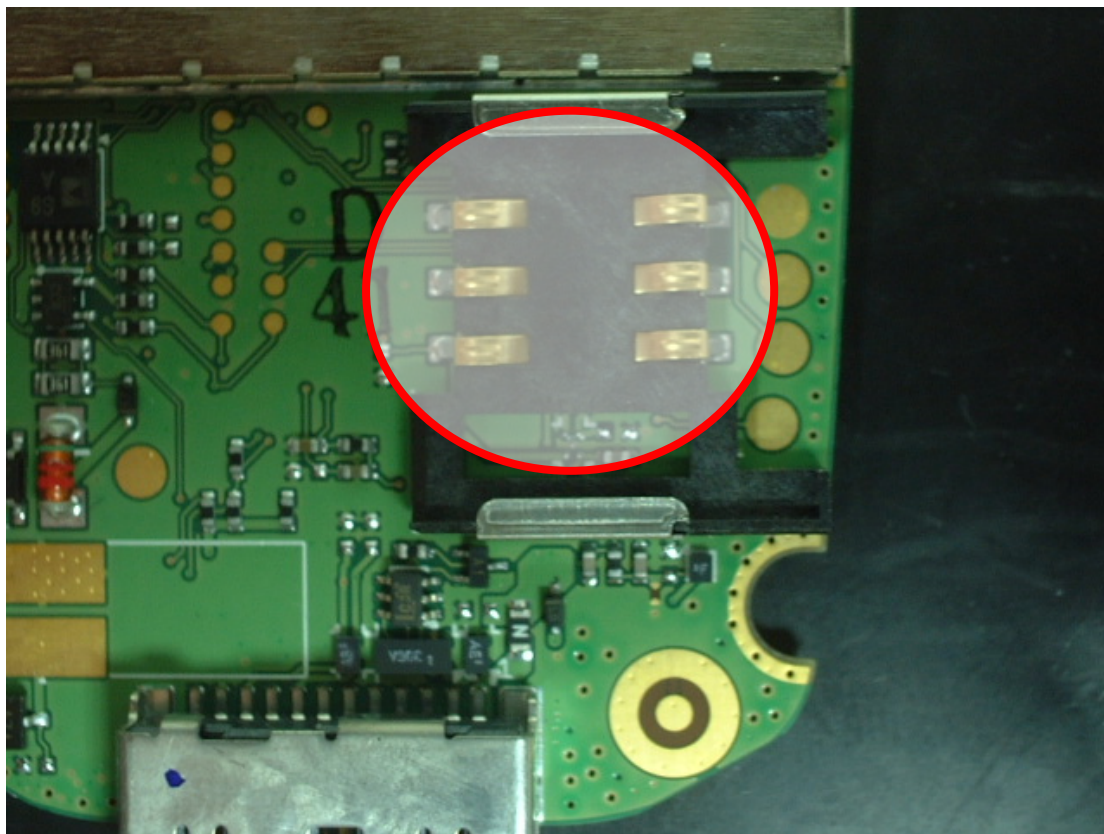
6. SIM reader (J302)

Fault symptoms	
Customer	GRT
Handset does not accept SIM	SIM card problem

Use soldering iron to remove defective component. Avoid excessive heat! Watch surrounding components! Resolder new component afterwards.

Soldering temperature: 240 - 255°C

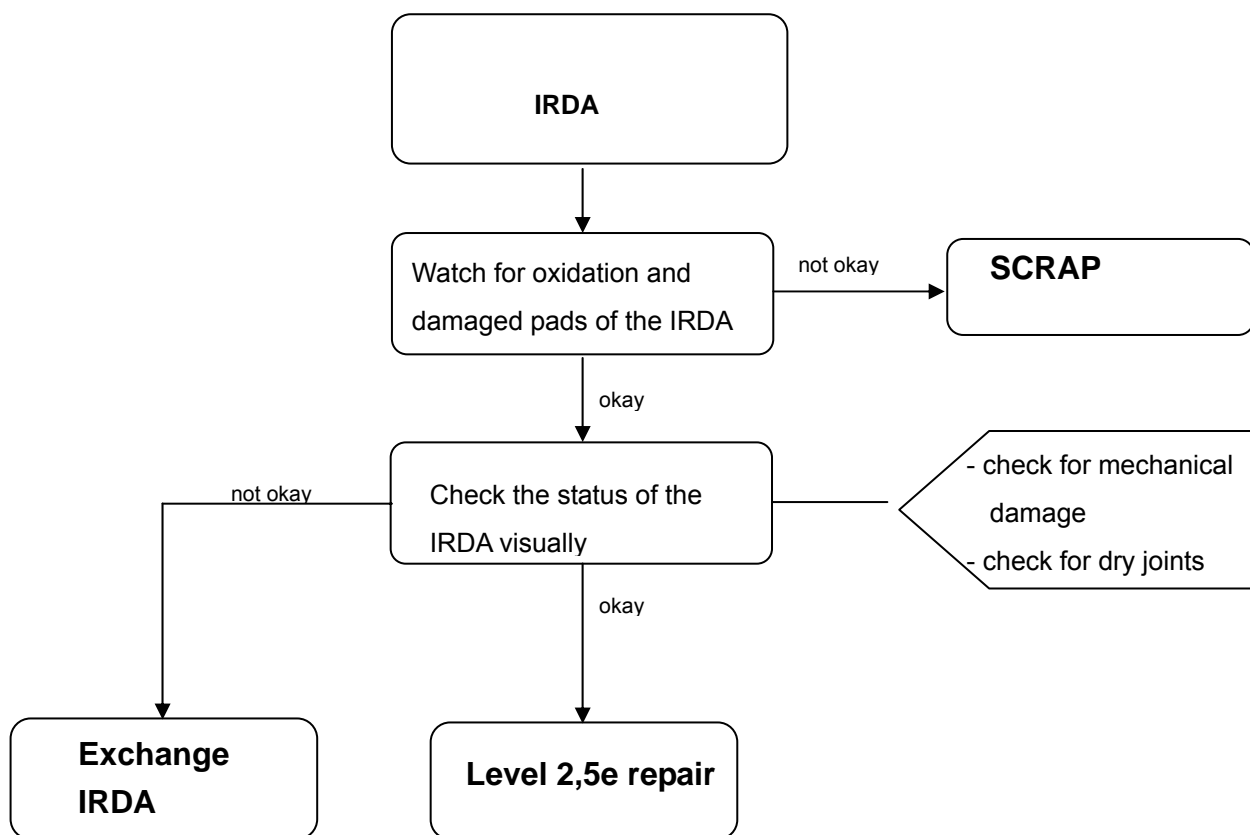
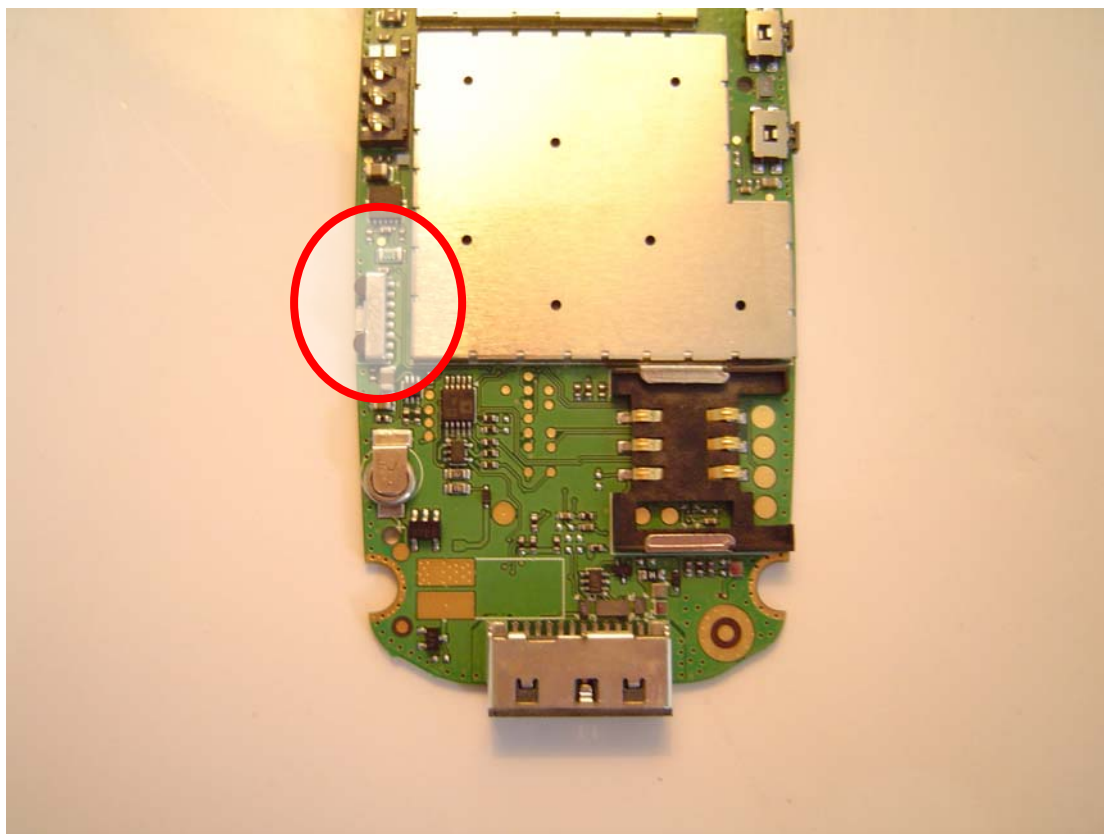
9. IRDA (U103)

Fault symptoms	
Customer	GRT
No infrared connection possible	n/a

Use soldering iron to remove defective component. Avoid excessive heat! Watch surrounding components! Resolder new component afterwards.

Soldering temperature: 240 - 255°C

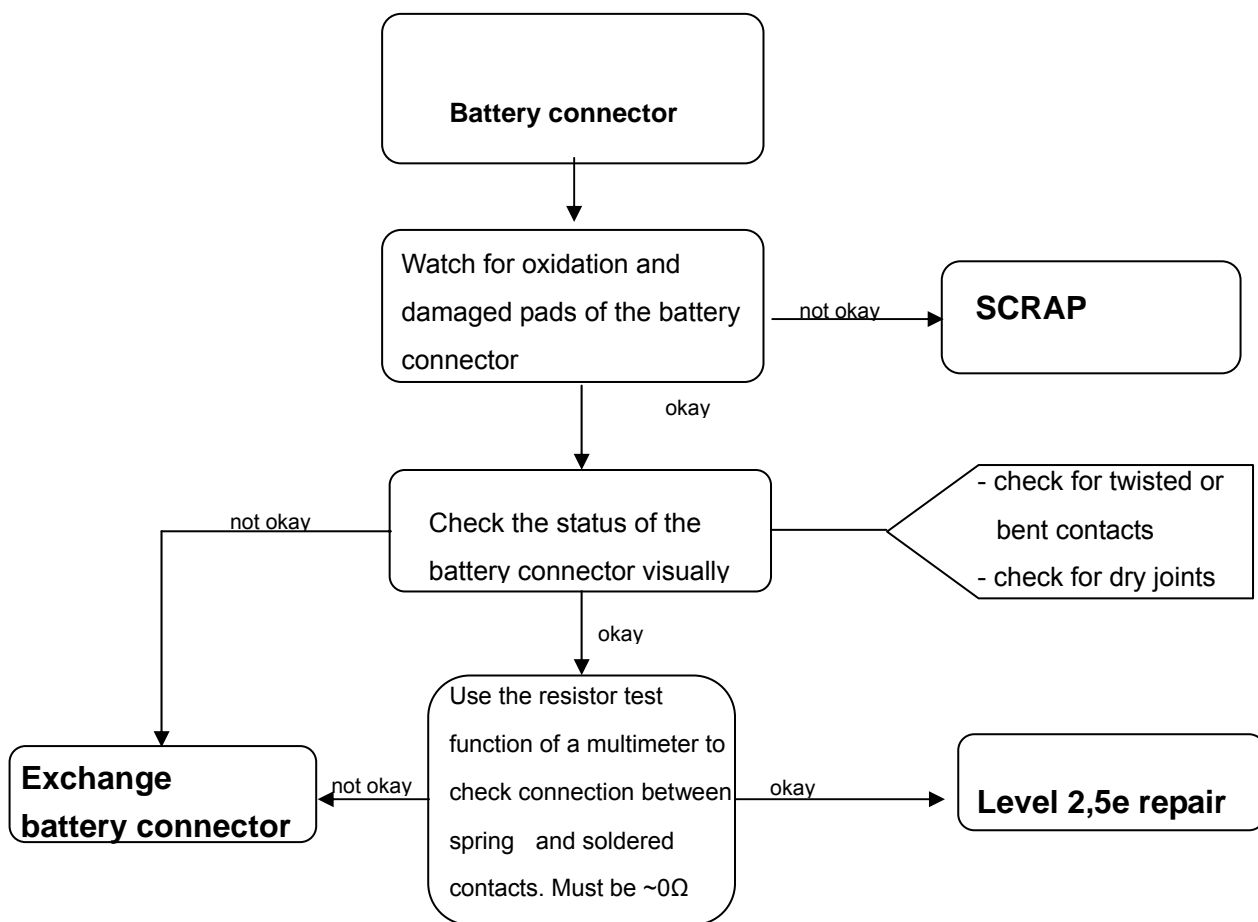
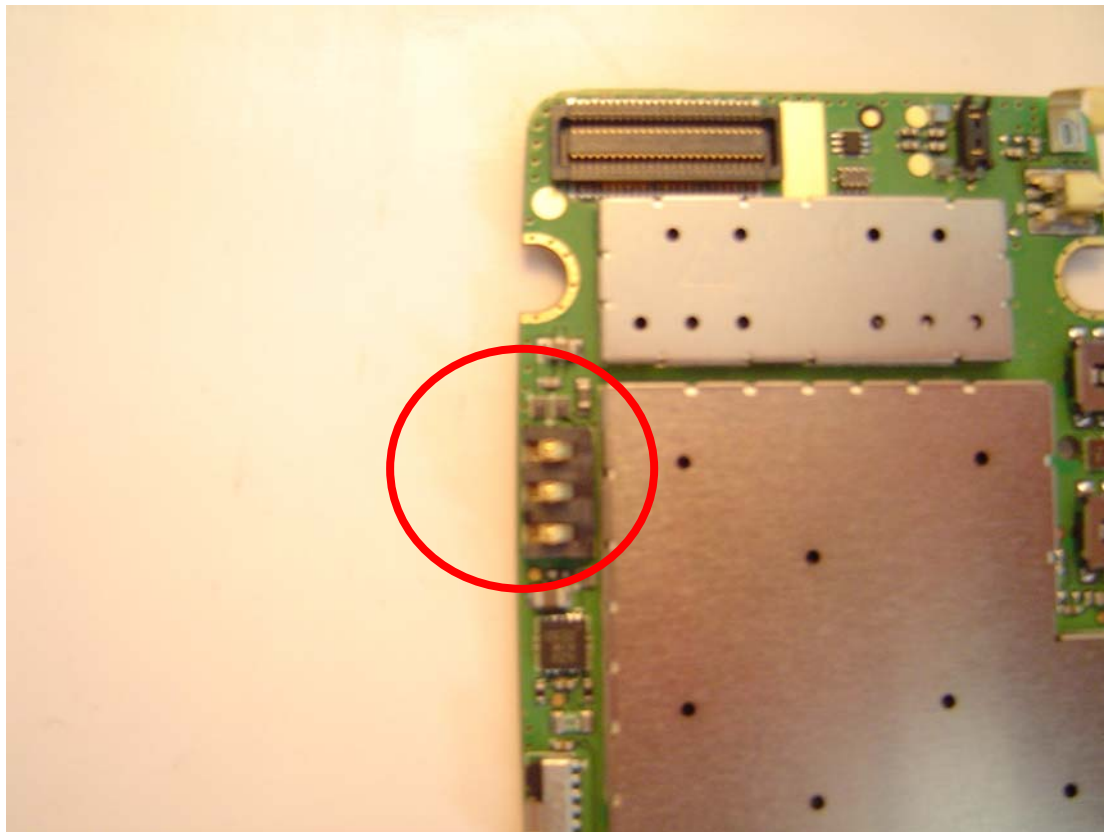
10. Battery connector (J300)

Fault symptoms	
Customer	GRT
Mobile does not switch on	No connection to GRT

Use soldering iron to remove defective component. Avoid excessive heat! Watch surrounding components! Resolder new component afterwards.

E-commerce order number: L50634-Z97-C376
Soldering temperature: 240 - 255°C
IRIS diagnosis code: 13000 Battery/ Mechanical damage

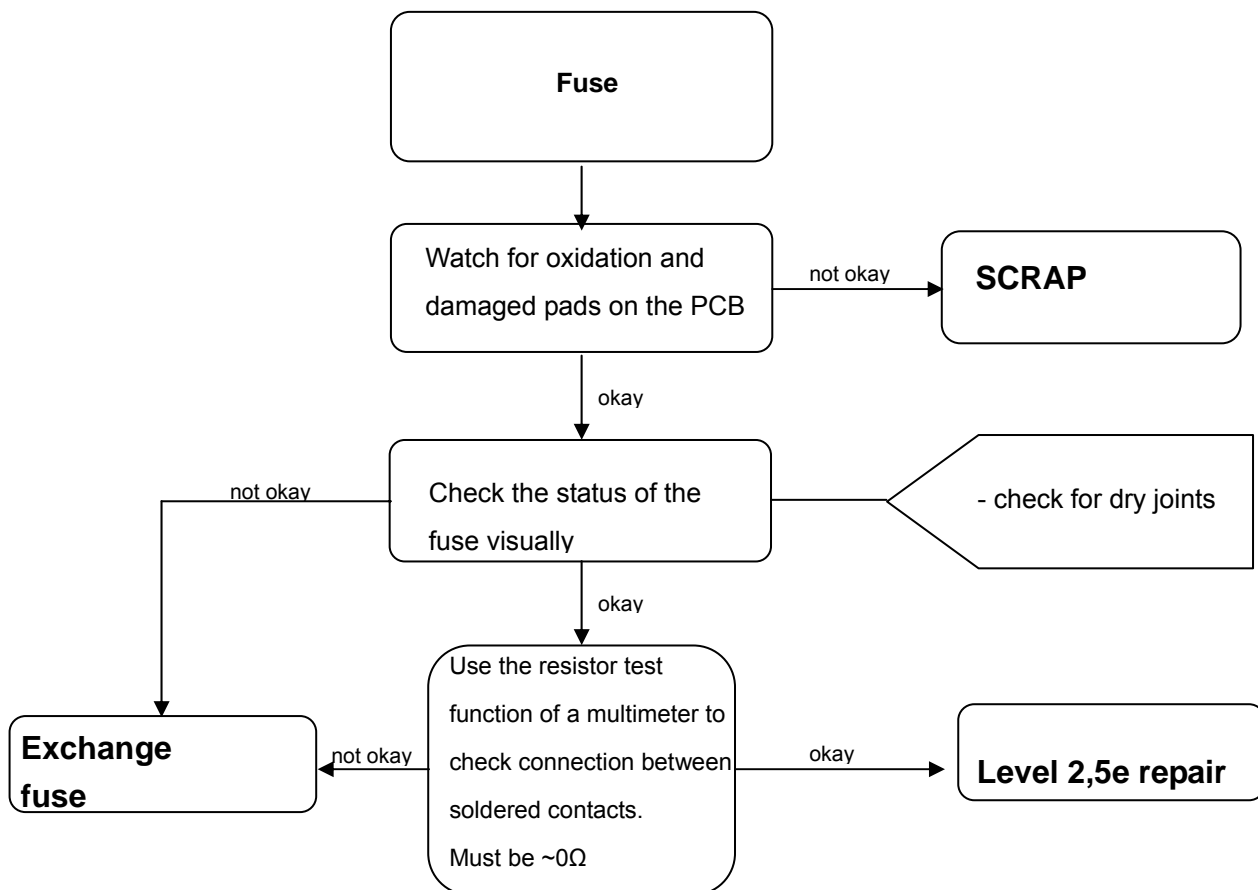
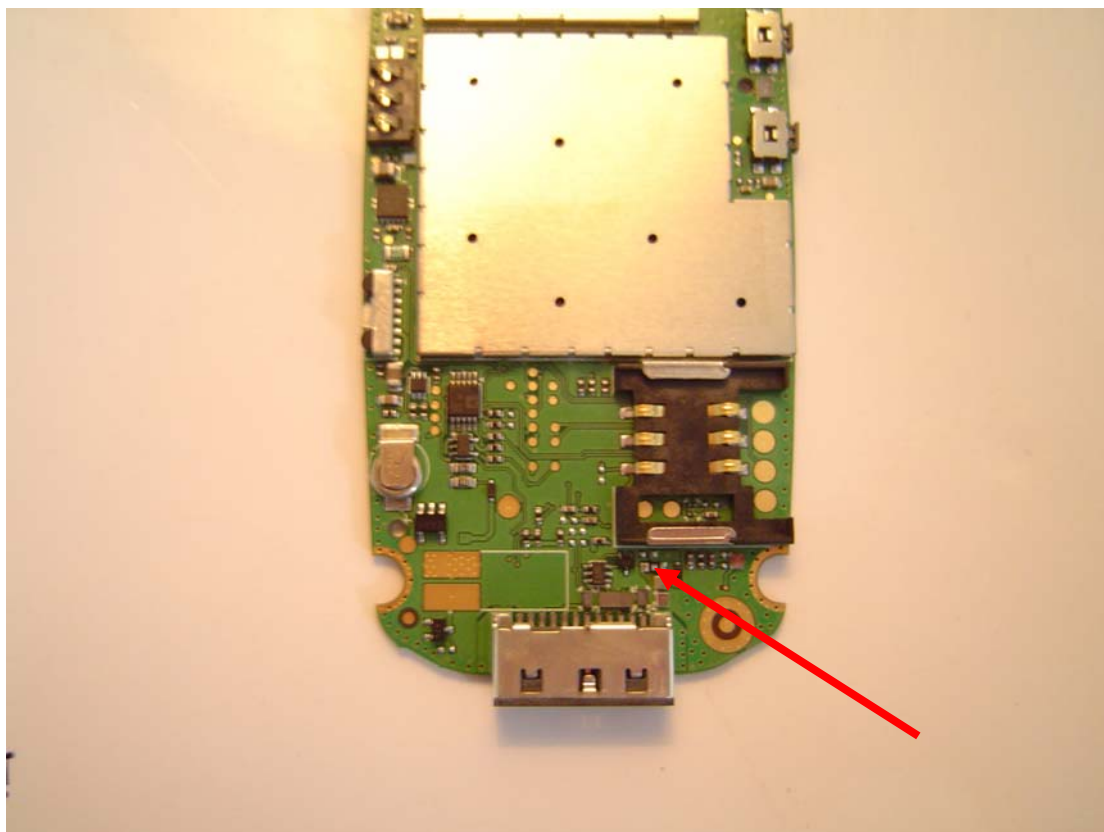
11. Fuse (F300)

Fault symptoms	
Customer	GRT
Battery charging does not work	n/a

Use soldering iron to remove defective component. Avoid excessive heat! Watch surrounding components! Resolder new component afterwards.

E-commerce order number: L50645-A820-Y20
Soldering temperature: 240 - 255°C
IRIS diagnosis code: 11100 Battery/ No charging/ Deep discharge

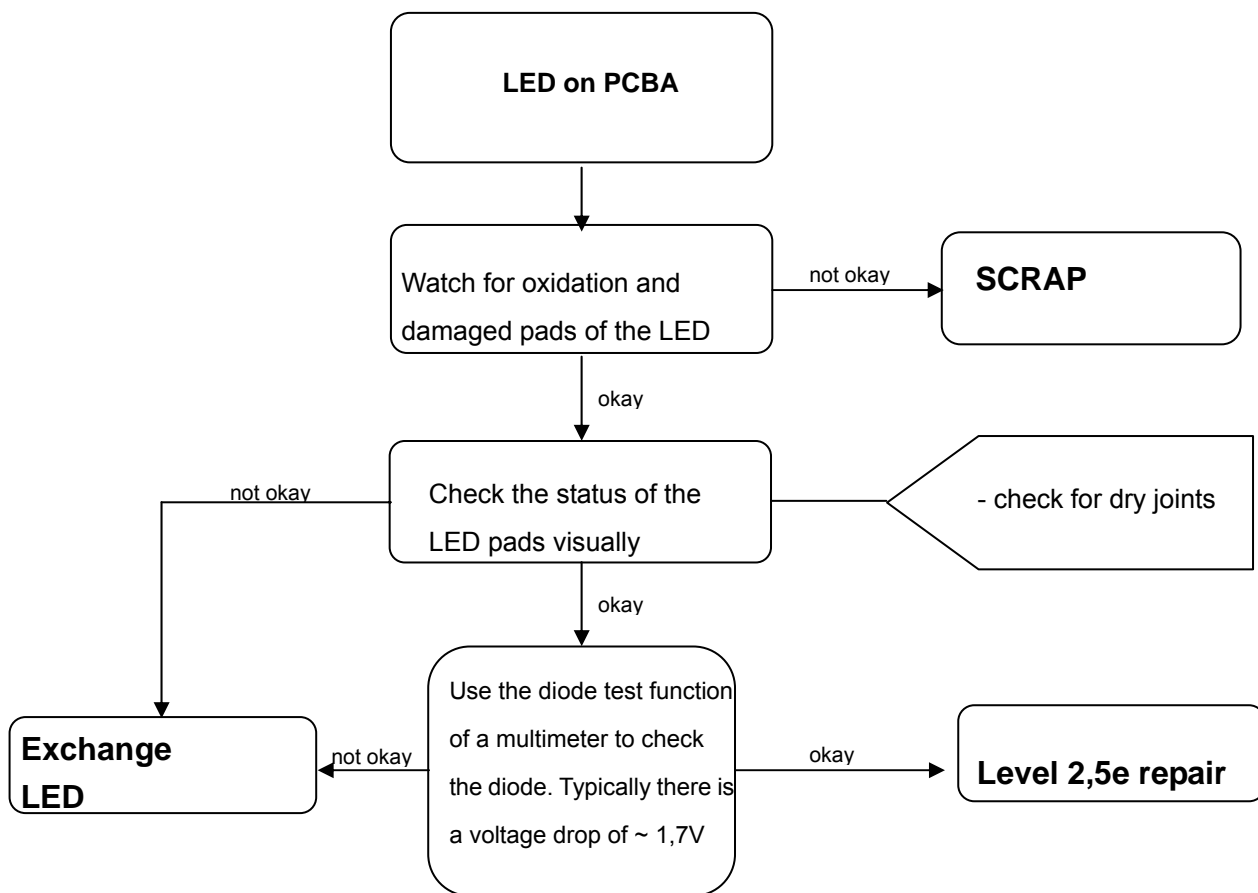
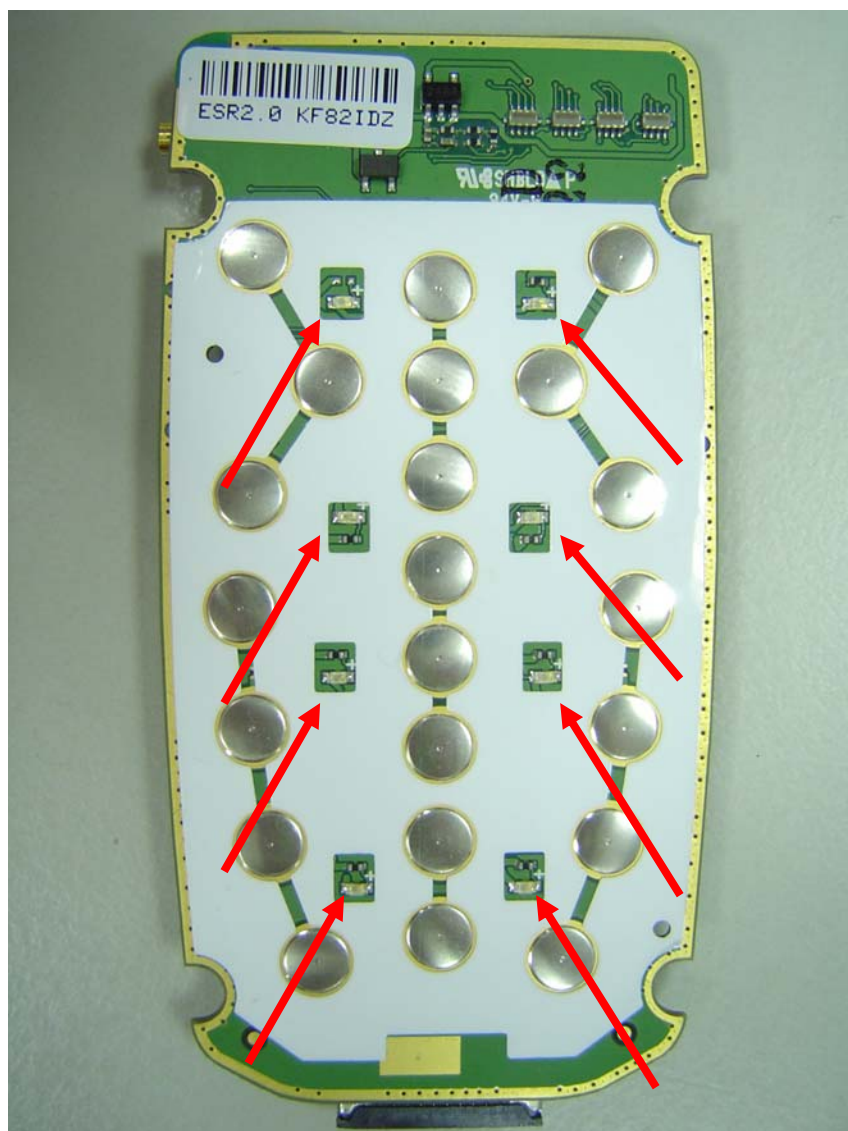
12. LED on PCBA

Fault symptoms	
Customer	GRT
LED does not work or not bright	n/a

Use soldering iron to remove defective component. Avoid excessive heat! Watch surrounding components! Resolder new component afterwards.

E-commerce order number: L50640-L2123-D670
Soldering temperature: 240 - 255°C
IRIS diagnosis code: 36000 Keys/ Illumination

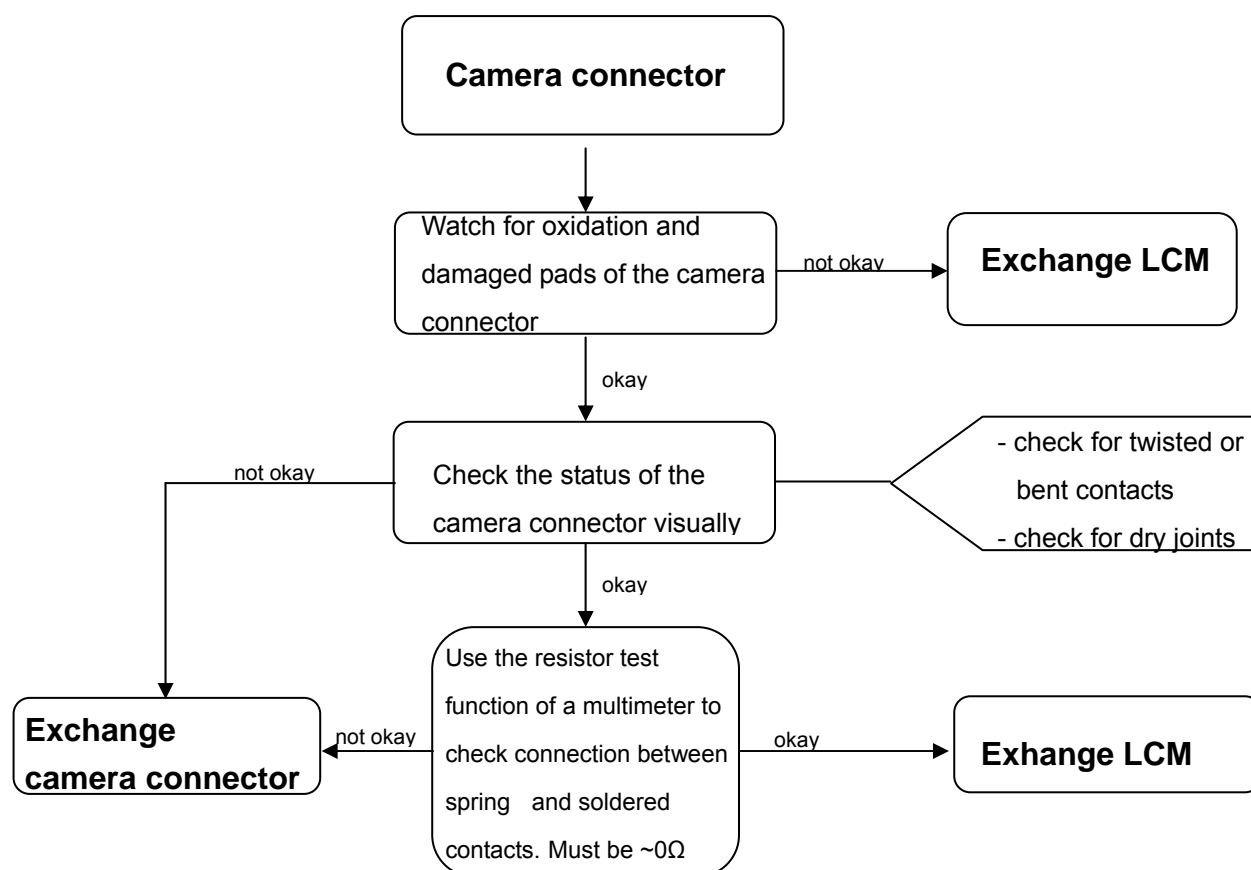
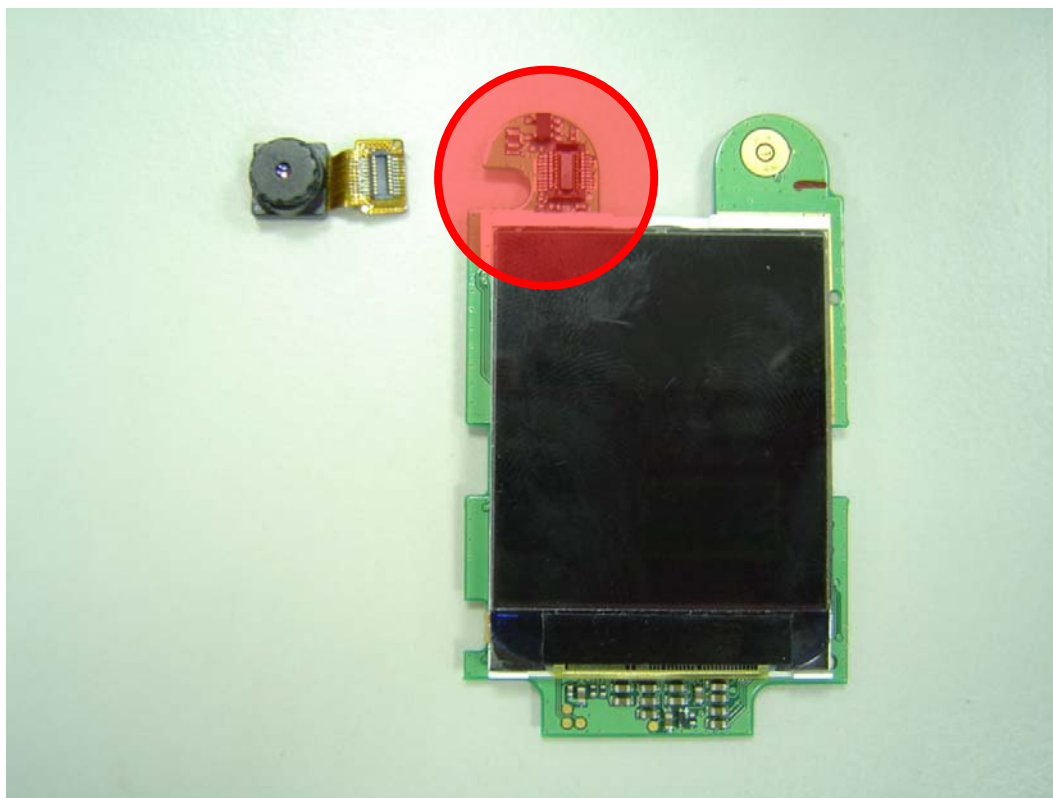
13. Camera connector

Fault symptoms	
Customer	GRT
Camera malfunction	n/a

Use soldering iron to remove defective component. Avoid excessive heat! Watch surrounding components! Resolder new component afterwards.

E-commerce order number: L50634-Z97-C378
Soldering temperature: 240 - 255°C
IRIS diagnosis code: BA000 Accessories/ Camera
