Service Repair Documentation

Level 2.5 – CFX 65

1	
Service Repair Documentation Level 2.5 - CFX65	V1.0

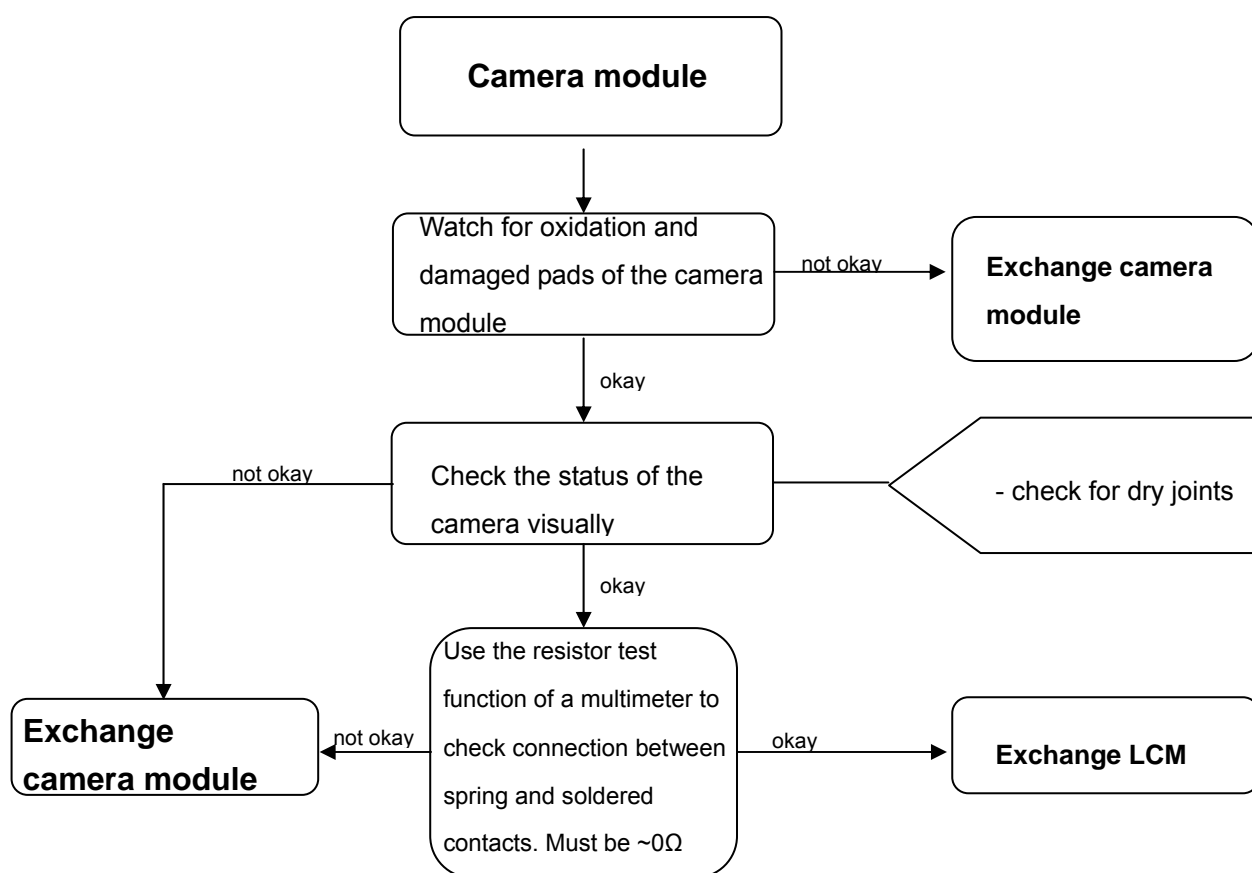
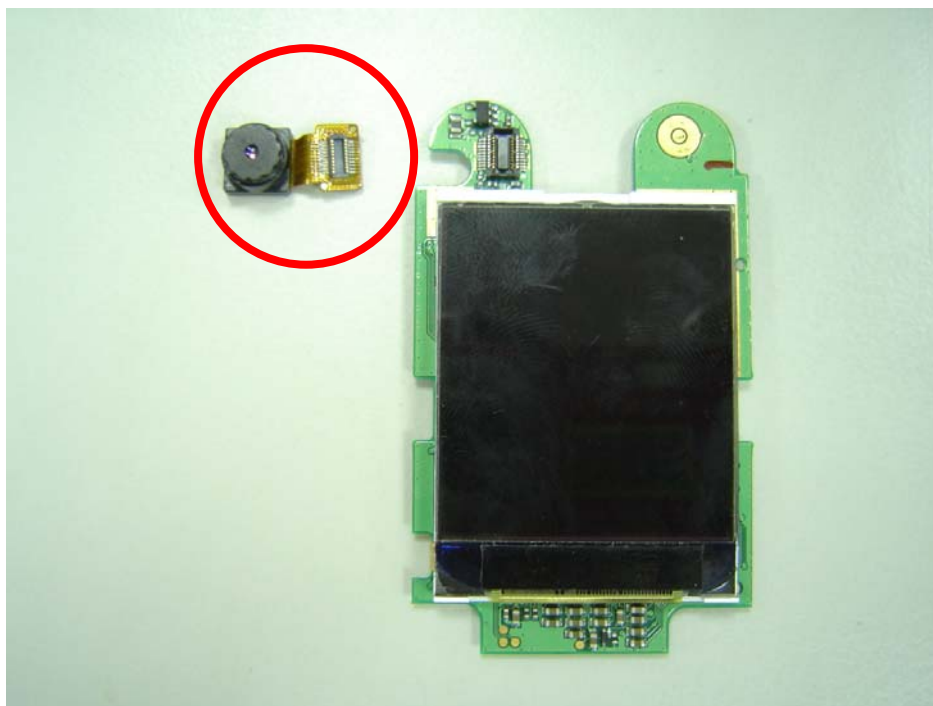
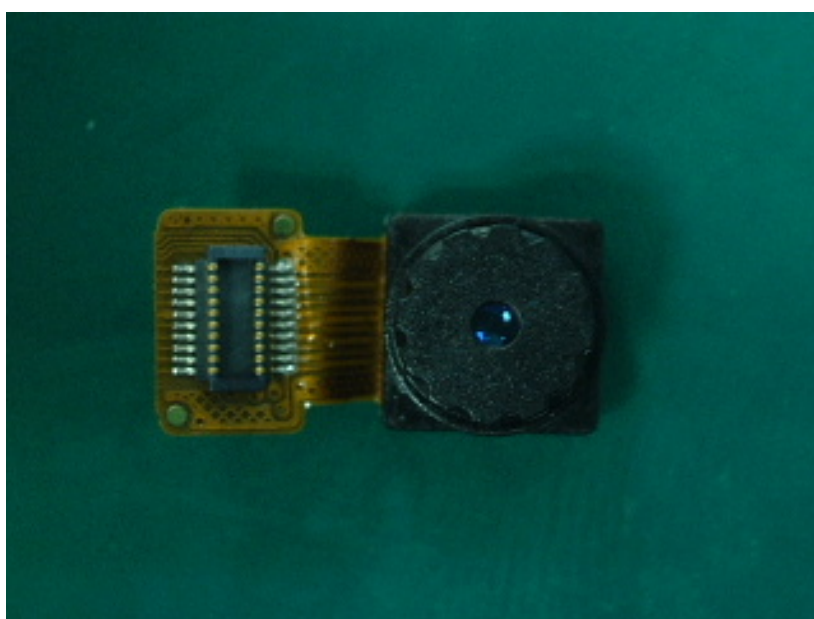
14. Camera module

Fault symptoms	
Customer	GRT
Camera malfunction	n/a

E-commerce order number: L50653-Z5-C297
Soldering temperature: 240 - 255°C
IRIS diagnosis code: BA000 Accessories/ Camera

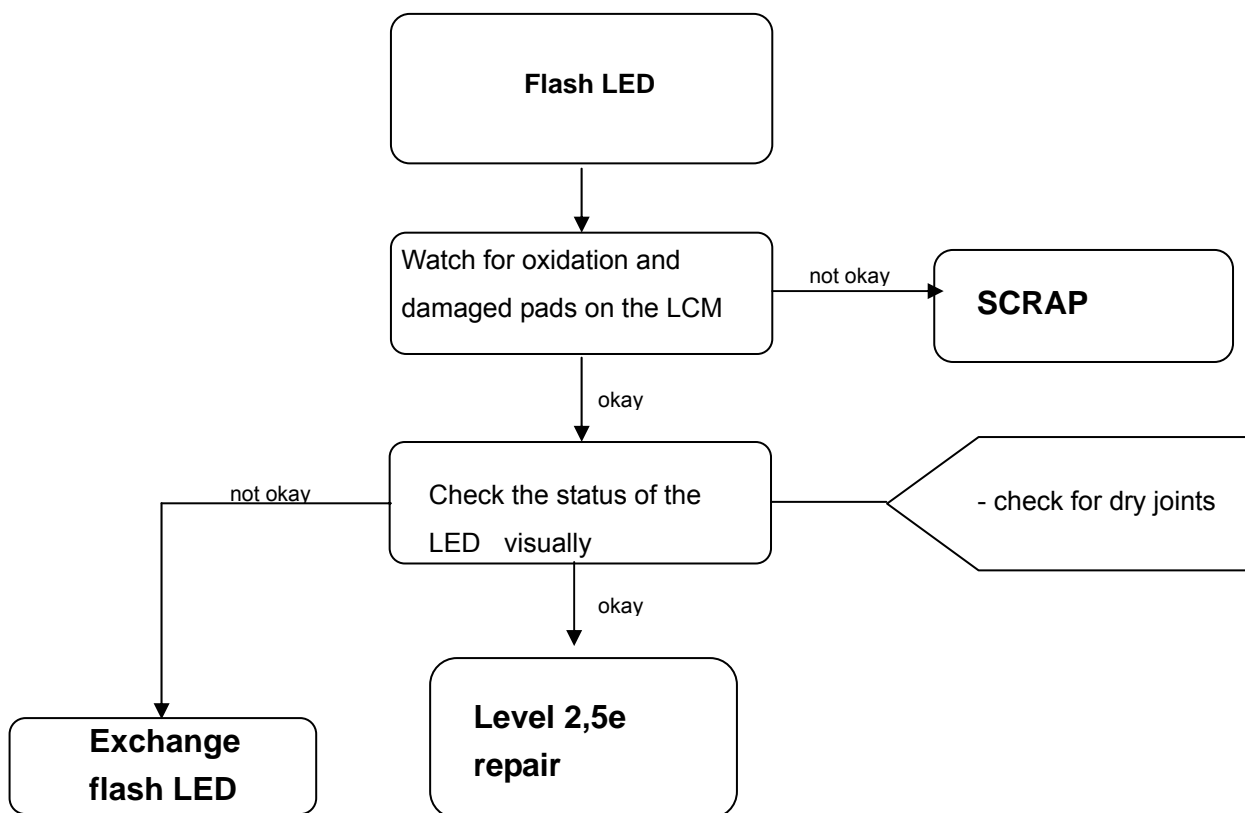
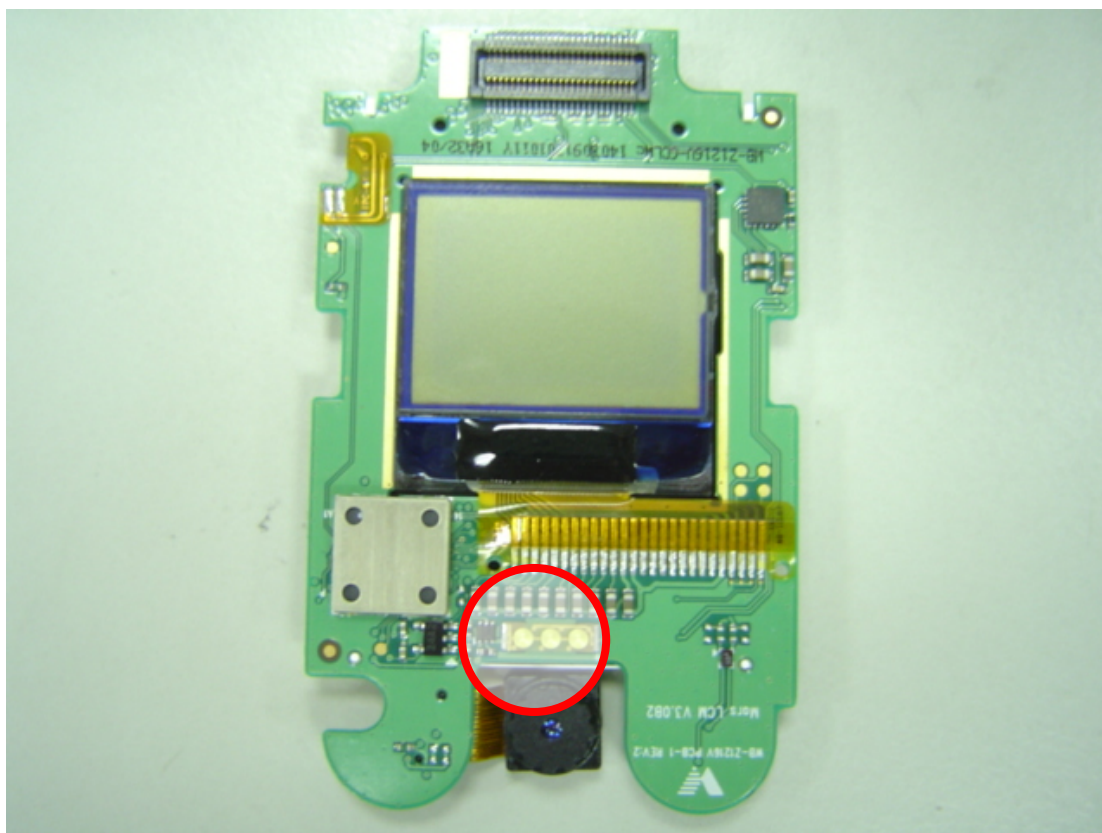
15. Flash LED on the LCM

Fault symptoms	
Customer	GRT
-Flash LED does not work -Flash LED not bright	n/a

Use soldering iron to remove defective component. Avoid excessive heat! Watch surrounding components! Resolder new component afterwards.

Soldering temperature: 240 - 255°C
