This Service Repair Documentation is intended to carry out repairs on Siemens repair level 2.5. The described failures shall be repaired in Siemens authorized local workshops only.

1. CL75 Board Layout

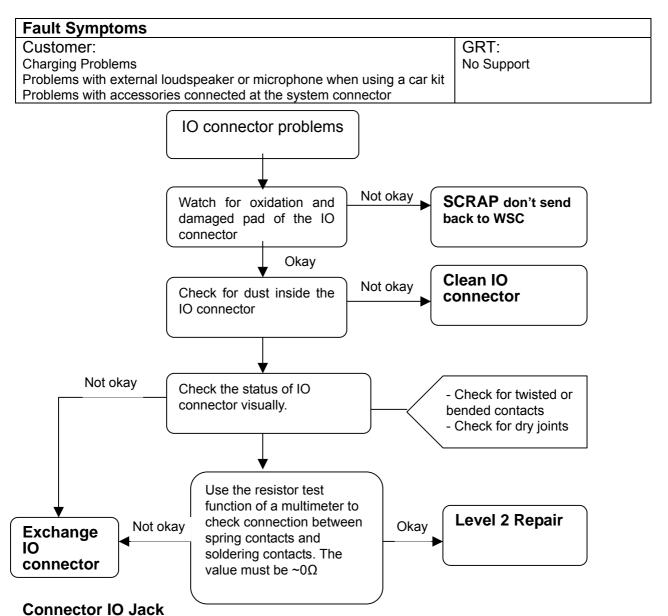
2. System Connector

IRIS Diagnose Code: 46100 Interface/ Charging Connector/ Mechanical Damage

47300 Interface/ Data Interface/ Mechanical Damage 4B100 Interface/ Headset Connector/ Mechanical Damage

Use soldering iron to remove defective component. Avoid excessive heat! Watch surrounding components! Re-solder new component afterwards.

E-commerce order number: C39334-Z97-C448 Soldering temperature: 240 – 255°C

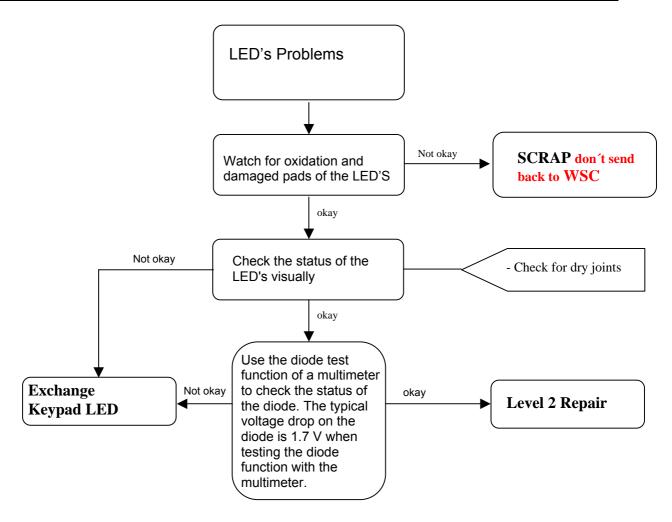
LED

IRIS Diagnose Code: 36000 Keys/Illumination

Use soldering iron to remove defective component. Avoid excessive heat! Watch surrounding components! Resolder new component afterwards. **Attention: Remove Metal Dome Sheet before!!!**

E-commerce order number: V20810-U6208-D670

Soldering temperature: 240 - 255°C

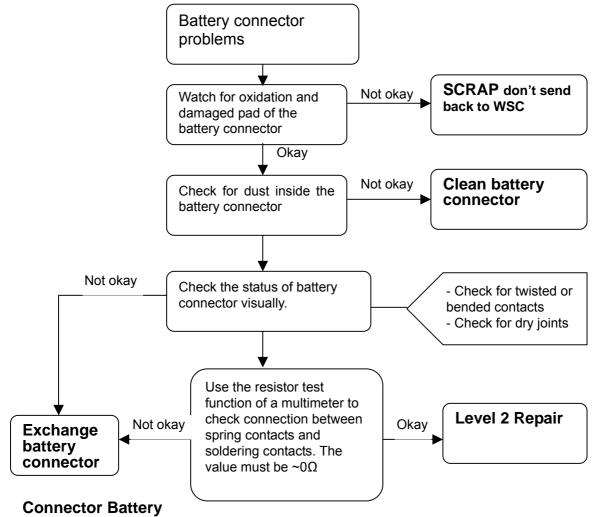
4. Battery Connector

Customer:	GRT:
	Mobile does not switch on	No Support

IRIS Diagnose Code: 91500 Functionality / Switch Off Problems / Battery Contacts Damage

Use hot air blower to remove defective component. Avoid excessive heat! Watch surrounding components!

E-commerce order number: C39334-Z97-C486 Soldering temperature: 240 – 255°C

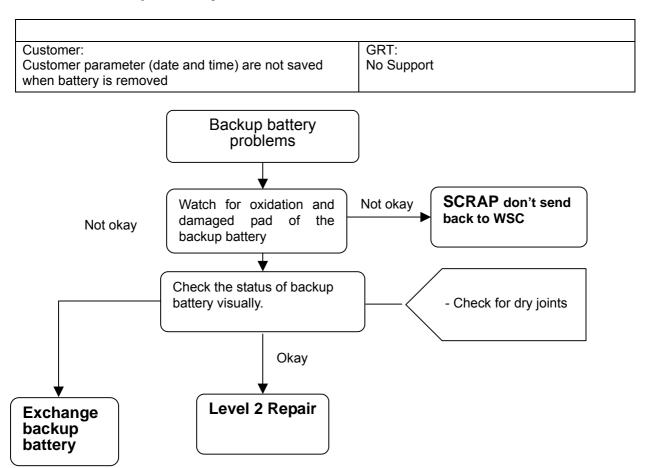
Backup Battery

IRIS Diagnose Code: C8100 Settings/ General / Clock / Date

Use hot air blower to remove defective component. Avoid excessive heat! Watch surrounding components! Re-solder new component afterwards.

E-commerce order number: V39328-F2705-Z2 Soldering temperature: 240 – 255°C

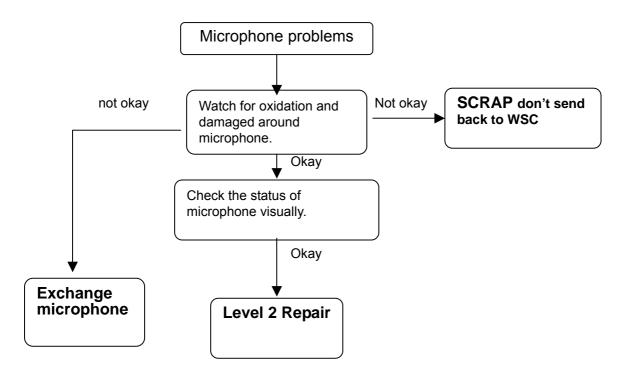
IRIS Diagnose Code: 73110 Acoustics/ Transmitting / Microphone / No Function

73130 Acoustics/ Transmitting / Microphone / Mechanical damage

73140 Acoustics/ Transmitting / Microphone / Noise

Use hot air blower to remove defective component. Avoid excessive heat! Watch surrounding components!

E-commerce order number: C39254-Z6-C139 Soldering temperature: 240 – 255°C

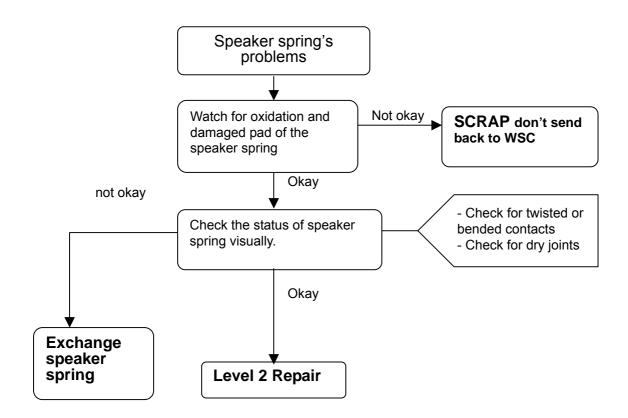
Speaker Spring

Fault Symptoms		
Customer:	GRT:	
No ring tone under correct setting.	No Support

IRIS Diagnose Code: 74000 Acoustics/ Ringer / No Function

41300 Acoustics/ Ringer / Mechanical Damage

Use tweezers to remove defective component. Avoid excessive heat! Watch surrounding components! Re-solder new component afterwards.

E-commerce order number: C39334-Z97-C487 Soldering temperature: 240 – 255°C

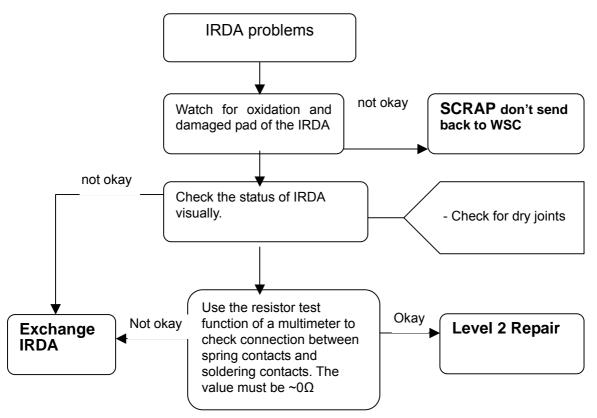
Fault Symptoms	
Customer:	GRT:
No infrared connection possible.	No Support

IRIS Diagnose Code: 41100 Interfaces/ IRDA / No Function

41300 Interfaces/ IRDA / Mechanical Damage

Use hot air blower to remove defective component. Avoid excessive heat! Watch surrounding components! Re-solder new component afterwards.

E-commerce order number: V20810-U6208-D670

Soldering temperature: 240 – 255°C

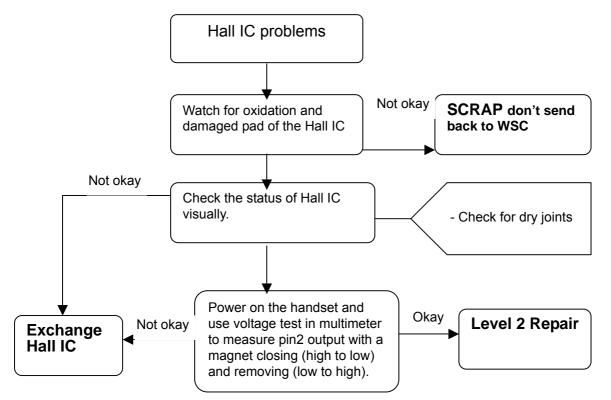
Hall IC

Fault Symptoms		
Customer:	GRT:	
No infrared connection possible.	No Support

Use hot air blower to remove defective component. Avoid excessive heat! Watch surrounding components! Re-solder new component afterwards.

E-commerce order number: V20810-U6207-D670

Soldering temperature: 240 – 255°C
