Service Repair Documentation

Level 2.5 - S65

Introduction

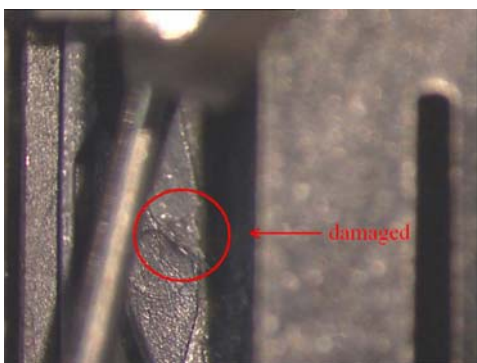
Lock mechanism damaged

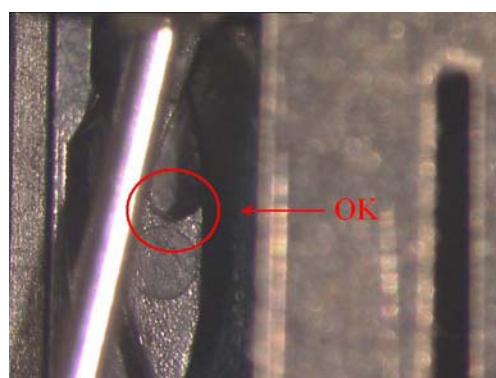
Lock mechanism OK

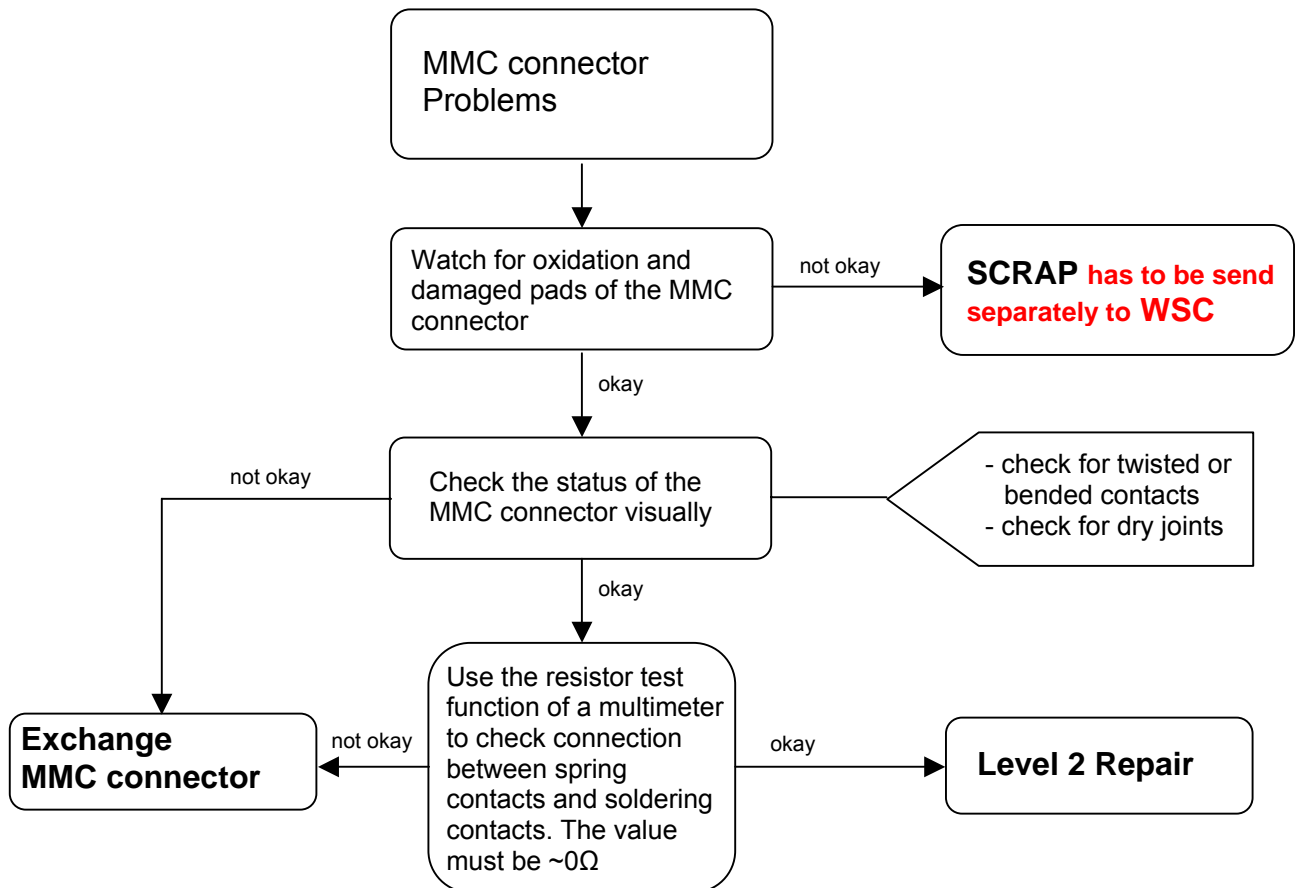
Connector MMC

Fault Symptoms	
Customer: MMC malfunction	GRT: Tbd.

Use soldering iron to remove defective component. Avoid excessive heat! Watch surrounding components! Resolder new component afterwards.

E-commerce order number: L36334-Z97-C342
Soldering temperature: 240 - 255°C
IRIS Diagnose Code: B1120 Accessories / Memory / MMC / Defect

Attention: Avoid excessive heat in order not to damage the plastic material of the connector (see problem SLIM-Lumberg connector)

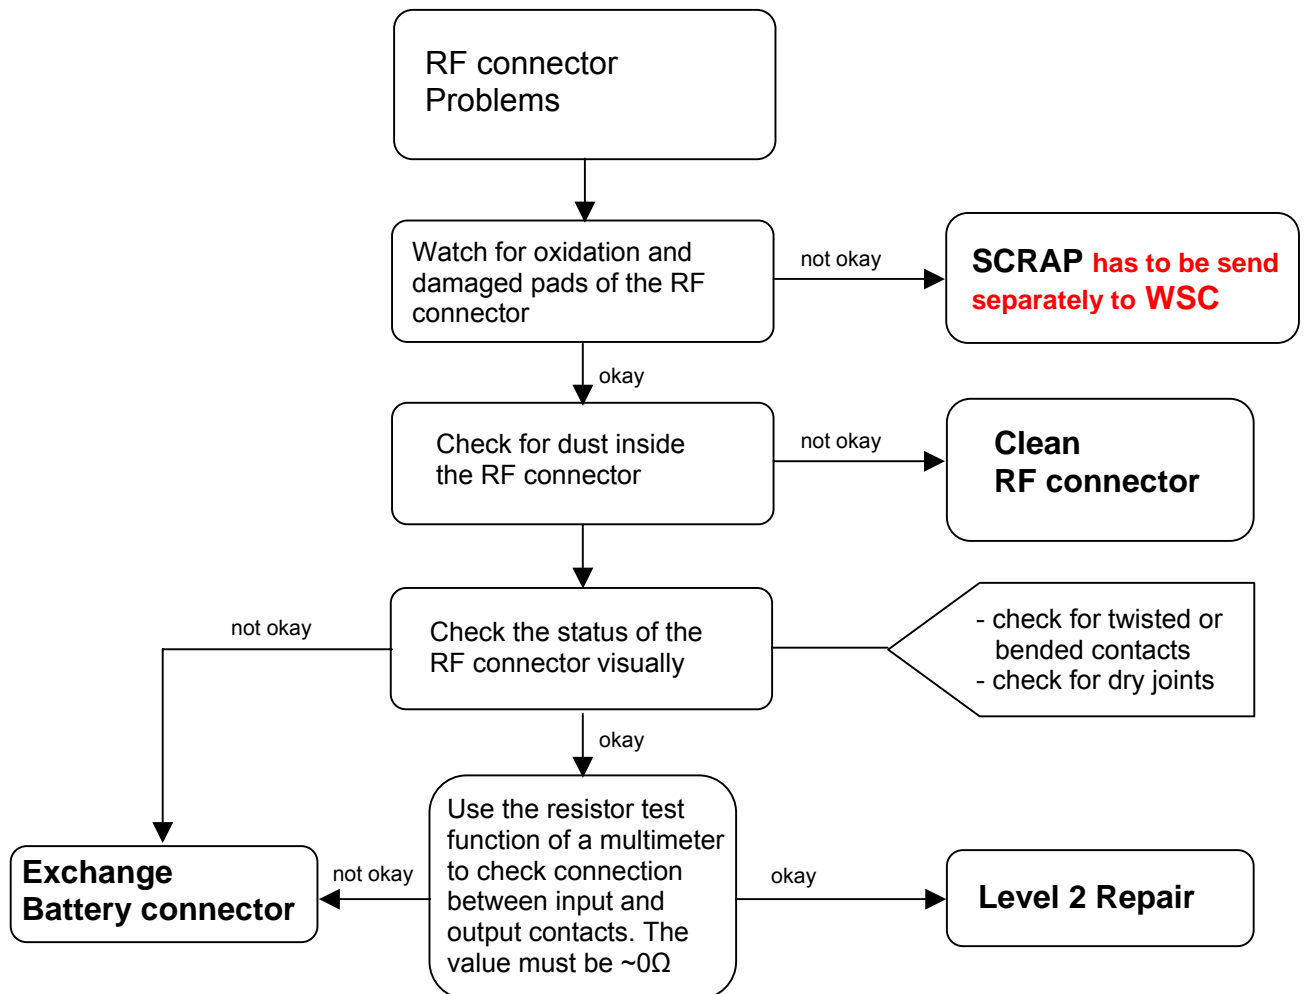
Connector RF

Fault Symptoms	
Customer: Network search No location update possible	GRT: Failure by TX/RX measurements No location update possible

Use hot air blower to remove defective component. Avoid excessive heat! Watch surrounding components! Resolder new component afterwards.

E-commerce order number: L36334-Z93-C297

Soldering temperature: 240 - 255°C

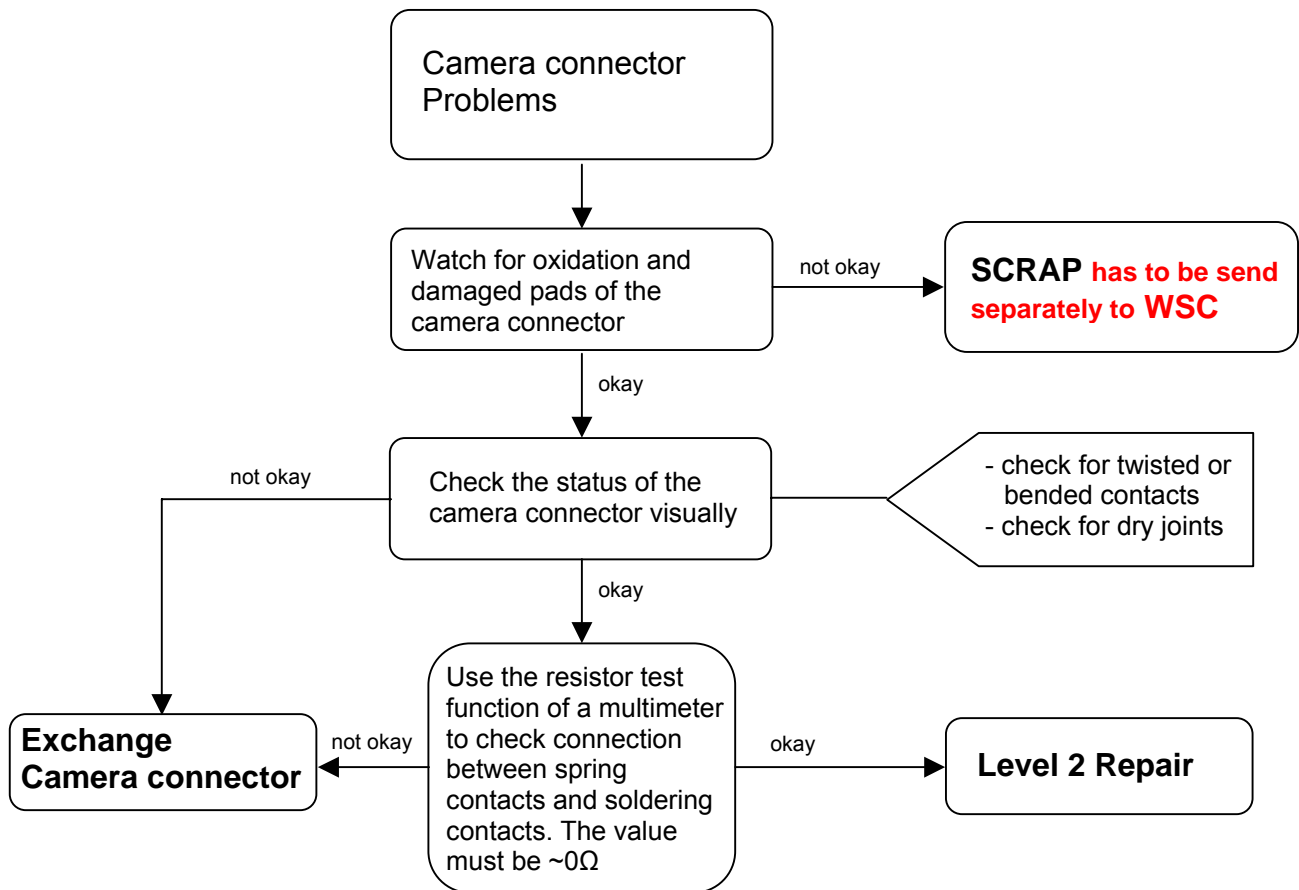
Connector CAMERA

Fault Symptoms	
Customer: Camera malfunction	GRT: Tbd.

Use hot air blower to remove defective component. Avoid excessive heat! Watch surrounding components! Resolder new component afterwards.

E-commerce order number: L36197-F5008-F341
Soldering temperature: 240 - 255°C
IRIS Diagnose Code: BA000 Accessories / Camera

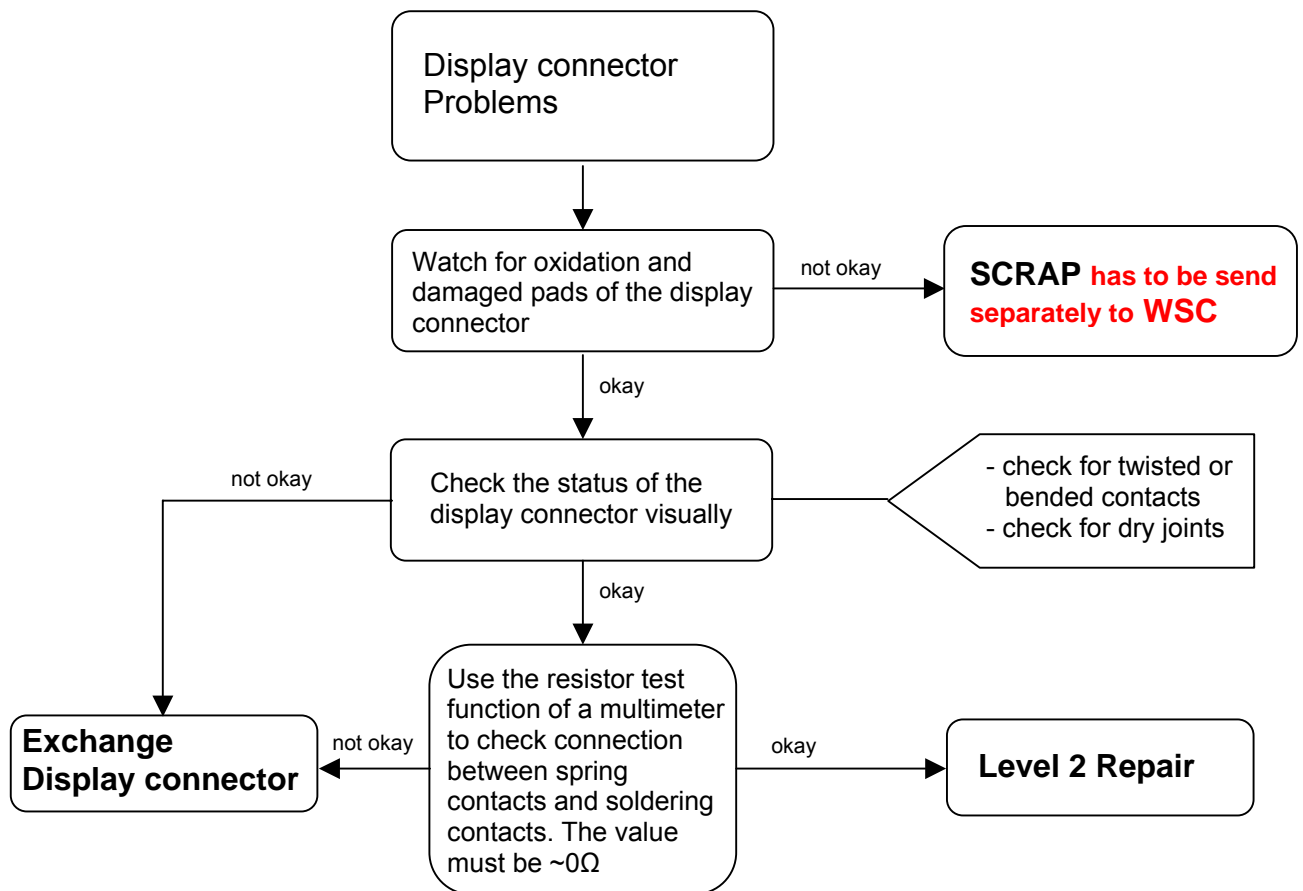
Connector DISPLAY

Fault Symptoms	
Customer: Display problems, like missing lines or columns on the LCD or display contrast problems or illumination problems	GRT: Display problems

Use hot air blower to remove defective component. Avoid excessive heat! Watch surrounding components!
Resolder new component afterwards.

E-commerce order number: L36334-Z97-C205
Soldering temperature: 240 - 255°C
IRIS Diagnose Code: 21000 Display / Performance
22000 Display / Background Illumination

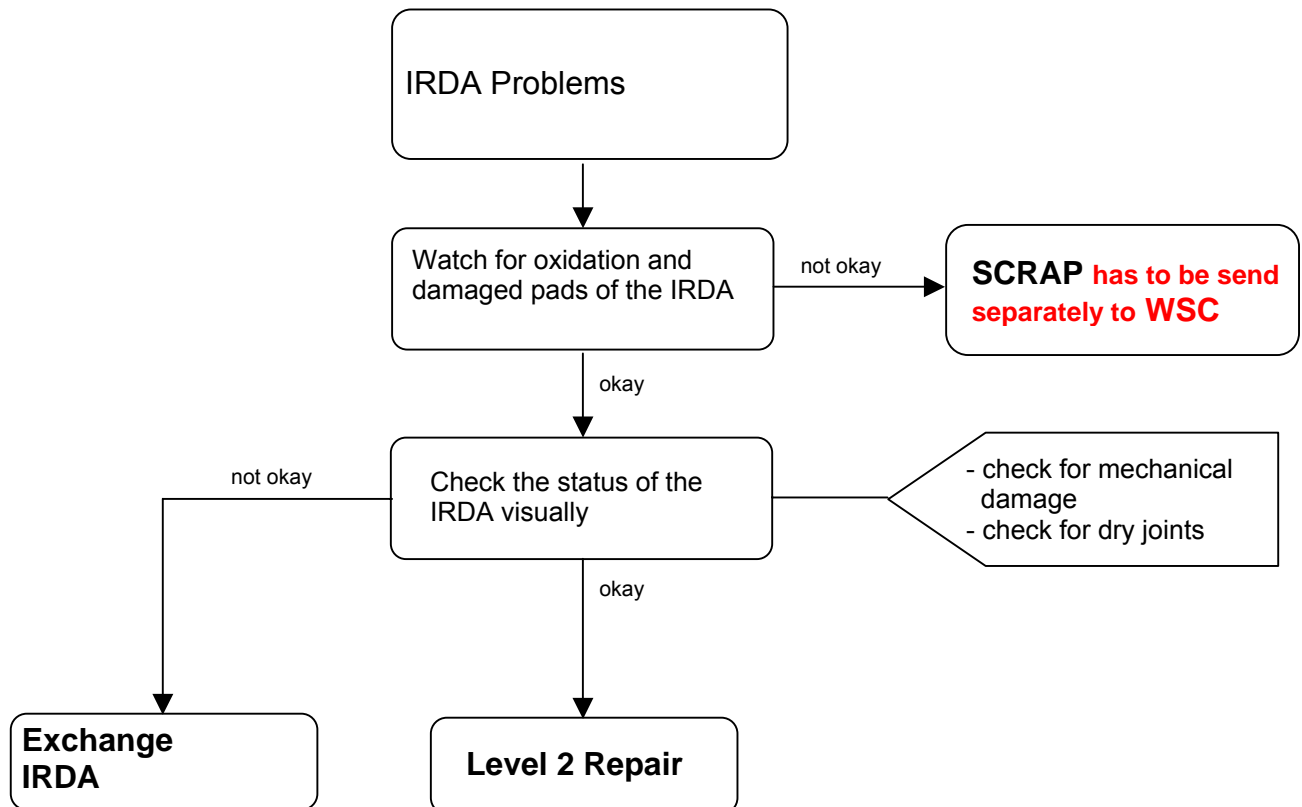
Fault Symptoms	
Customer: No infrared connection possible	GRT: Tbd.

Use hot air blower to remove defective component. Avoid excessive heat! Watch surrounding components! Resolder new component afterwards.

E-commerce order number: L36810-U6130-D670
 Soldering temperature: 240 - 255°C
 IRIS Diagnose Code: 41100 Interfaces / IRDA / No Function
 41300 Interfaces / IRDA / Mechanical Damage

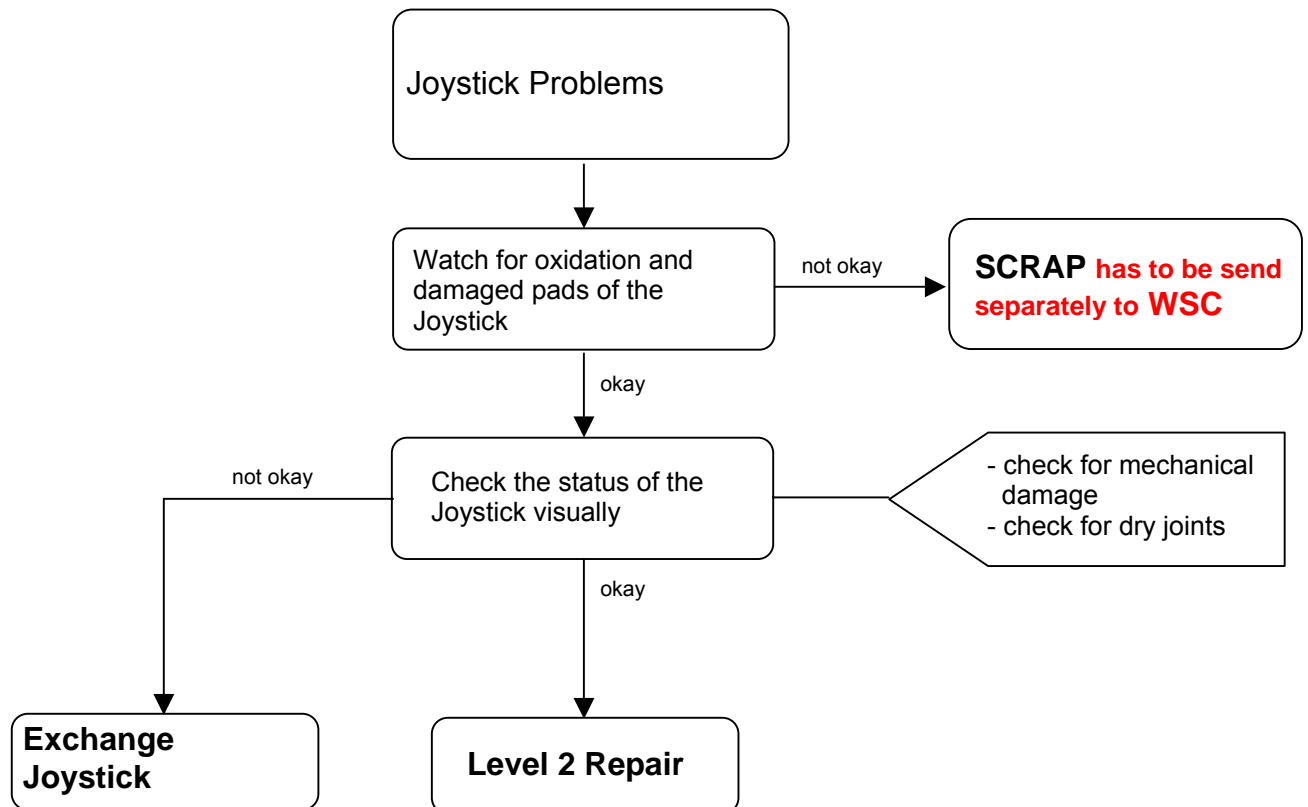
Fault Symptoms	
Customer: Joystick malfunction	GRT: Tbd.

Use hot air blower to remove defective component. Avoid excessive heat! Watch surrounding components!
 Resolder new component afterwards.

E-commerce order number: L36315-Z77-C218
 Soldering temperature: 240 - 255°C
 IRIS Diagnose Code: 32100 Keys / Main / No Function
 32200 Keys / Main / Reduced Functionality
