Service Repair Documentation

Level 2.5 – SF65

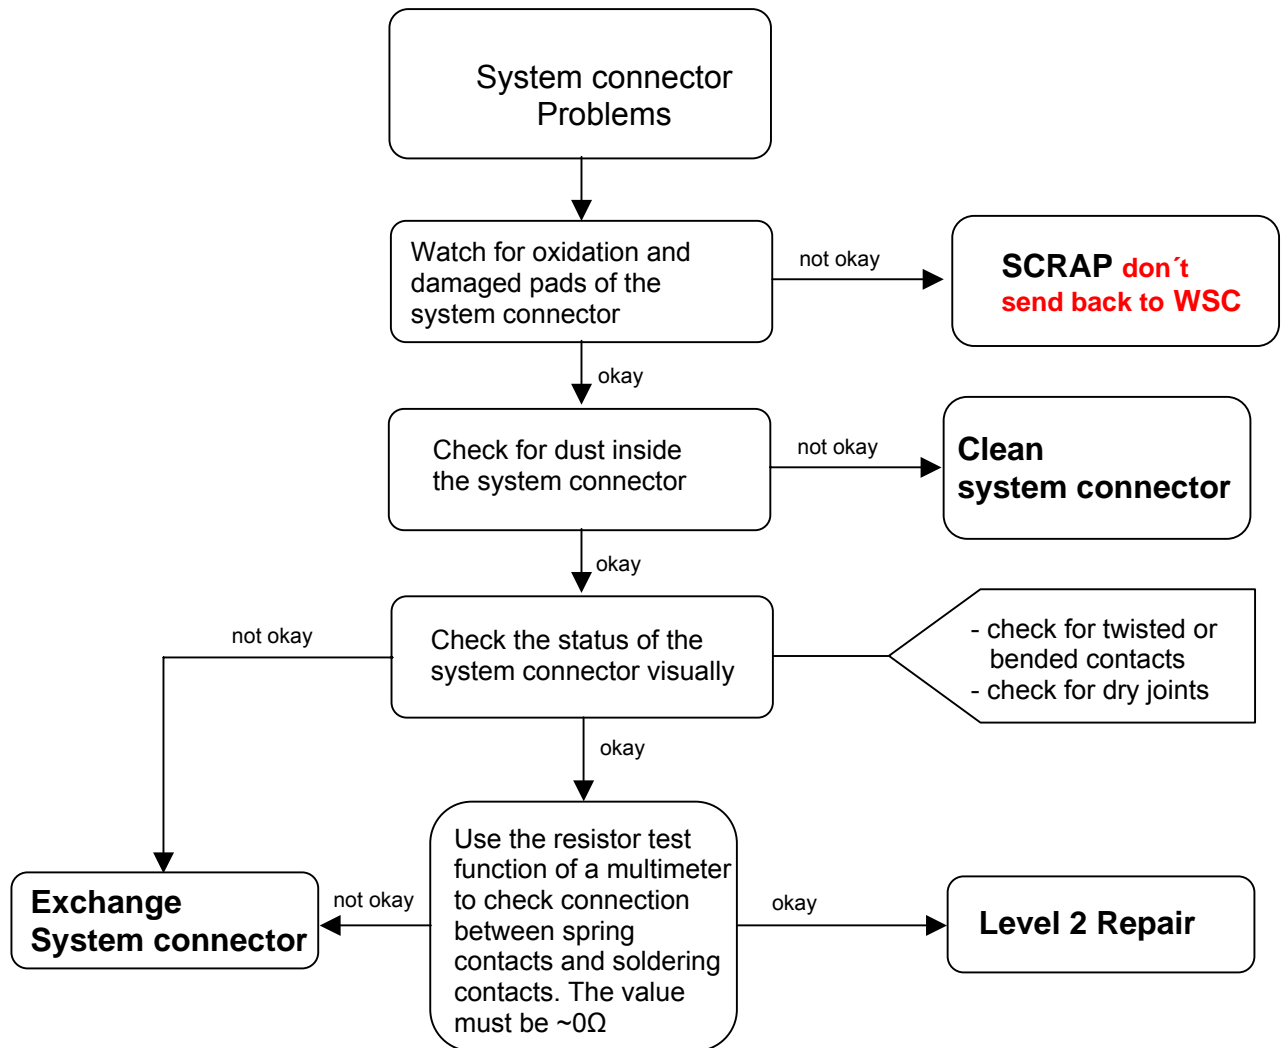
System Connector

Fault Symptoms	
Customer: Charging Problems Problems with external loudspeaker or microphone when using a car kit Problems with accessories connected at the system connector	GRT: No connection to GRT Tbd.

Use soldering iron to remove defective component. Avoid excessive heat! Watch surrounding components! Resolder new component afterwards.

E-commerce order number: L50634-Z97-C64
Soldering temperature: 240 - 255°C
IRIS Diagnose Code: 46100 Interface/Charging Connector/Mechanical Damage
47300 Interface/Data Interface/Mechanical Damage
4B100 Interface/Headset Connector/Mechanical Damage

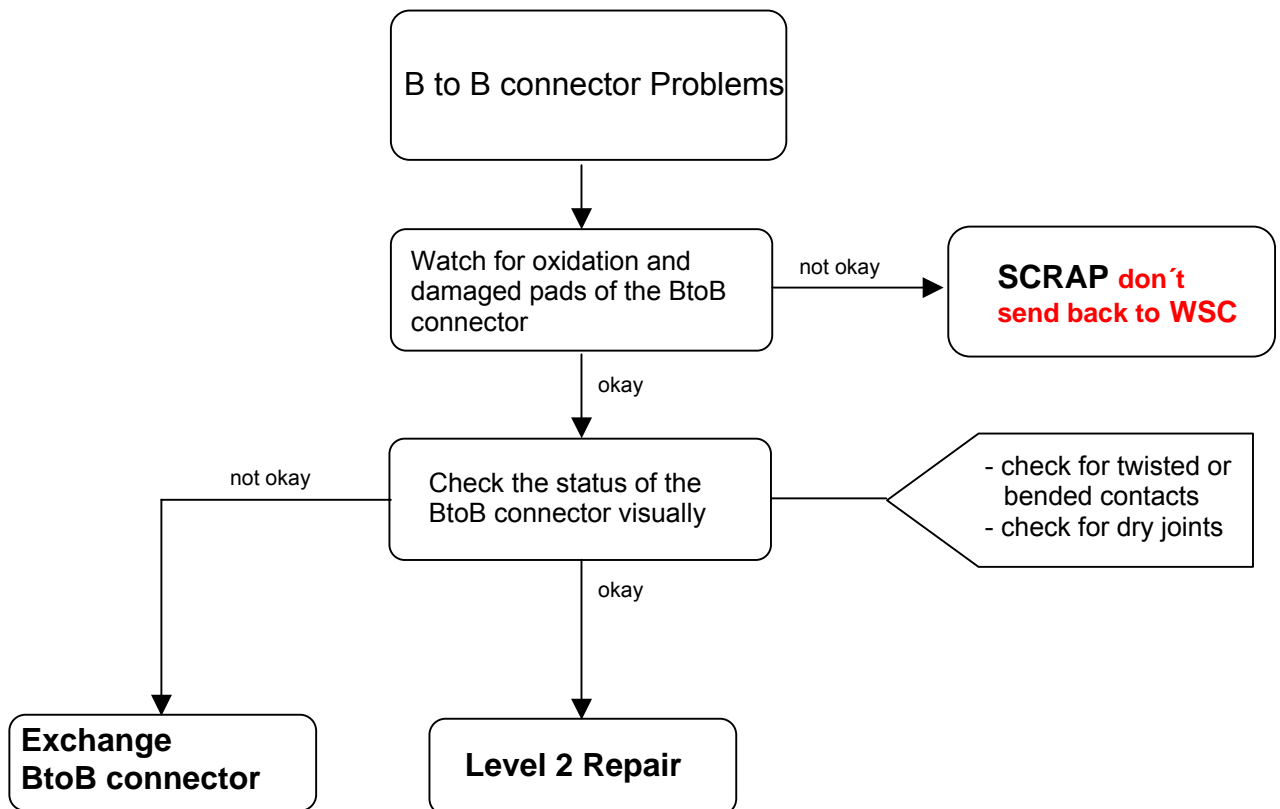
Display Connector - Board to Board Connector

Fault Symptoms	
Customer: Display problems, like missing lines or columns on the LCD or display contrast problems or illumination problems	GRT: Display problems

Use soldering iron to remove defective component. Avoid excessive heat! Watch surrounding components! Resolder new component afterwards.

E-commerce order number: L50634-Z97-C58
 Soldering temperature: 240 - 255°C
 IRIS Diagnose Code: 2A100 Display/Performance
 2A100 Display/Background Illumination
 72110 Acoustics/Receiving/Earcap/No Function
 72170 Acoustics/Receiving/Earcap/Low Voice Level

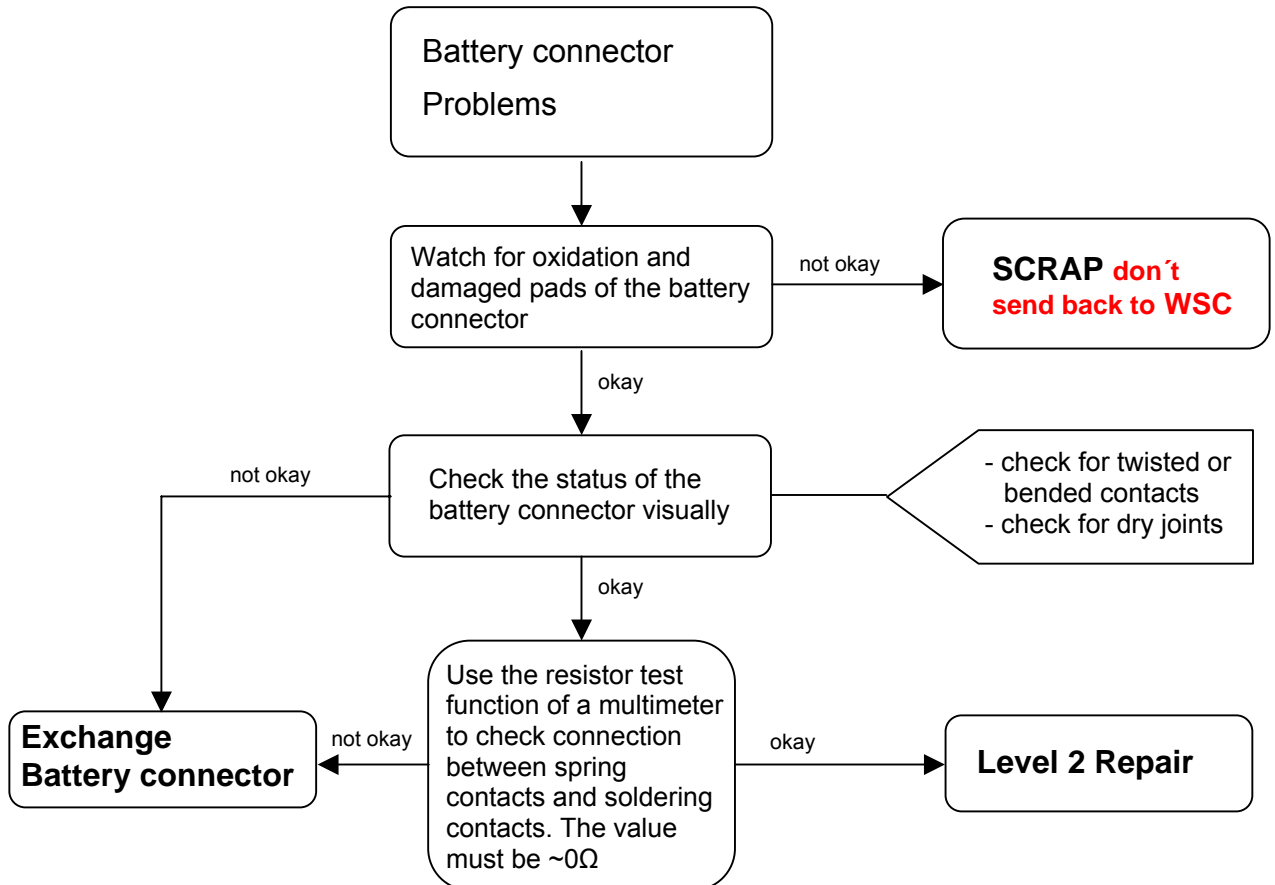
Connector BATTERY

Fault Symptoms	
Customer: Mobile does not switch on	GRT: No connection to GRT

Use soldering iron to remove defective component. Avoid excessive heat! Watch surrounding components! Resolder new component afterwards.

E-commerce order number: L50634-Z97-C59
Soldering temperature: 240 - 255°C
IRIS Diagnose Code: 13000 Battery/Mechanical Damage

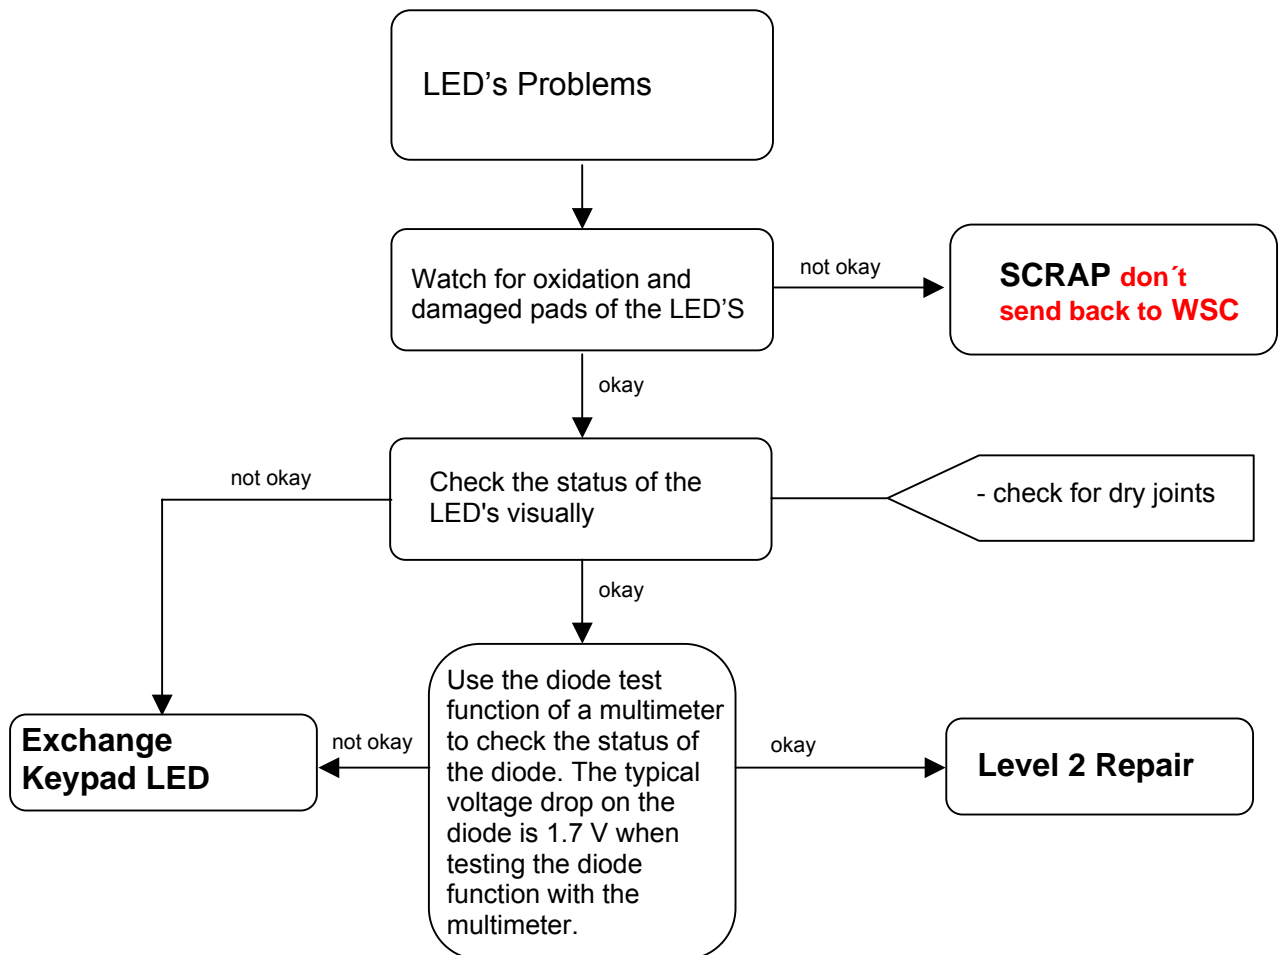
White LED

Fault Symptoms	
Customer: Keypad illumination does not work	GRT: Tbd.

Use soldering iron to remove defective component. Avoid excessive heat! Watch surrounding components! Resolder new component afterwards. **Attention: Remove Metal Dome Sheet before!!!**

E-commerce order number: L50640-Z97-C64
Soldering temperature: 240 - 255°C
IRIS Diagnose Code: 36000 Keys/Illumination

Use soldering iron to remove defective component. Avoid excessive heat! Watch surrounding components! Resolder new component afterwards.

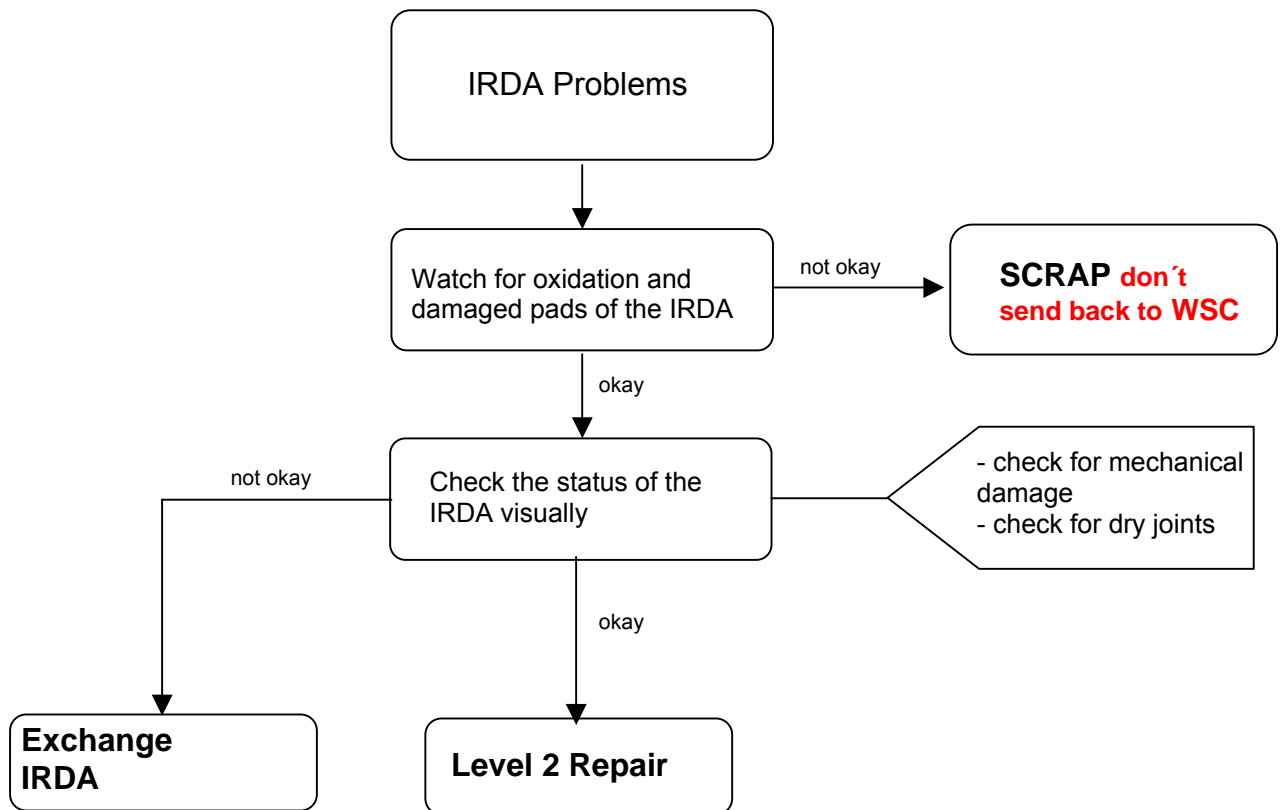
Fault Symptoms	
Customer: No infrared connection possible	GRT: Tbd.

Use soldering iron to remove defective component. Avoid excessive heat! Watch surrounding components! Resolder new component afterwards.

E-commerce order number: L50610-U6189-D670
 Soldering temperature: 240 - 255°C
 IRIS Diagnose Code: 41100 Interfaces / IRDA / No Function
 41300 Interfaces / IRDA / Mechanical Damage

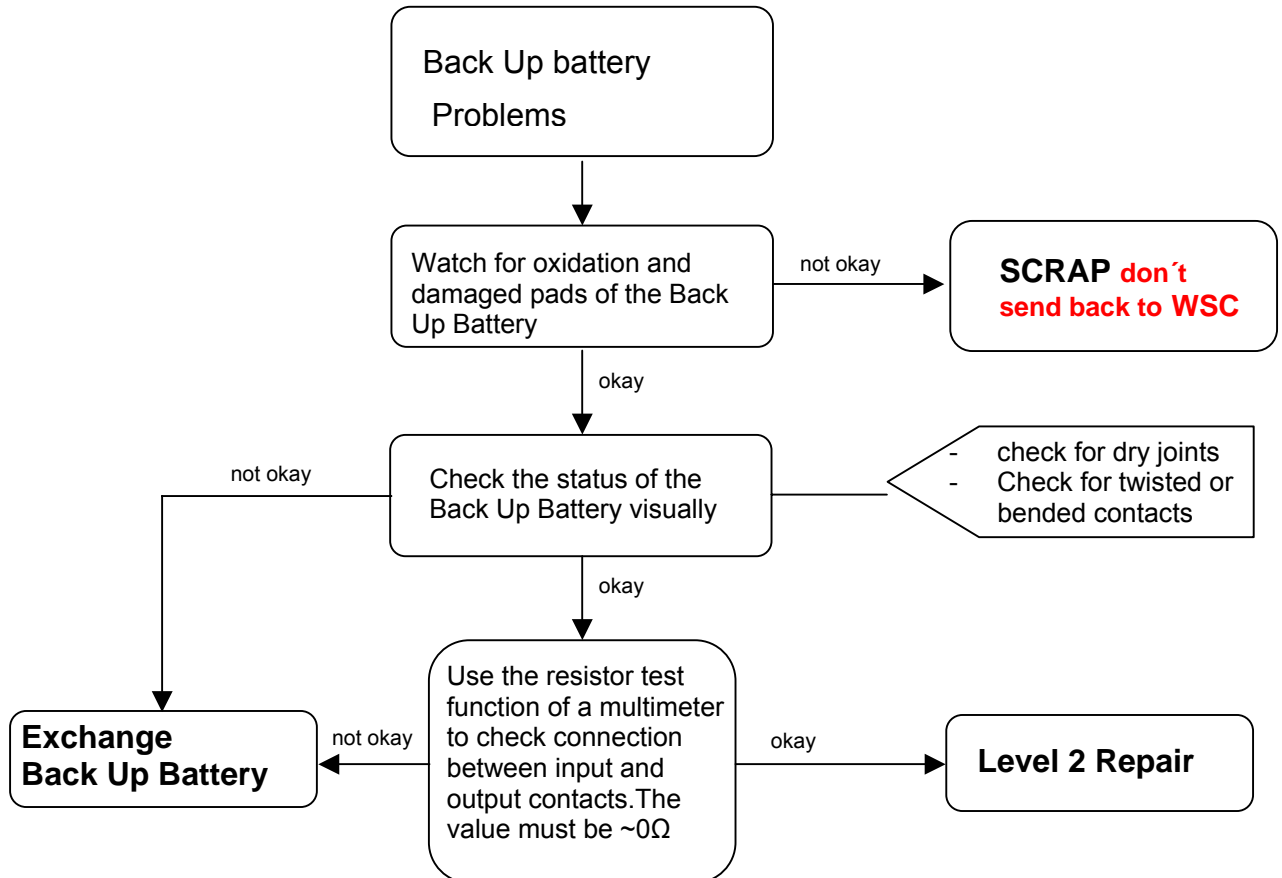
Back Up Battery

Fault Symptoms	
Customer: Customer parameter (date and time) are not saved when battery is removed	GRT: Tbd.

Use soldering iron to remove defective component. Avoid excessive heat! Watch surrounding components! Resolder new component afterwards.

E-commerce order number: L50628-F2705-Z1
 Soldering temperature: 240 - 255°C
 IRIS Diagnose Code: 16000 : Battery / Backup Battery Performance
