# Service Repair Documentation

## Level 3 (basic)

### S80/82/SFG75

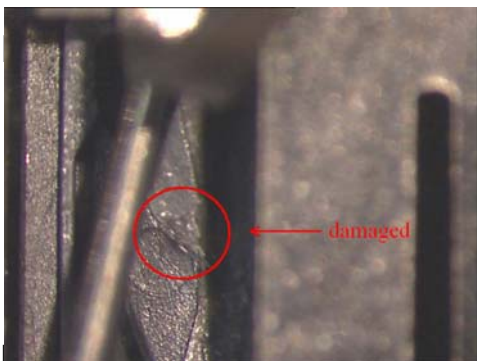
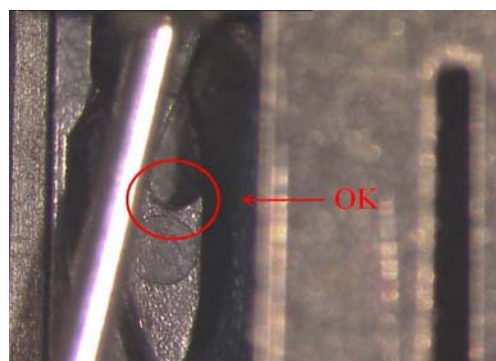
## Samples of critical area:

The MMC Reader is located on the opposite of the SLIM-Lumberg connector. Therefore the risk to damage the plastic material of this MMC-Reader is potentially high if excessive heat is used while removal or soldering of the SLIM-Lumberg connector.

- a) Remove the SLIM-Lumberg connector with a soldering iron and Resolder Wick
- b) Clean the Pads afterwards
- c) Solder the new connector by using soldering iron under consideration of the max. allowed temperature range.
