ST55

Level 2.5

Repair Documentation

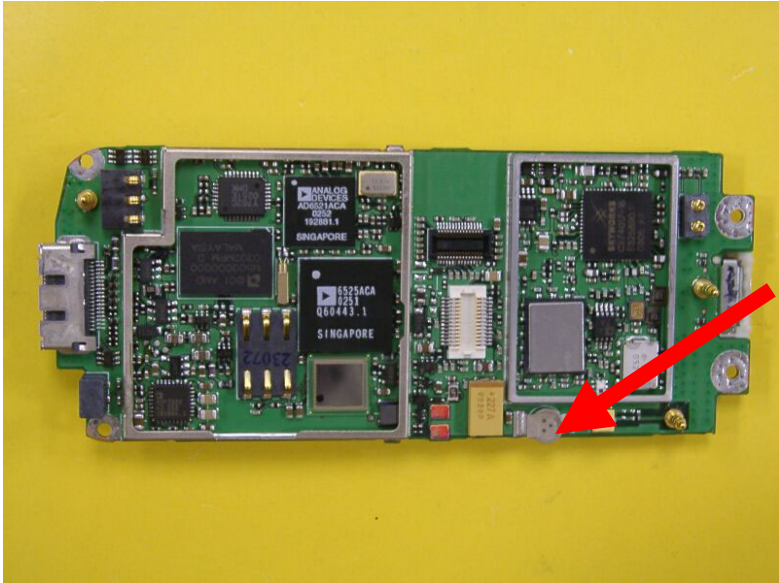
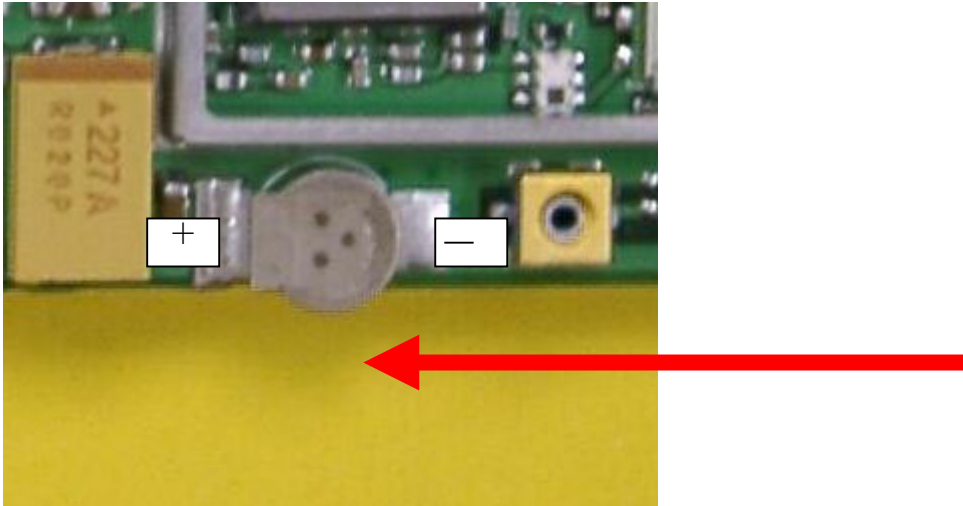
Figure 1.2: ST55 Board RTC Placement (RTC) (Top View)

Time/Clock will reset each time power on.
No call records can be saved.

Visual check and measure with a multimeter to detect if the RTC is oxidized or deformed.

1. Remove the defected RTC by Hot Air Blower (350°C ~ 400 °C) (350~400 °C).
2. Put on new RTC and add solder at the "+" side first.
3. Then add solder at the "-" side.
- 4.

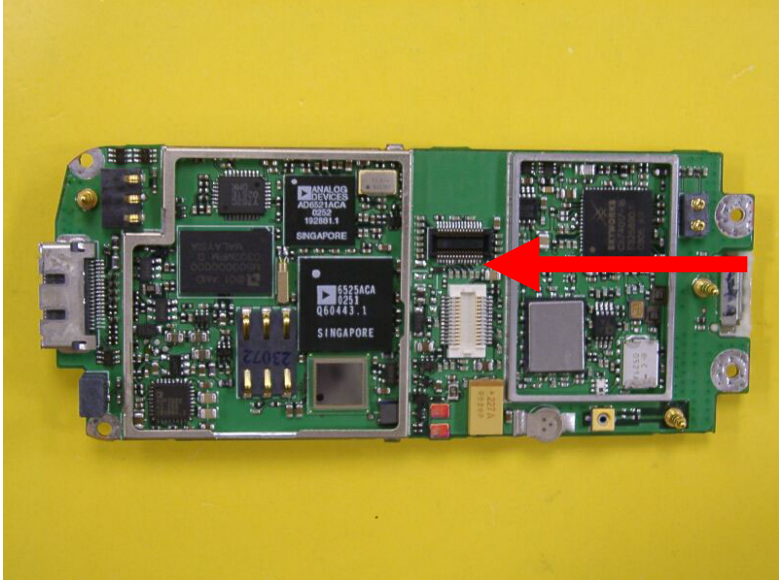
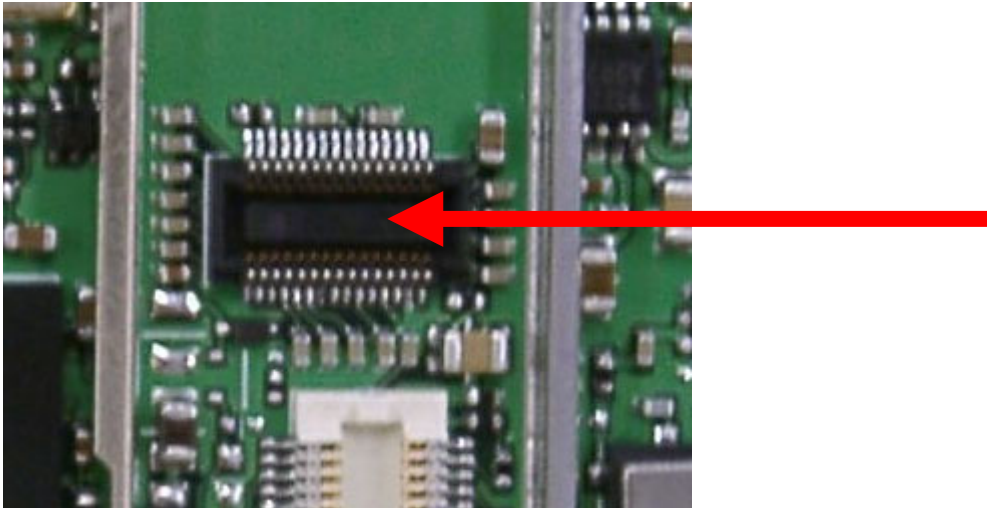
Figure 2.2: ST55 Board LCD Connector Placement (J503) (Top View)

No screen or wrong display.

Visual check and measure with a multimeter to detect if pins are cold, insufficient soldering, oxidized or deformed.

- 1.Re-solder this connector if cold or insufficient soldering.
- 2.Use hot blower to remove defective connector and add solder on pads.
Avoid excessive heat! Watch surrounding component!
- 3.Heat and put on a new connector to enhance adhesion.
- 4.Re-solder new connector afterwards.

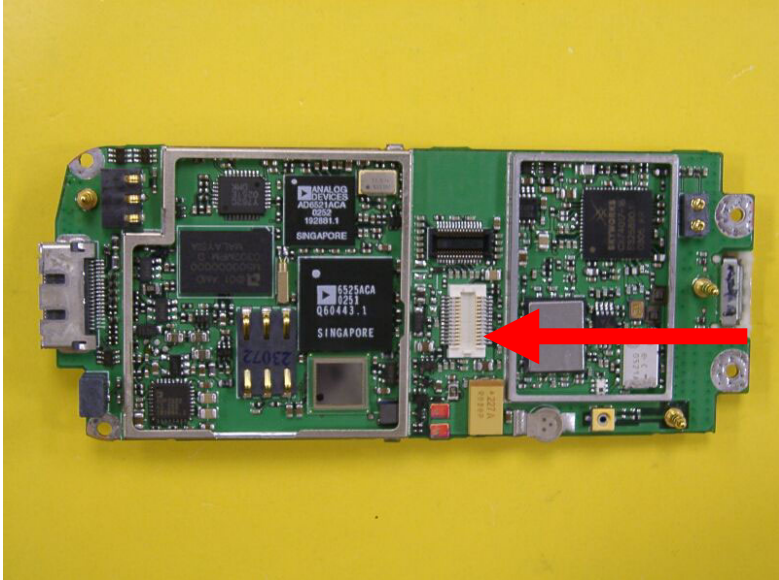
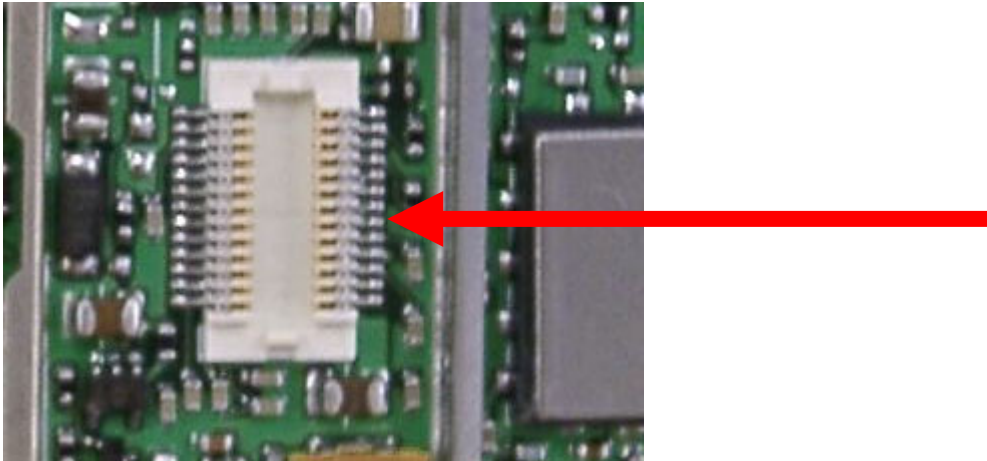
Figure 3.2: ST55 Board Camera Connector Placement (J504) (Top View)

The picture captured by camera can't be shown on screen or abnormal display.

Visual check and measure with a multimeter to detect if the pins are cold, insufficient soldering, oxidized or deformed.

- 1.Re-solder this connector if cold or insufficient soldering.
- 2.Use hot blower to remove defective connector and add solder on pads.
Avoid excessive heat! Watch surrounding component!
- 3.Heat and put on a new connector to enhance adhesion.
- 4.Re-solder new connector afterwards.

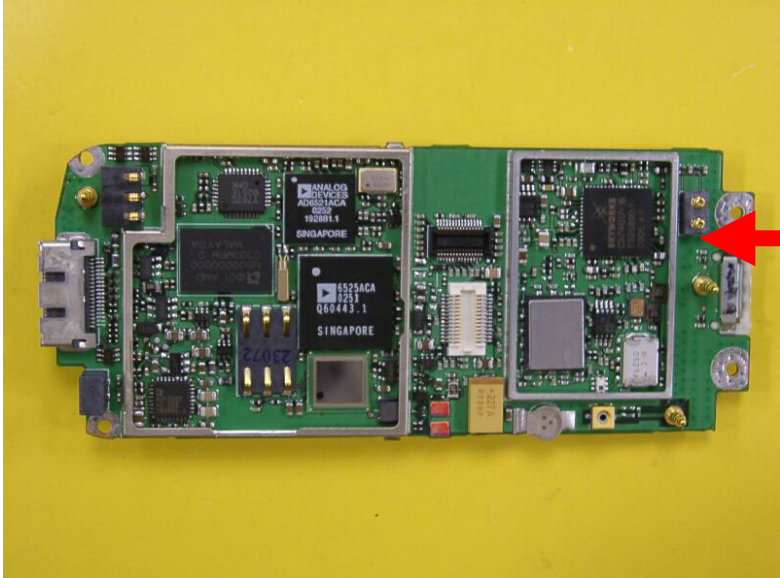
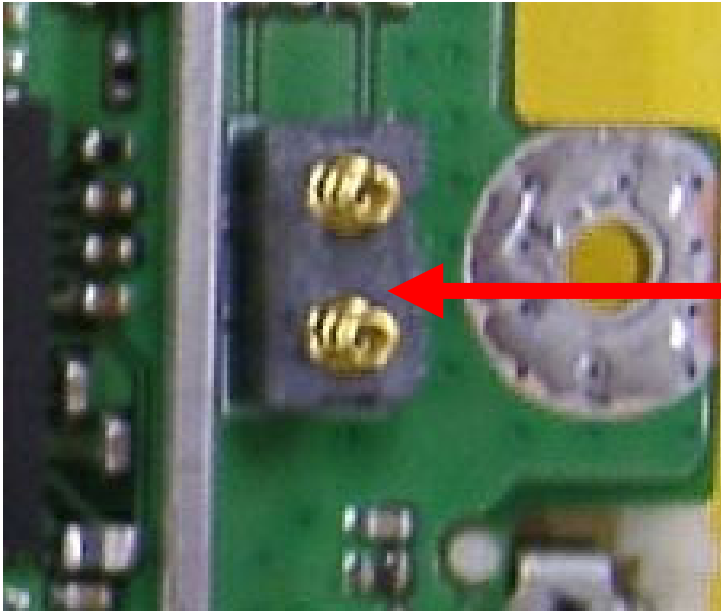
Figure 4.2: ST55 Board Speaker Spring Placement (JP202) (Top View)

No ring tone while setting and a call coming.

Visual check if the springs are oxidized or deformed.

1. Use hot blower to remove the defective connector.
Avoid excessive heat! Watch surrounding components!
2. Add solder on pads.
3. Heat and put on a new connector to enhance adhesion.

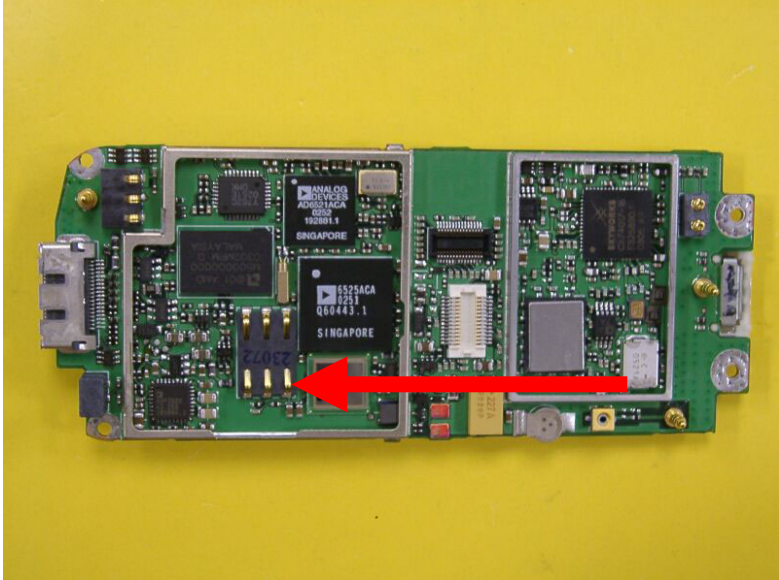
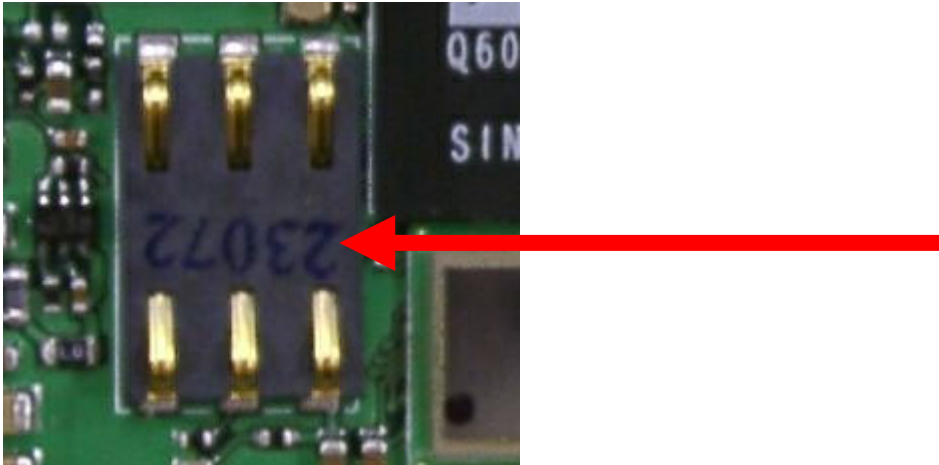
Figure 5.2: ST55 Board SIM Connector Placement (J101) (Top View)

Always "Insert SIM card" showed under normal operation.

Visual check and measure with multimeter if pins are cold, insufficient soldering, oxidized or deformed.

- 1.Re-solder this connector if cold or insufficient soldering.
- 2.Use hot blower to remove the defective connector if oxidized or deformed and absorb remaining tin on pads.
3. Put on new connector and add solder on pins in diagonal sequence.

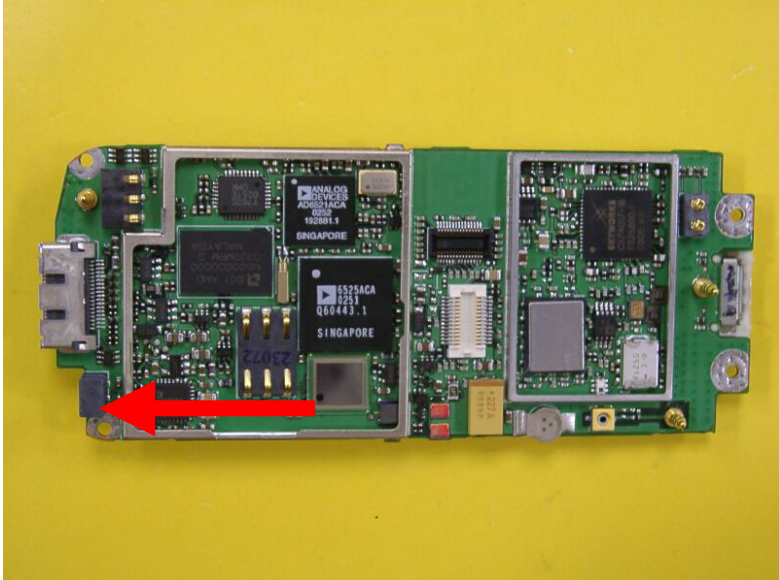
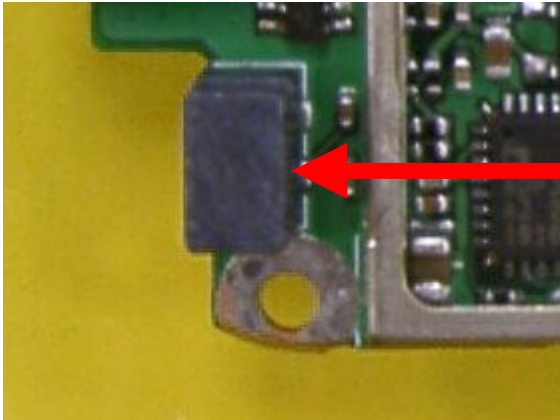
Figure 6.2: ST55 Board MIC Connector Placement (JP201) (Top View)

The called party can't hear any voice.

Measure pin2 to R206 with multimeter to check cold or insufficient soldering.

- 1.Use hot blower to remove the defective connector.
Avoid excessive heat! Watch surrounding components!
- 2.Add solder on pads.
- 3.Heat and put on a new connector to enhance adhesion.

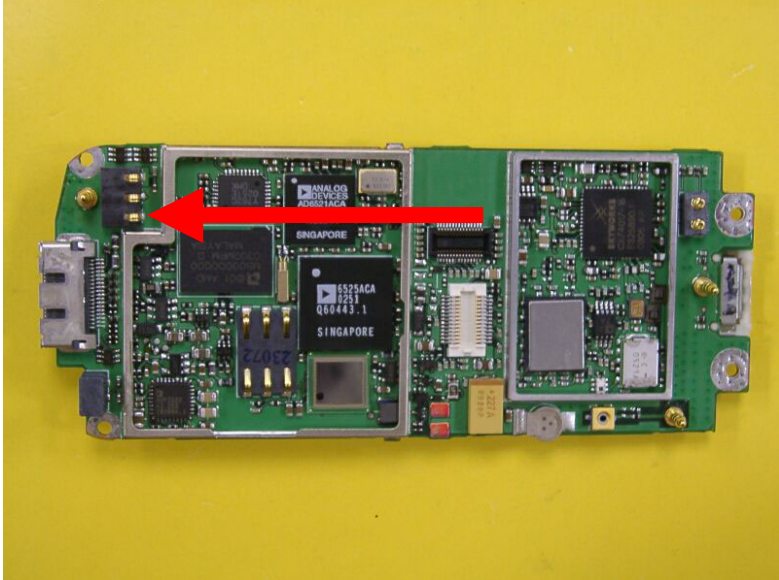
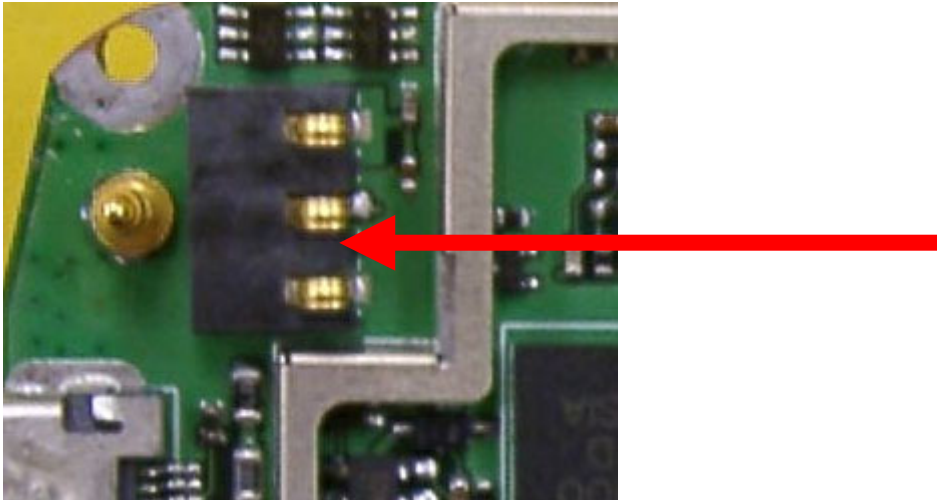
Figure 7.2: ST55 Board Battery Connector Placement (JP301) (Top View)

Can't power on under normal operation.
Can't charge by this mobile when power off.

Eye check pins if oxidized or deformed.
Measure pins to test points (VBAT, GND) by the multimeter to check conductivity.

1. Use hot blower to remove the defective connector.
Avoid excessive heat! Watch surrounding components!
2. Add solder.
3. Heat and put on a new connector to enhance adhesion.
4. Re-solder if needed.

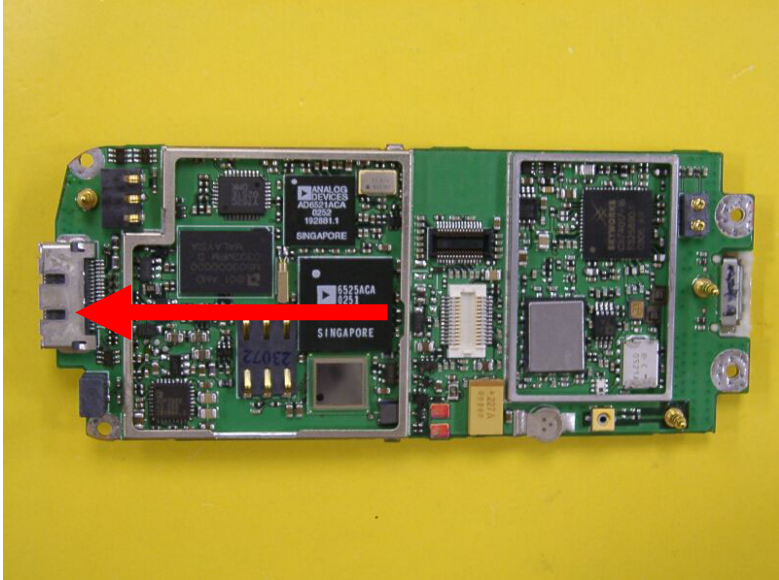
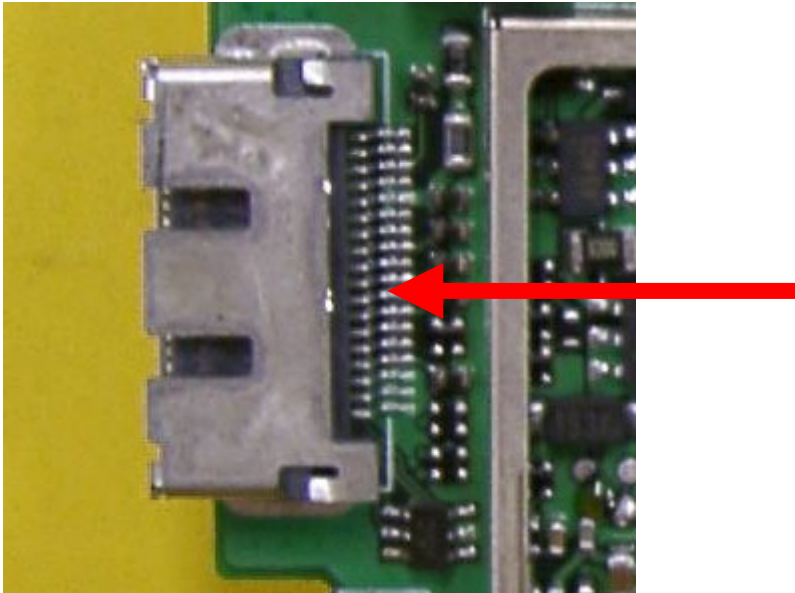
Figure 8.2: ST55 Board IO Connector Placement (JP401) (Top View)

Can't charge. No charging icon shown when plugging the charger in. Earphones can't be used.

Visual check and measure with multimeter if pins are cold, insufficient soldering, oxidized or deformed.

1. Re-solder this connector if cold or insufficient soldering.
2. Use hot blower to remove the defective connector.
Avoid excessive heat! Watch surrounding components!
3. Add solder.
4. Heat and put on a new connector to enhance adhesion.
5. Re-solder if needed.

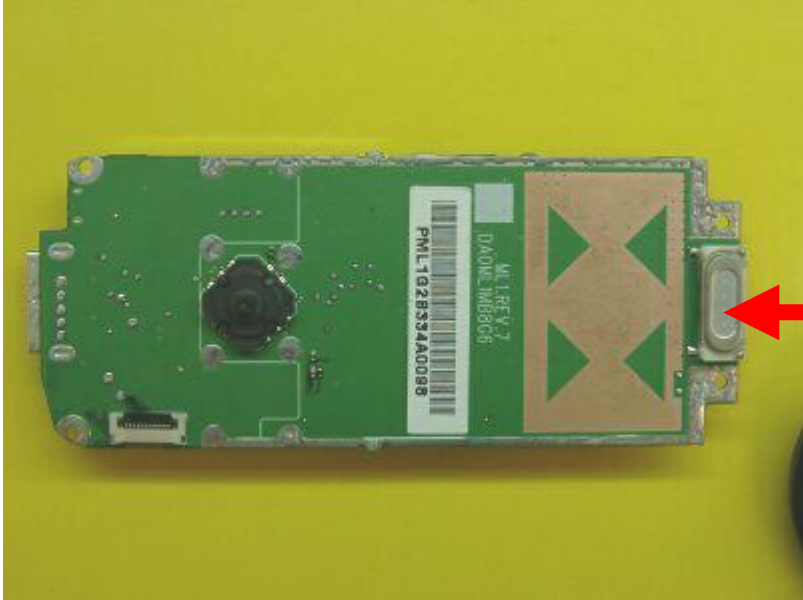
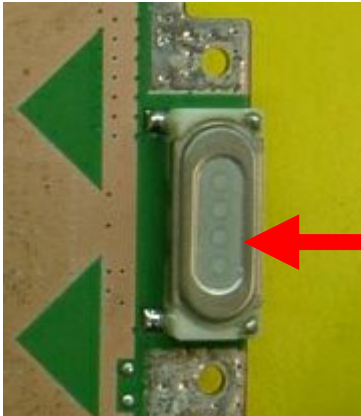
Figure 9.2: ST55 Board Earpiece Placement (JP203) (Top View)

The caller can't hear any voice.

Visual check and measure with multimeter to detect if pins are cold, insufficient soldering, oxidized or deformed.

1. Re-solder this connector if cold or insufficient soldering.
2. Heat and remove the defective earpiece by Soldering Iron (350°C ± 20 °C) from the topside.
3. Put on a new earpiece.
4. Heat and press the earpiece to the right position gently.
Avoid excessive heat! Watch surrounding component!
5. Re-solder if needed.

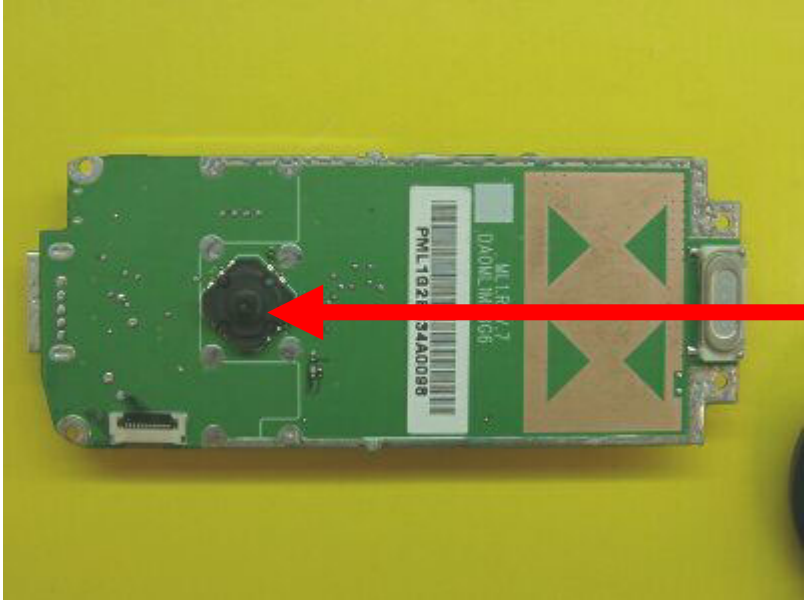
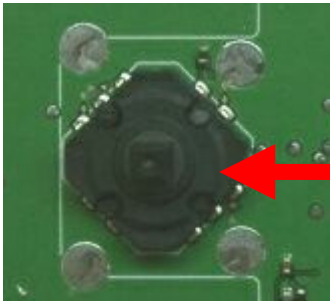
Figure 10.2: ST55 Board Joystick Placement (SW401) (Top View)

The joystick will be no function under normal operation.

Visual check and measure with multimeter if pins are cold, insufficient soldering, oxidized or deformed.

- 1.Re-solder this connector if cold or insufficient soldering.
- 2.Use hot blower to remove the defective connector if oxidized or deformed and absorb remaining tin on pads.
3. Put on new connector and add solder on pins in diagonal sequence.

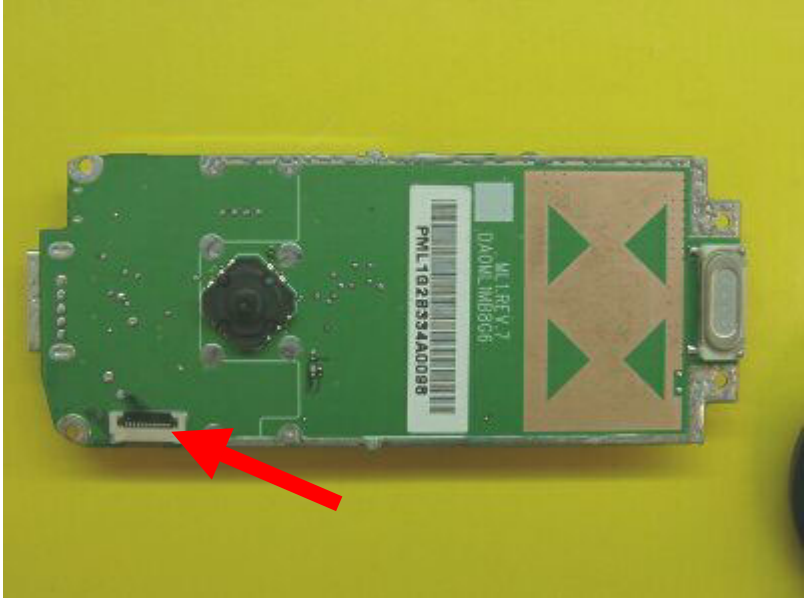
Figure 11.1: ST55 Board Keypad Connector Side (Top View)

Can't power on/off.
No response while pressing keys under normal operation.

Visual check and measure with multimeter if pins are cold, insufficient soldering, oxidized or deformed.

1. Re-solder this connector if cold or insufficient soldering.
2. Use hot blower to remove the defective connector.
Avoid excessive heat! Watch surrounding components!
3. Add solder.
4. Heat and put on a new connector to enhance adhesion.
5. Re-solder if needed.
