FIELD SERVICE BULLETIN

FSB Number: LVCCFSB2004-53

Subject: 3G Talon Integrated A835 Front Housing / Keypad

Model Affected: 3G Talon Integrated A835's

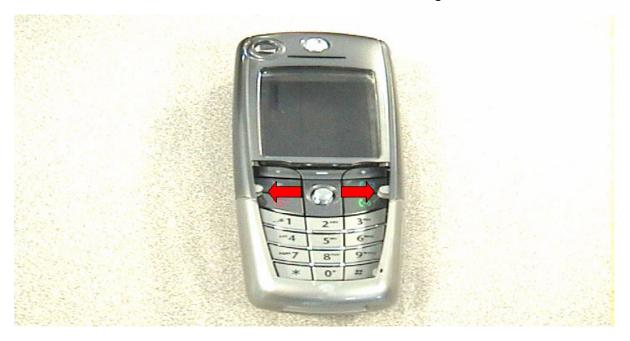
1. When removing the front housing on the A835, the screw bosses must clear the keypad or possible damage could occur to the EL bond and other assembled parts. In the picture below the two red arrows show the screw bosses, which need to clear the keypad during the disassembly process.

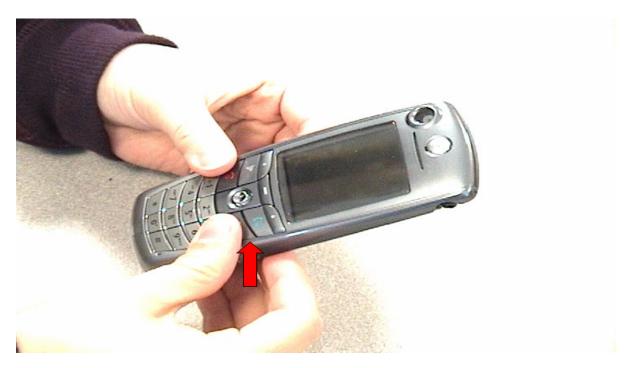
2. The First step is to flex the right hand side of the housing. The red area below shows where the screw boss is that needs to clear the keypad during disassembly.

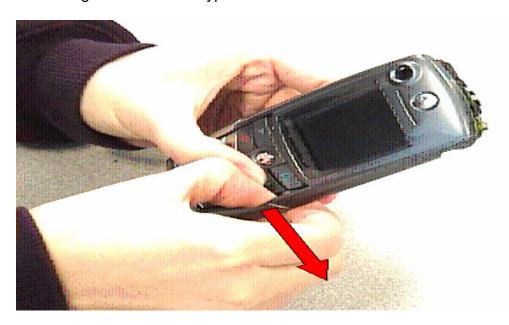
3. Secure the unit with your left hand by firmly pressing down on the keypad and holding the rear of the unit. With your right thumb, expand the right side of the housing by pulling your thumb in the direction of the red arrow. Once the screw boss is clear, lift the right hand side of the housing using your thumb and index finger around the keypad.

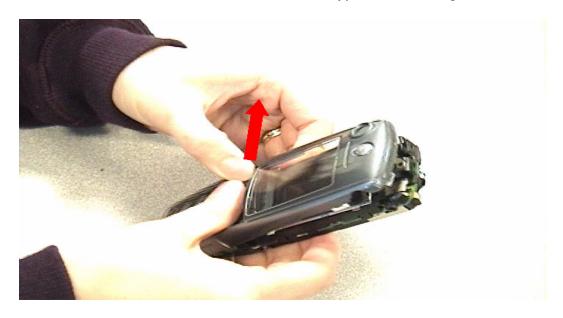
4. Once the right side of the housing is apart, use your right hand to secure the unit. Flex the left side of the housing using your left thumb as show by the red arrow. Once the screw boss is clear of the keypad, lift housing off the unit.

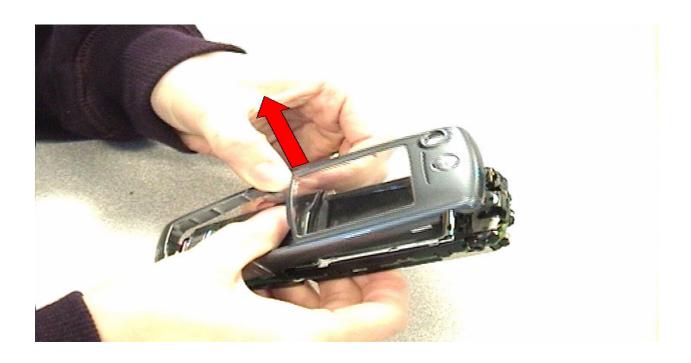
5. Once the screw boss is clear of the keypad, lift the housing off the unit as show below.

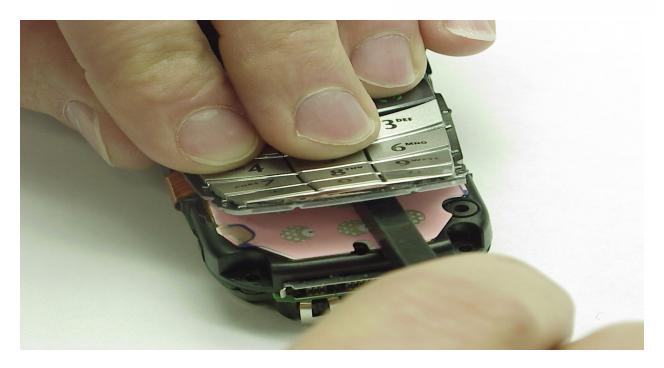
9. Carefully continue to insert the plastic disassembly tool to break the adhesive bond between the keypad and the EL backlighting as shown in the following pictures. Do not tear off the keypad at anytime. Continue to use the plastic disassembly tool to lift the keypad off.

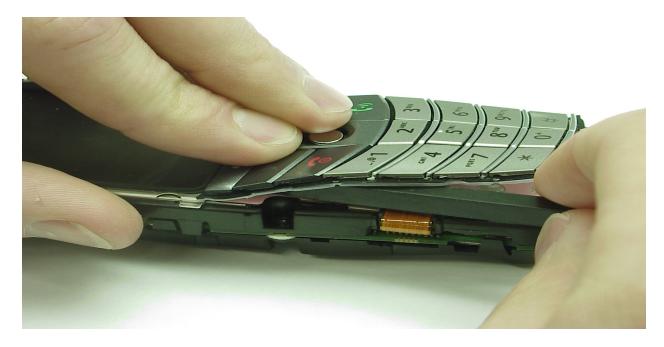
11. Continue to insert plastic disassembly tool until keypad is no longer adhered to the EL back lighting.
